Name Of Dam: UPPER CLINCH WATERSHED DAM NO. 8 Location: TAZEWELL COUNTY, VIRGINIA Inventory Number: VA 18501

## PHASE I INSPECTION REPORT NATIONAL DAM SAFETY PROGRAM

NORFOLK DISTRICT CORPS OF ENGINEERS

GILBERT ASSOCIATES, INC.

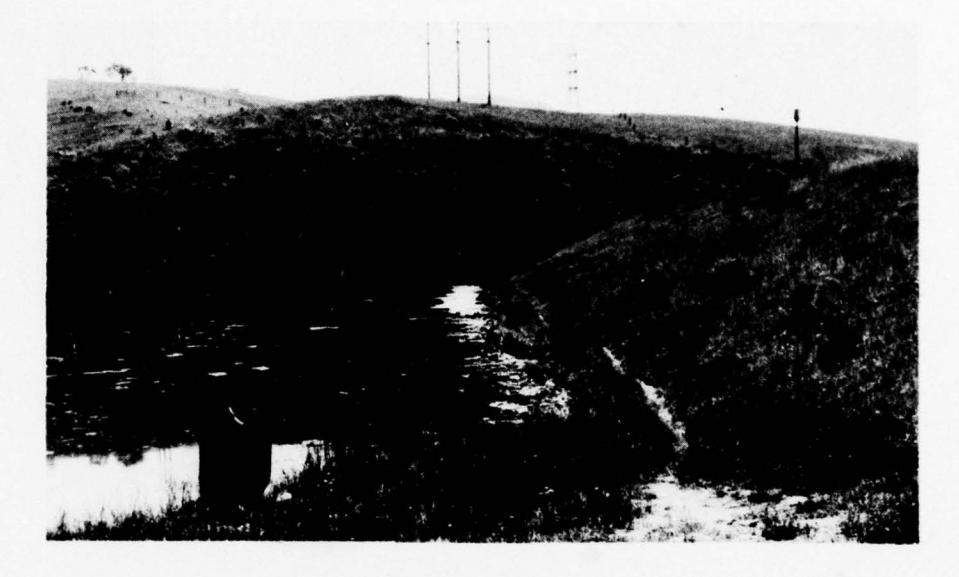
VIEW FROM EMERGENCY SPILLWAY - NOTE RIPRAP AT WATERLINE

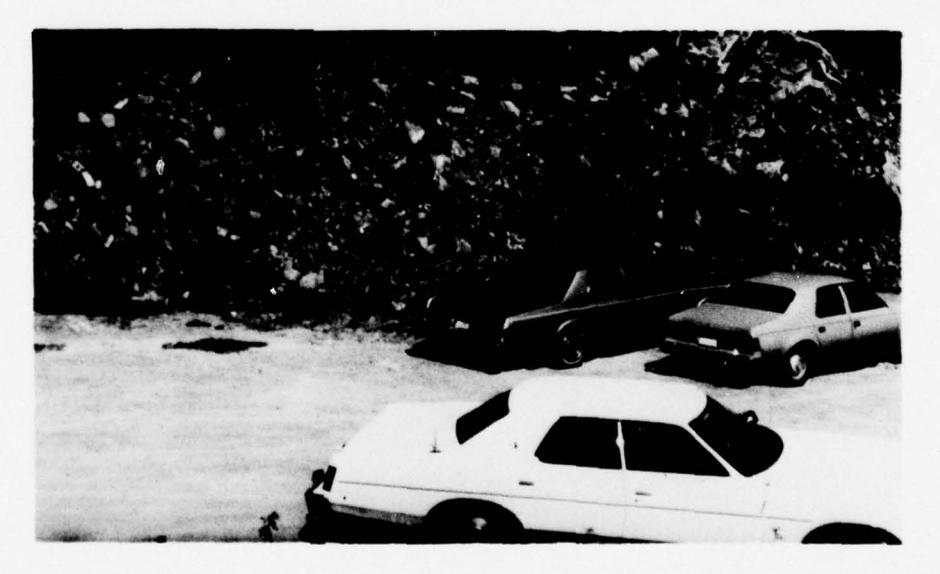
EMERGENCY SPILLWAY LOOKING DOWNSTREAM; BUILDING IN FOREGROUND IS FOR RECREATION ONLY
