Name Of Dam: LAUREL BED DAM

Location: RUSSELL COUNTY, VIRGINIA Inventory Number: VA 16701 PHASE I INSPECTION REPORT NATIONAL DAM SAFETY PROGRAM

PHASE I INSPECTION REPORT NATIONAL DAM SAFETY PROGRAM NAME OF DAM Laurel Bed Dam ID# VA 16701

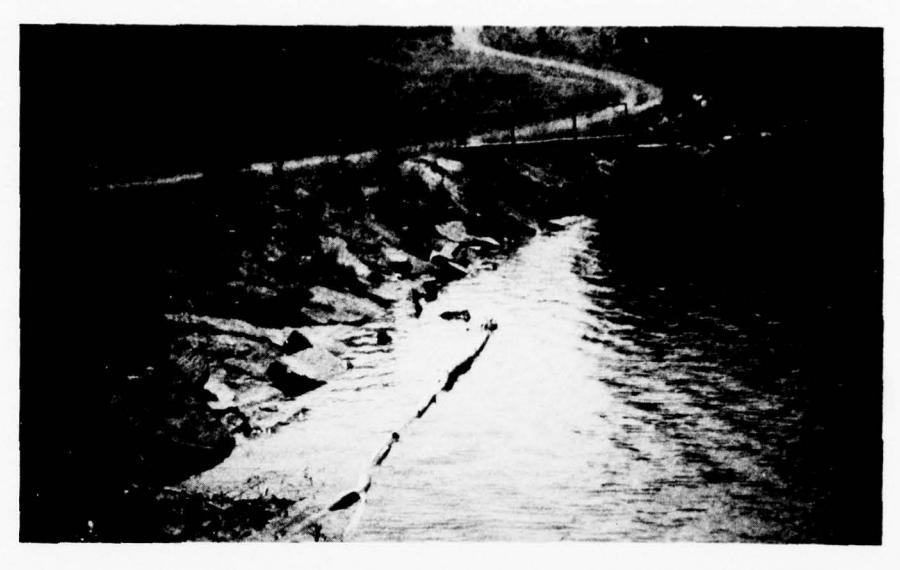
June 5, 1978

UPSTREAM FACE OF DAM SHOWING PRINCIPAL SPILLWAY AND DETERIORATING RIPRAP

no serious erosion has occurred the surface is deteriorating. This should be watched closely. REMARKS OR RECOMMENDATIONS design standards and although Riprap does not meet modern Sheet 1 Riprap consists of large stones scattered observed but riprap looks like it has been and will be subject to attack from No observed erosion or other structural over 2 inch stone layer: No erosion Crest appeared to be straight both vertically and horizontally. failure of any of the junctions. OBSERVATIONS EMBANKMENT None Observed None Observed None Observed ice. VERTICAL AND HORIZONTAL ALIGNMENT OF THE CREST SLOUGHING OR EROSION OF EMBANKMENT AND ABUTMENT AND ABUTMENT, SPILLWAY AND DAM JUNCTION OF EMBANKMENT CRACKING AT OR BEYOND VISUAL EXAMINATION OF UNUSUAL MOVEMENT OR RIPRAP FAILURES SURFACE CRACKS THE TOE SLOPES

7.2.4 Inspection Program: We recommend that the Owner establish a semi-annual inpection program to monitor the conditions at the dam. Particular attention should be given to monitoring seepage rates and wear of the riprap on the upstream face of the dam.

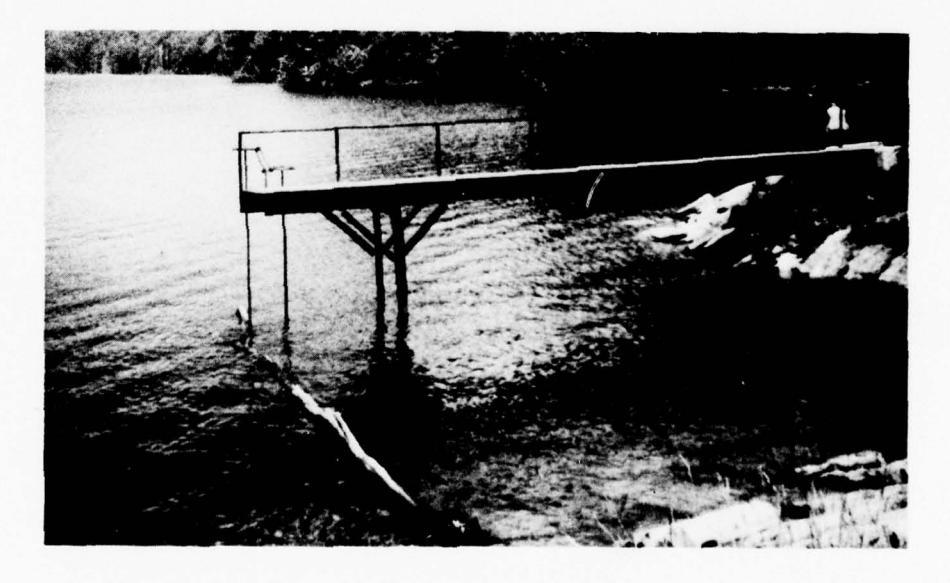
June 5, 1978

BRIDGE AND CONTROL RODS TO THE TWO 8 INCH SHALLOW RESERVOIR OUTLETS

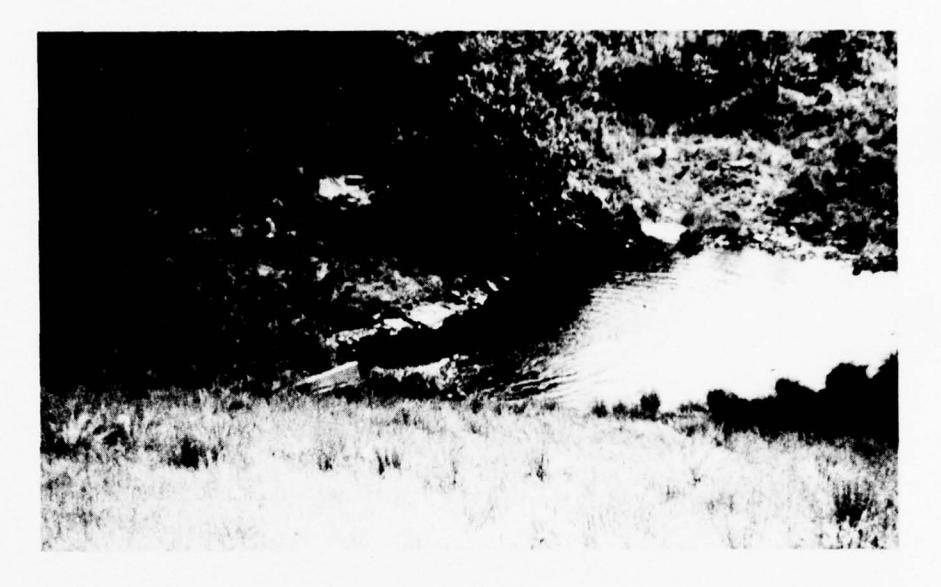
June 5, 1978

VIEW FROM TOP RIGHT OF DAM LOOKING DOWNSTREAM AT OUTLET

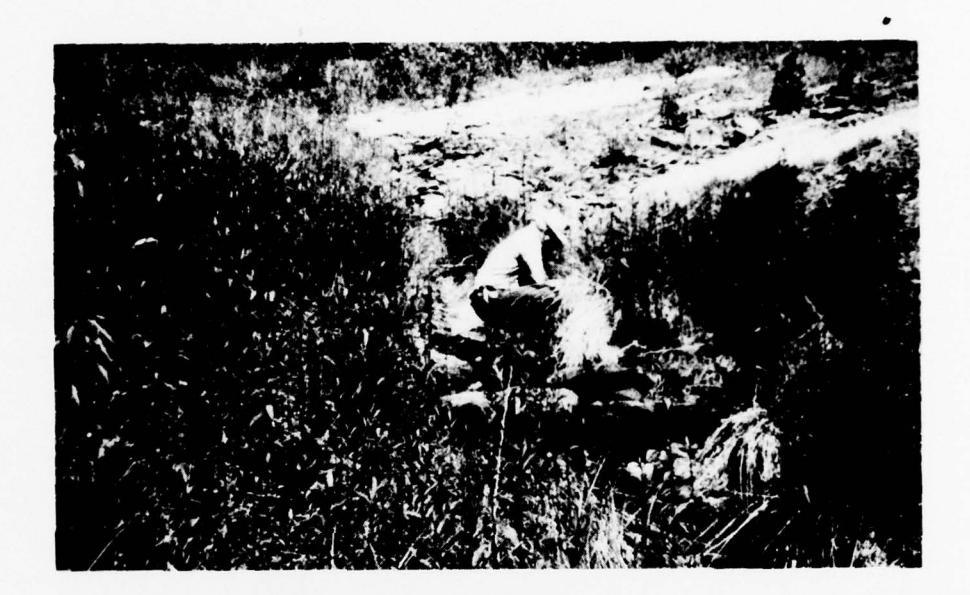
June 5, 1978

The emergency spillway had a light covering of weeds and its surface consisted primarily of the native soils. Although the surface materials appeared to lack erosion resistance there was no erosion observed near the crest.

Three seepage areas were observed and are shown on the Plan View in Appendix I. Area 1 is in the emergency spillway channel and Area 2 is on the abutment slope about 70 feet below the dam crest. Although the seepage in areas 1 and 2 appeared to be from the same source, the temperature of the water in the spillway was 49° F and that on the adjacent abutment slope was 56° F. The seepage was estimated at 30 g.p.m. in the spillway and at 4 g.p.m. on the slope. The water was clear in both locations, but the larger flow in area 1 is causing some erosion in the spillway chute. Area 3 was the smallest area with a flow estimated at 1 to 2 g.p.m. It is located near the toe of the dam on the right abutment.

VIEW FROM EMERGENCY SPILLWAY CHUTE LOOKING UPSTREAM AT EROSION AND SPRING AREA. APPENDIX III FIELD OBSERVATIONS

7.2.3 Spillway Redesign: The emergency spillway should be protected against erosion. It is recommended that the owner enlist the services of a consultant to design a paving material for the spillway crest which will resist erosion. The emergency spillway capacity was not found to be "seriously inadequate", but future consideration should be given to enlarging it in order to meet the PMF design flood criteria. This work should be carried out in conjunction with the recommendations in Section 7.2.2.
