EISENHUTH DAM

NDS ID No. PA-00662 DER ID No. 54-55

PHASE I INSPECTION REPORT

NATIONAL DAM INSPECTION PROGRAM

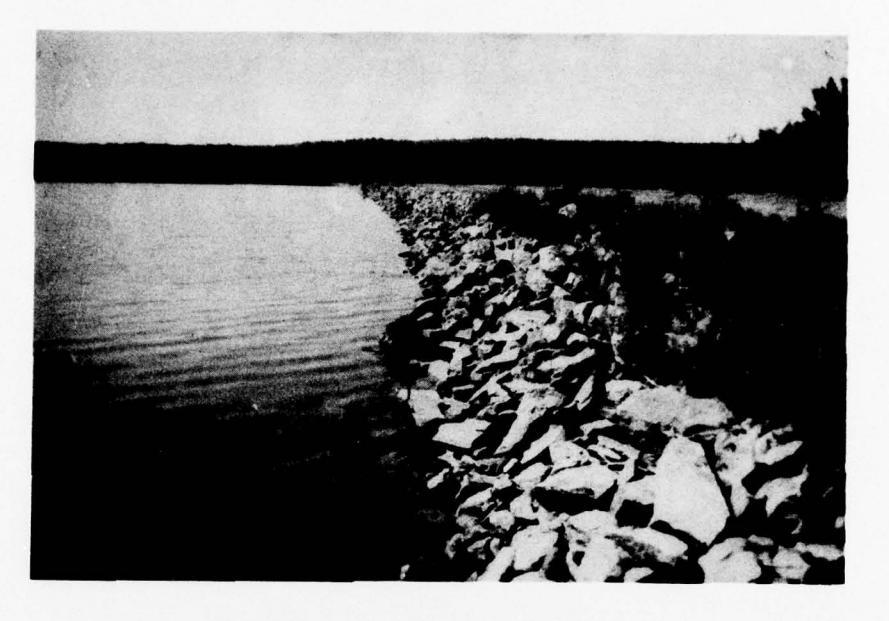
A. Riprap on Upstream Slope of Embankment.

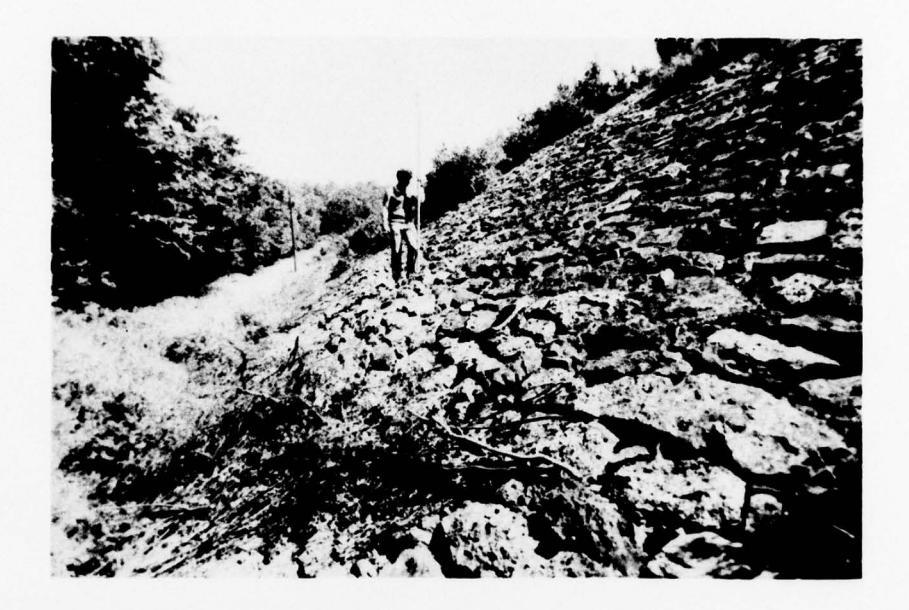
(2) <u>Embankment</u>. Three seepage areas were observed at or near the toe of the embankment. Bulges near the downstream toe were noted on the embankment slope. The detailed description and evaluation of these conditions are in Paragraph 3.1b.(4) and Paragraph 3.2a.(4), respectively.

C. Downstream Toe of Embankment and Bulging of Riprap.

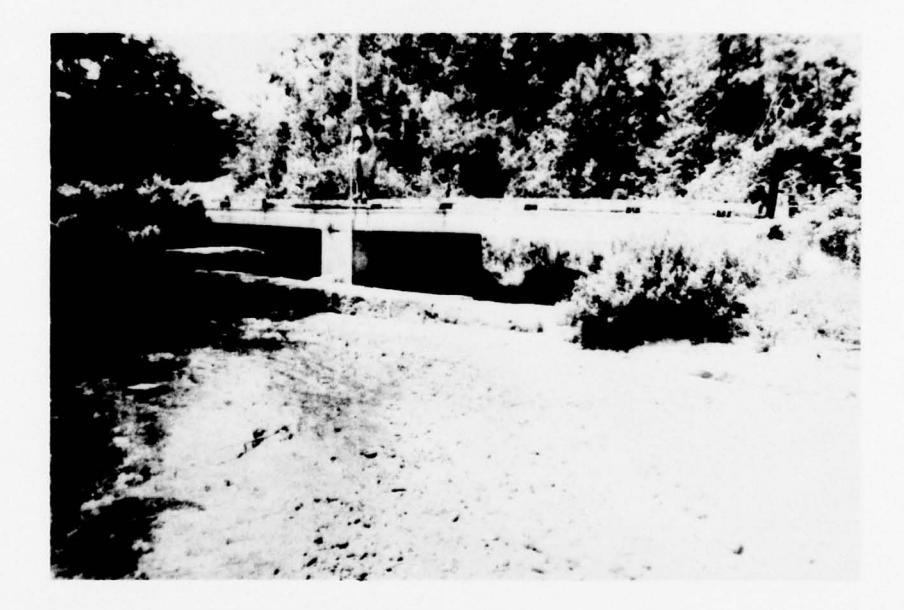
Three tension cracks were observed on the bottom surface of the bridge deck. The cracks extend normal to flow in the channel and were 1/8 inch wide and 1/4 inch deep. No evidence of differential movement at any crack in the bridge deck was observed. The prestressed beams supporting the bridge deck are successively offset about 3/8 inch. The top of the concrete weir that is 44 feet downstream of the bridge was spalled to a depth of 1 inch over a 28-inch by 12-inch area. Coarse aggregate was exposed on the downstream face of the weir directly below the notch in the weir.

D. Left Spillway Approach Channel, Masonry Weir, and Roadway Bridge.

(3) Monitor cracking at the left spillway bridge and at the left spillway right training wall. If changes are noted, take appropriate action.

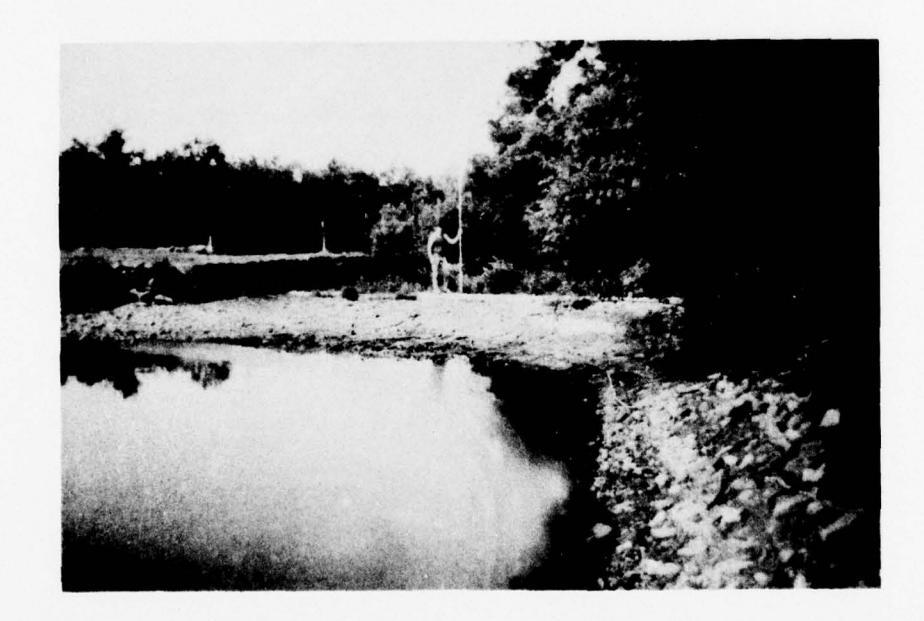
F. Right Spillway Approach Channel and Masonry Spillway Weir.

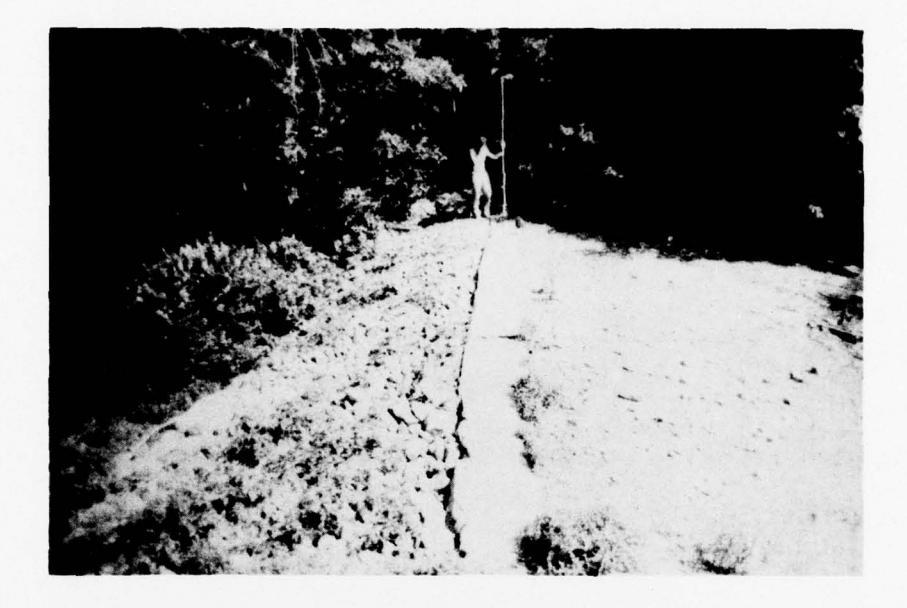
G. Right Spillway Masonry Weir -Looking Towards Right Abutment.

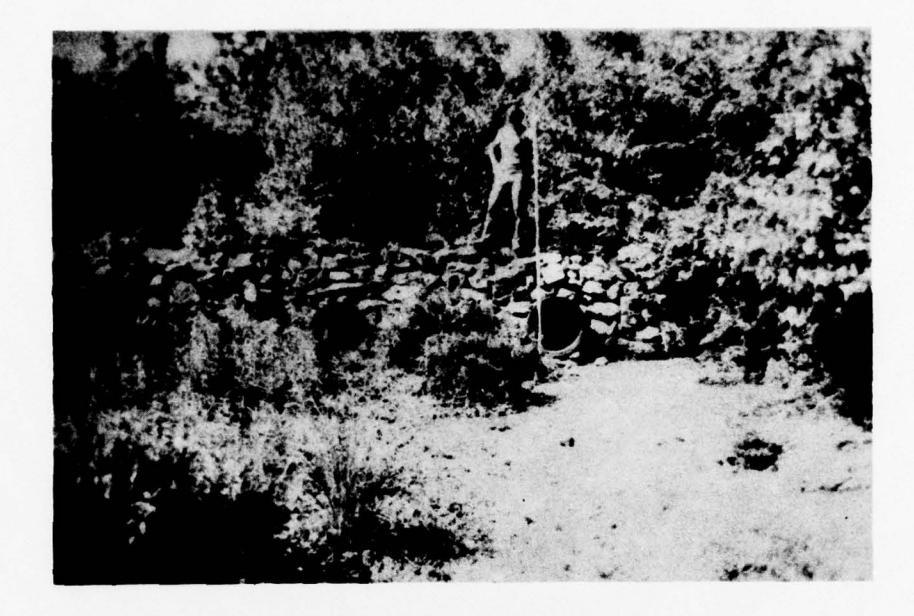
I. Roadway Embankment and Culverts at Downstream End of Right Spillway Outlet Channel.
