2 OCT 1978

PHASE I INSPECTION REPORT NATIONAL DAM SAFETY PROGRAM AMAWALK DAM, INVENTORY NO. 45 CROTON RIVER BASIN WESTCHESTER COUNTY, NEW YORK

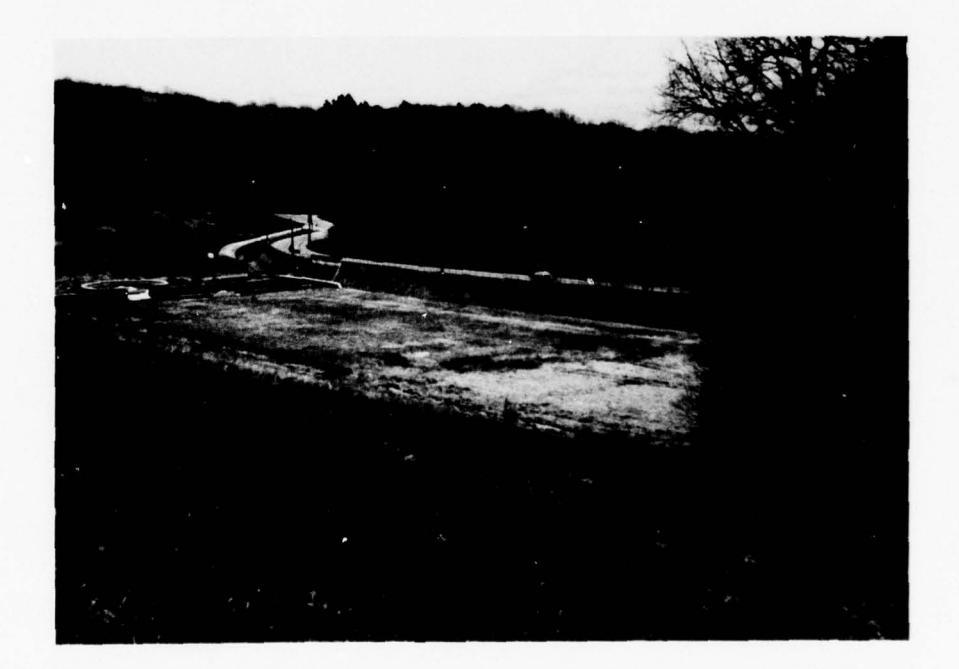
(B) The toe ditch on the right side of embankment contains debris, loose deposits and vegetation growth.

DOWNSTREAM SLOPE, TOE DITCH, RIGHT ABUTMENT CONTACT SHOWING THE AREA OF SEEPAGE [OBSERVATIONS (A), (B) AND (C)]

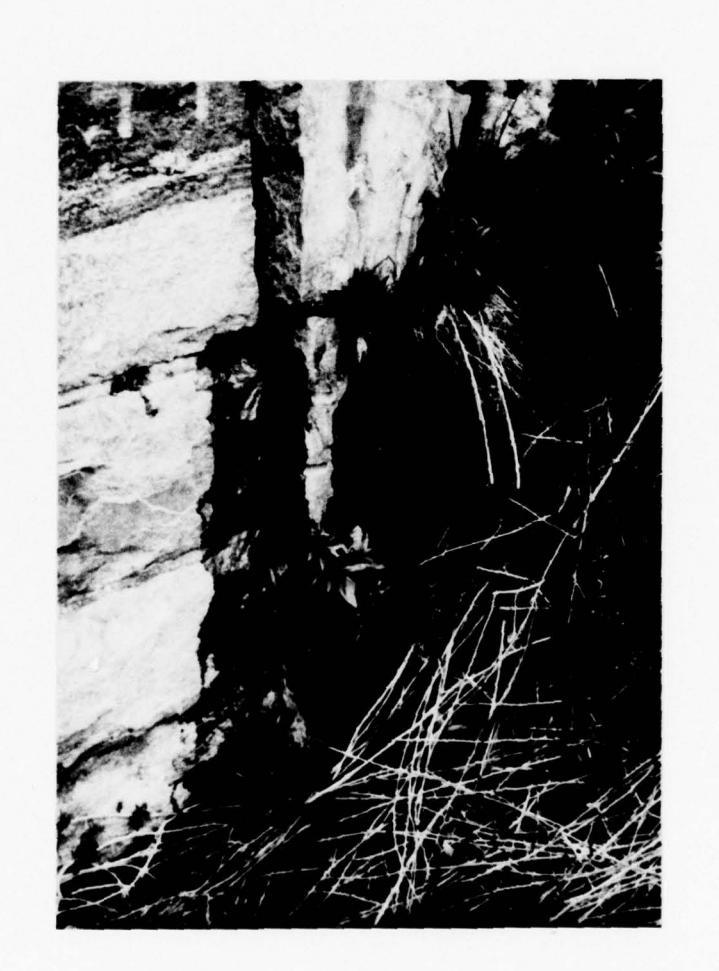
(Q) The stone wall left of the gate chamber has moved about 3-inches downstream and 2-inches vertically downward along a construction joint. This movement appears to be the result of inadequate surface drain-age mentioned in (H).

DETAIL OF WALL JOINT LEFT OF GATEHOUSE WHERE MOVEMENT AND SEEPAGE WAS NOTED. [OBSERVATIONS (I) AND (Q)]

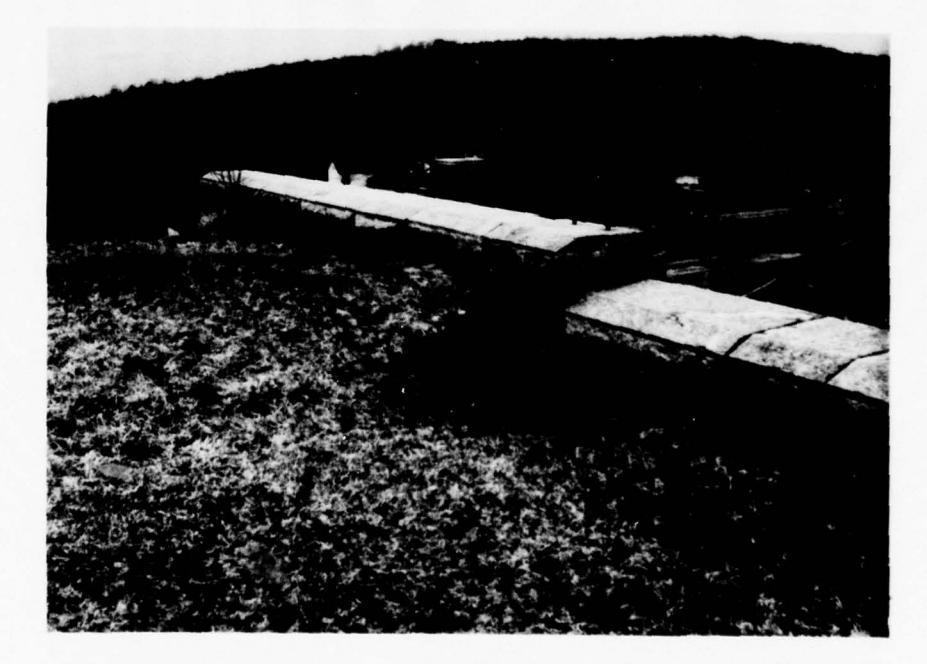
(D) Surface erosion was noted on the crest on both sides of the spillway wall.

EROSION ON CREST AT SPILLWAY WALL [OBSERVATION (D)] (THE STEP IN THE WALL IS NOT MOVEMENT)

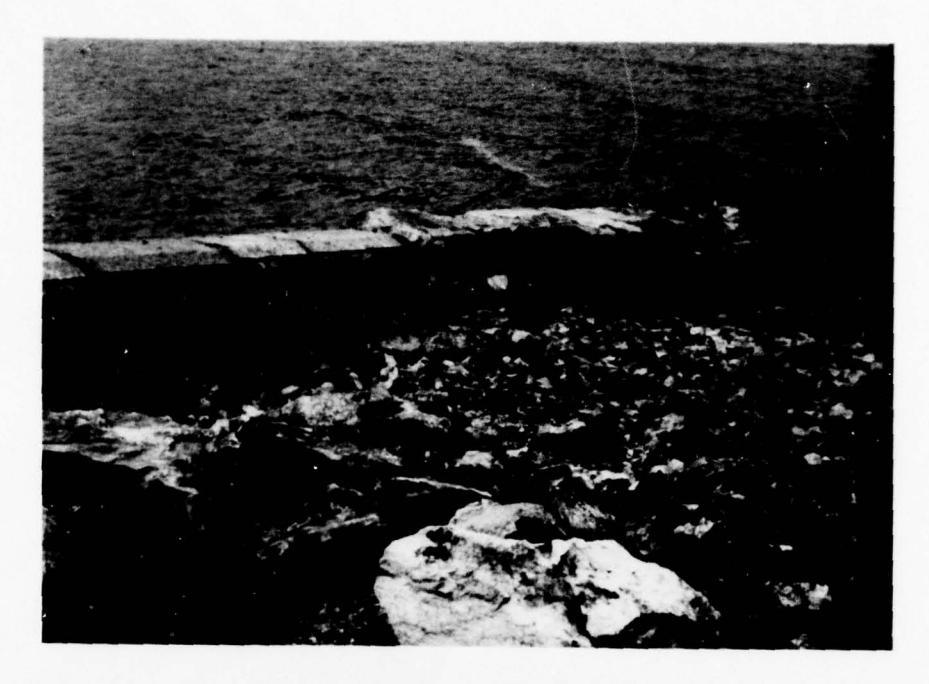
(F) There is some damage to the riprap near the left spill-

(L) Both spillway inlet walls at reservoir level are in damaged condition; large stones comprising the masonry wall are loose and/or dislocated.

RIP-RAP AND SPILLWAY WALL DAMAGES [OBSERVATIONS (F) AND (L)]

f. The damage to the spillway walls should be repaired. The movements of the spillway chute walls will probably stop after the downstream drainage improvements have been carried out. g. Minor riprap damage should be corrected. The small size riprap on the main embankment is subject to damage by major storms. An inspection, and, if needed, corrective work should be carried out after such storms. The riprap on the auxiliary dam is considerably heavier than that on the main dam; there are some depressions, however, in this riprap which require some maintenance work.

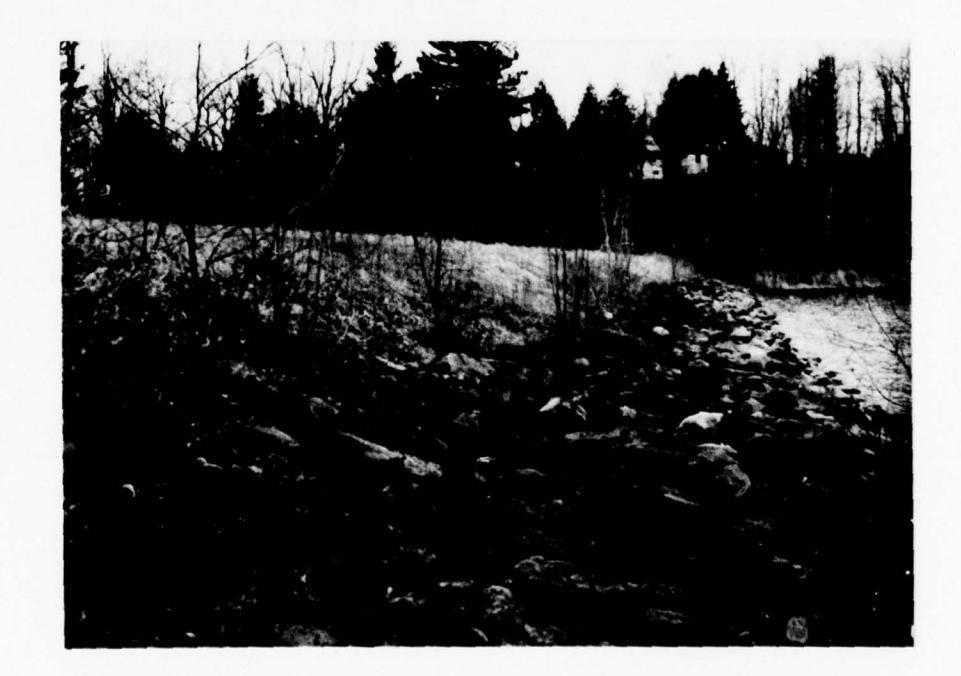
UPSTREAM SLOPE OF AUXILIARY EMBANKMENT

d. The minor vegetation growth noted on both upstream and downstream slopes of the main embankment should be removed. There is much denser and heavier growth, however, on the auxiliary dam which should also be removed.
