National Dam Safety Program. Lake Meade Dam, Susquehanna River Basin, Commonwealth of Pennsylvania, Adams County (NDS-PA-331). Phase I Inspection Report.

LAKE MEADE DAM

# PHASE I INSPECTION REPORT

NATIONAL DAM SAFETY PROGRAM

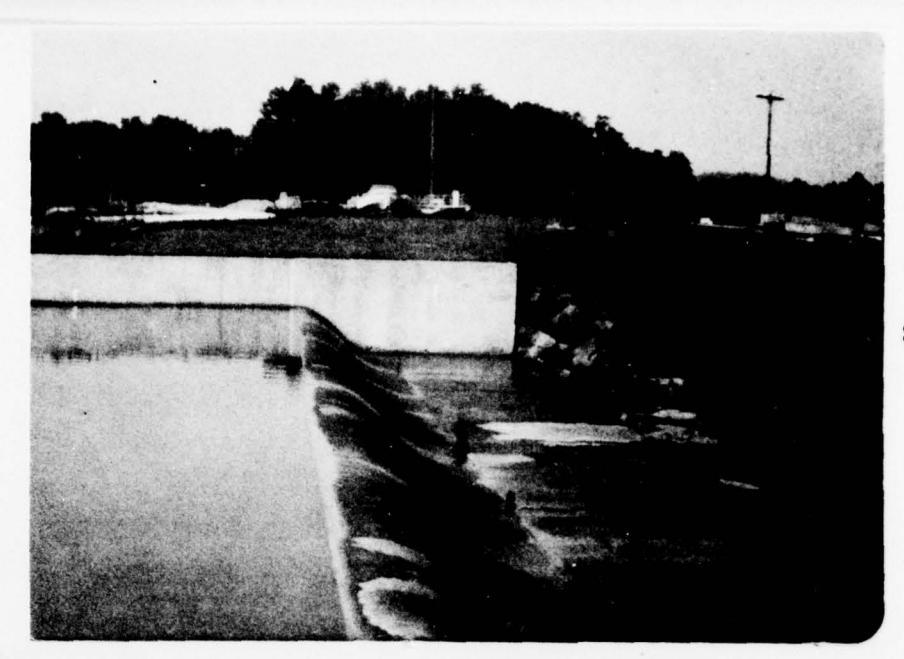
Spillway Weir

The spillway weir is located near the left abutment. The concrete weir and retaining walls were in good condition. Some minor cracking has occurred in the slabs below the weir. It appears that the slab was poured on rock and if the cracks do not widen, no future problems are expected. At the end of the spillway slab a large part of the downstream cutoff wall is exposed. The placing of large boulders should be recommended to prevent undermining of this slab. Most of the long spillway chute is excavated in rock and unlined. The rock appears to be hard. The chute makes a 90-degree right bend close to the spillway and then parallels the toe of the embankment over a length of 1200 feet. Possible erosion could occur opposite the weir where the channel makes the bend, but this would not affect the safety of the structure.

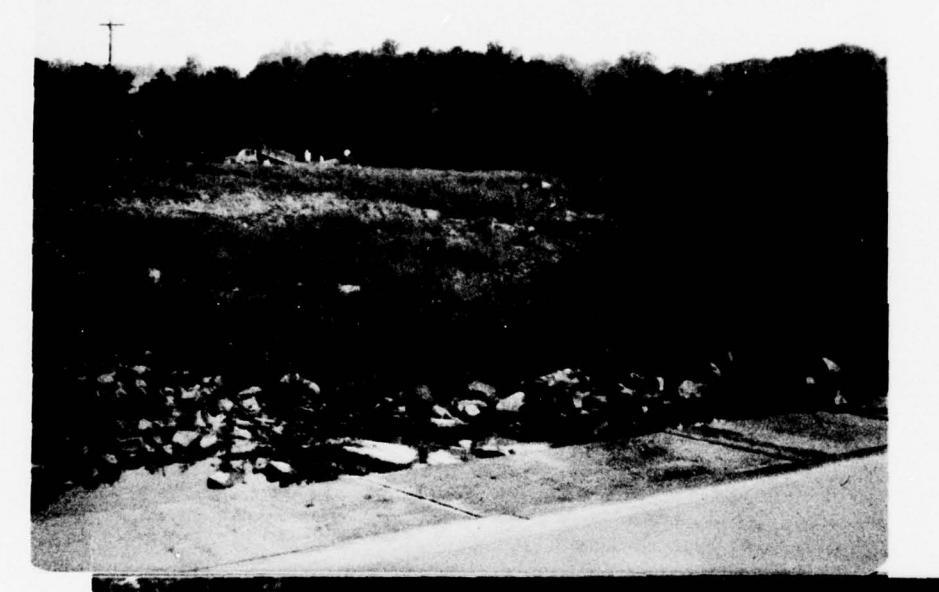
Downstream Apron Spillway

The visual inspection of the spillway, spillway chute and valve box did indicate that all structures are in good condition. There was no excessive cracking, spalling or deflection in any of the structures. The deep exposure of the downstream cutoff wall of the weir would indicate the need of placing some heavy stone in this area.
