AFWL-TR-77-274 AFWL-TR-77-27

Final Report

AIR FORCE WEAPONS LABORATORY Air Force Systems Command Kirtland Air Force Base, NM 87117

TION PAGE	READ INSTRUCTIONS
N. REPORT NUMBER	2. GOVT ACCESSION	NO. 3 RECIPIENT'S CATALOG NUMBER
AFWL-TR-77-274		
4. TITLE (and Subcillo)		TYPE OF REPORT & PERIOD COVERED
ERACTURE ANALYSIS OF REENTRY	YEHICLE STRUCTURA	Final Report
MATERIALS	and the second	6 PERFORMING ONG, REPORT NUMBER
7 AUTHOR(a)		B CONTRACT OF GRANT NUMBER(1)

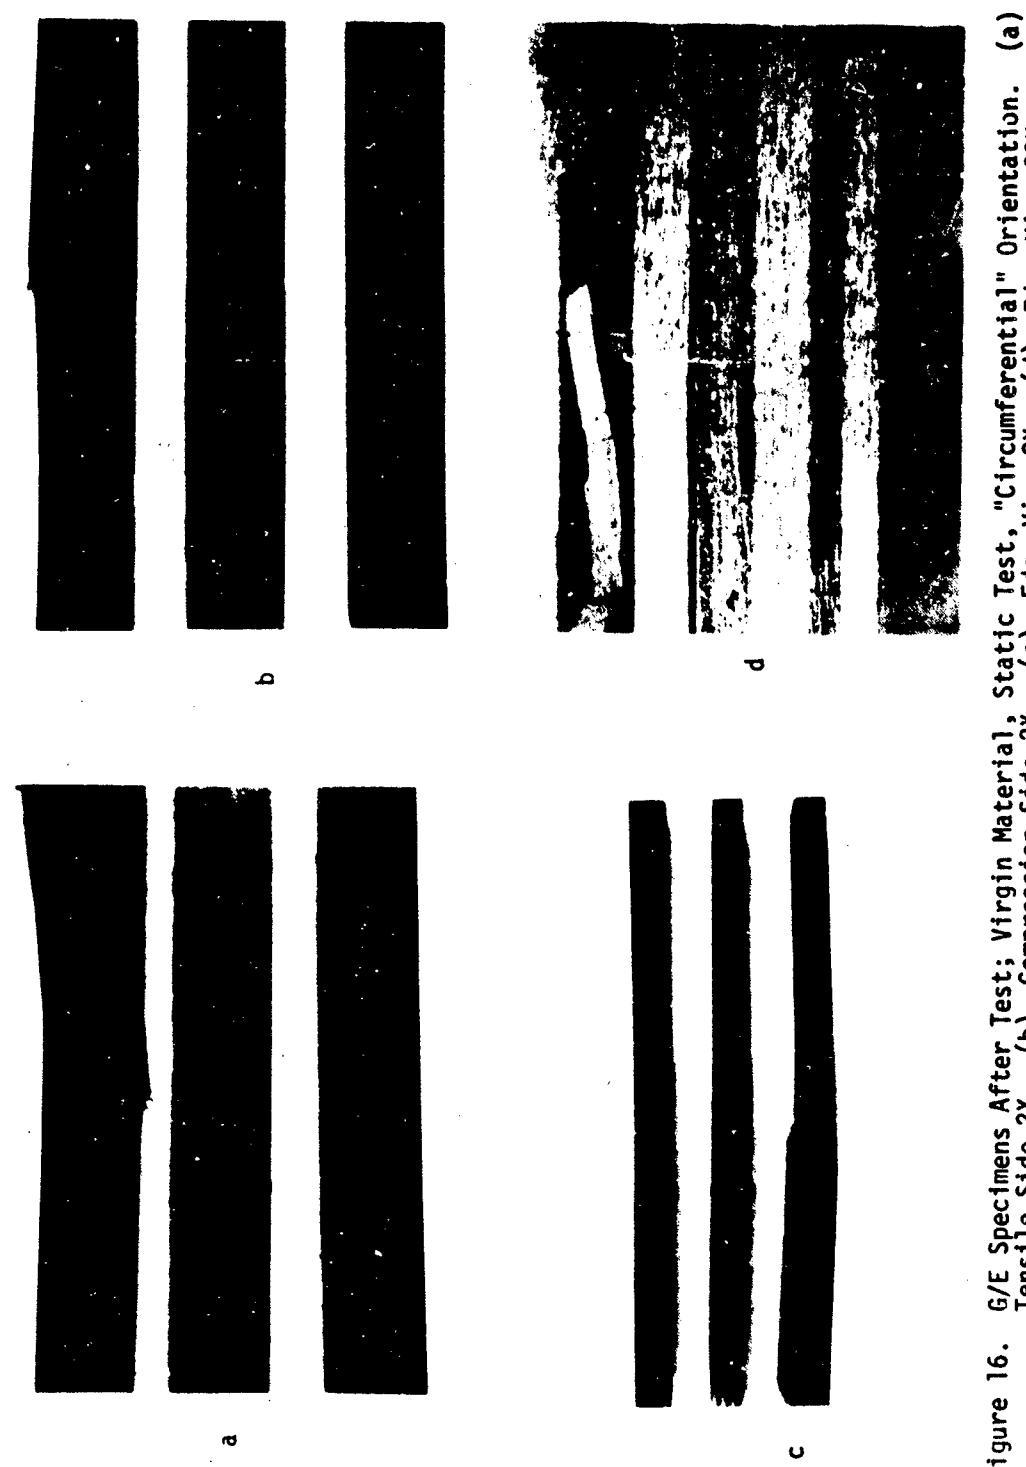
Visual examination of the specimens revealed that the "circumferential" specimens had less damage than the "axial" specimens. In the static test on the "circumferential" specimens, the outermost ply on the tensile side did not always fracture completely. As seen in figure 16, only a longitudinal split occurred on one specimen; on another, there was a transverse crack about one third of the way across the specimen, ending at a longitudinal split; and on the third "circumferential" specimen tested statically, there was a transverse crack across the specimen. All of the "circumferential" specimens tested statically had a transverse crack across the compression side of the specimen directly under where it was loaded. Two of these specimens appeared to have a fair amount of residual strength. Although the statically tested "circumferential" specimens had delamination, it was considerably less than most of the other specimens - less than all the "axial" specimens, and less than the "circumferential" specimens tested dynamically.

G/E Specimens After Test; Virgin Material, Static Test, "Circumferential" Orientation. Tensile Side 2X. (b) Compression Side 2X. (c) Edge View 2X. (d) Edge View 20X. Figure 16.

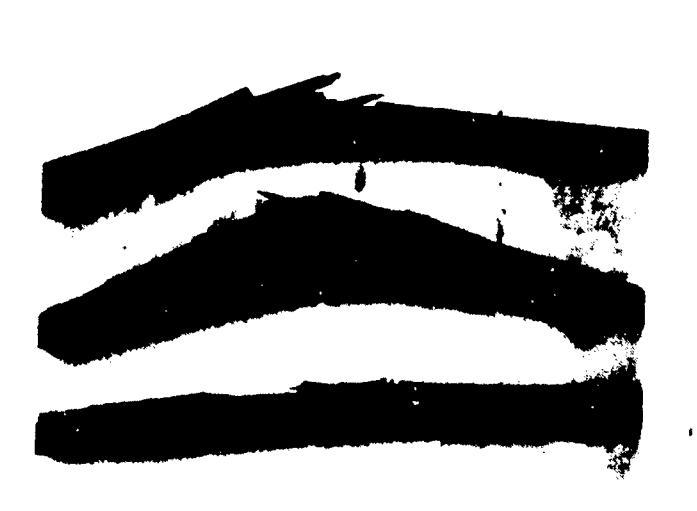
The statically tested "axial" specimens are shown in figure 18 and the dynamically tested "axial" specimens are shown in figure 19. There was not a substantial difference between the visual appearance of the statically tested and dynamically tested "axial" specimens. In all of the specimens, the outermost five plies (one layer of 90° and one layer of 0° plies) remained intact on the compression side and all of the remaining plies fractured. Again, there was a considerable amount of delamination which occurred on all specimens.

Figure 18. G/E Specimens After Test; Virgin Material, Static Test, "Axial" Orientation. (a) Tensile Side 2X. (b) Edge View 2X.

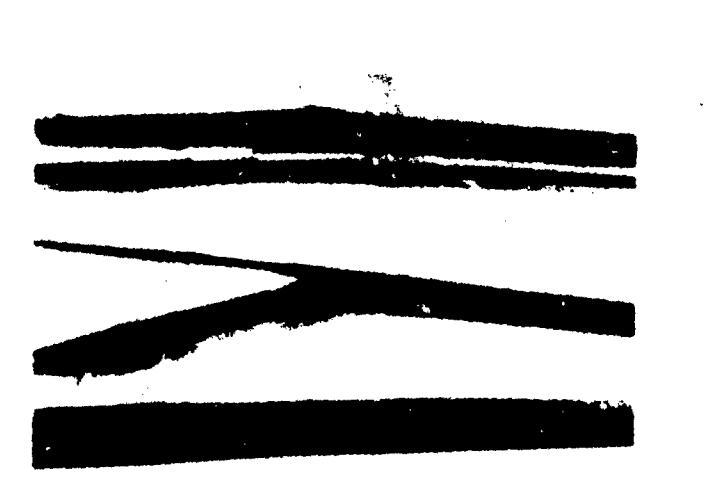
Samples which had been degraded by mechanical impact prior to test are shown in figures 20, 21, 22, and 23 after they had been tested. There appeared to be virtually no difference between the degraded specimens and the specimens made of virgin material. As in the virgin material, the specimens in the "circumferential" orientation broke with finer delaminations when tested dynamically than when tested statically - see figures 20b and 21b. There did not appear to be significant difference between the two test conditions in the "axial" specimens.

Figure 20. G/E Specimens After Test; Degraded Material, Static Test, "Circumferential" Orientation. (a) Edge View 2X. (b) Edge View 10X.

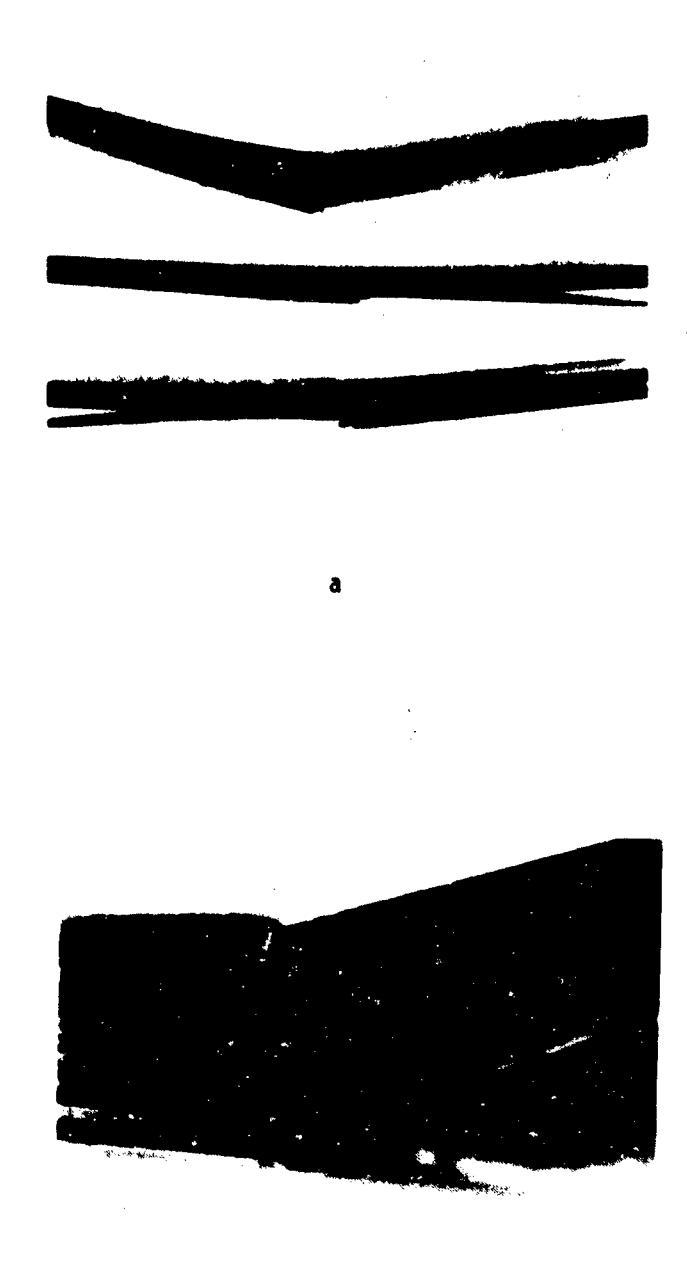
Figure 21. G/E Specimens After Test; Degraded Material, Dynamic Test, "Circumferential" Orientation. (a) Edge View 2X. (b) Edge View 10X.

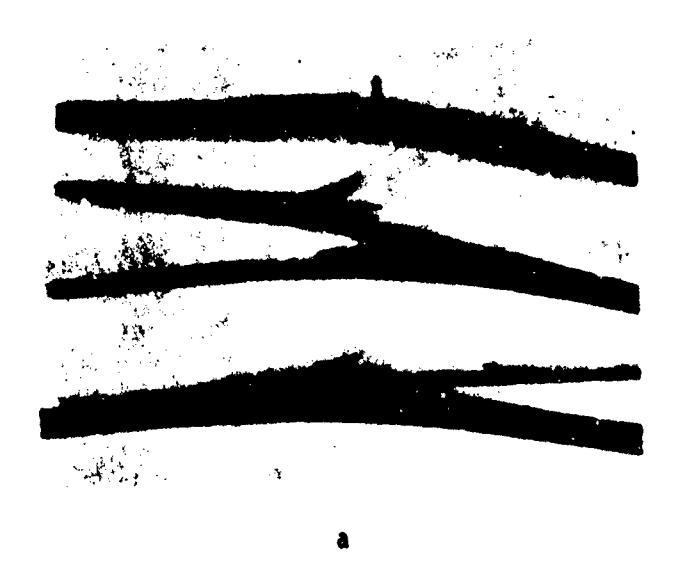
Figure 22. G/E Specimens After Test; Degraded Material, Static Test, "Axial" Orientation. 2X.

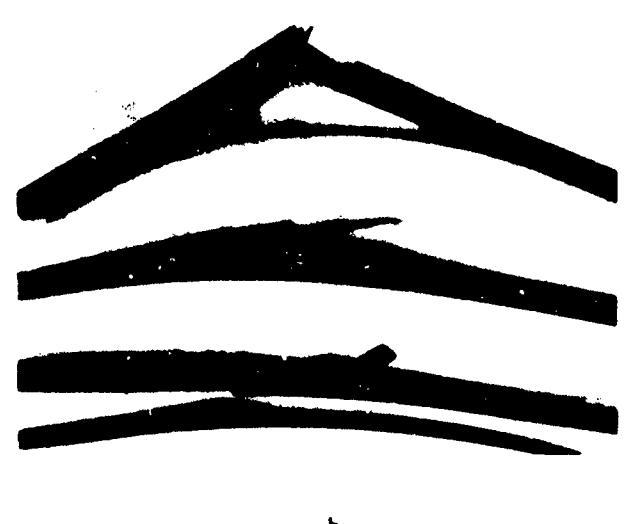
Figure 23. G/E Specimens After Test; Degraded Material, Dynamic Test, "Axial" Orientation. 2X.

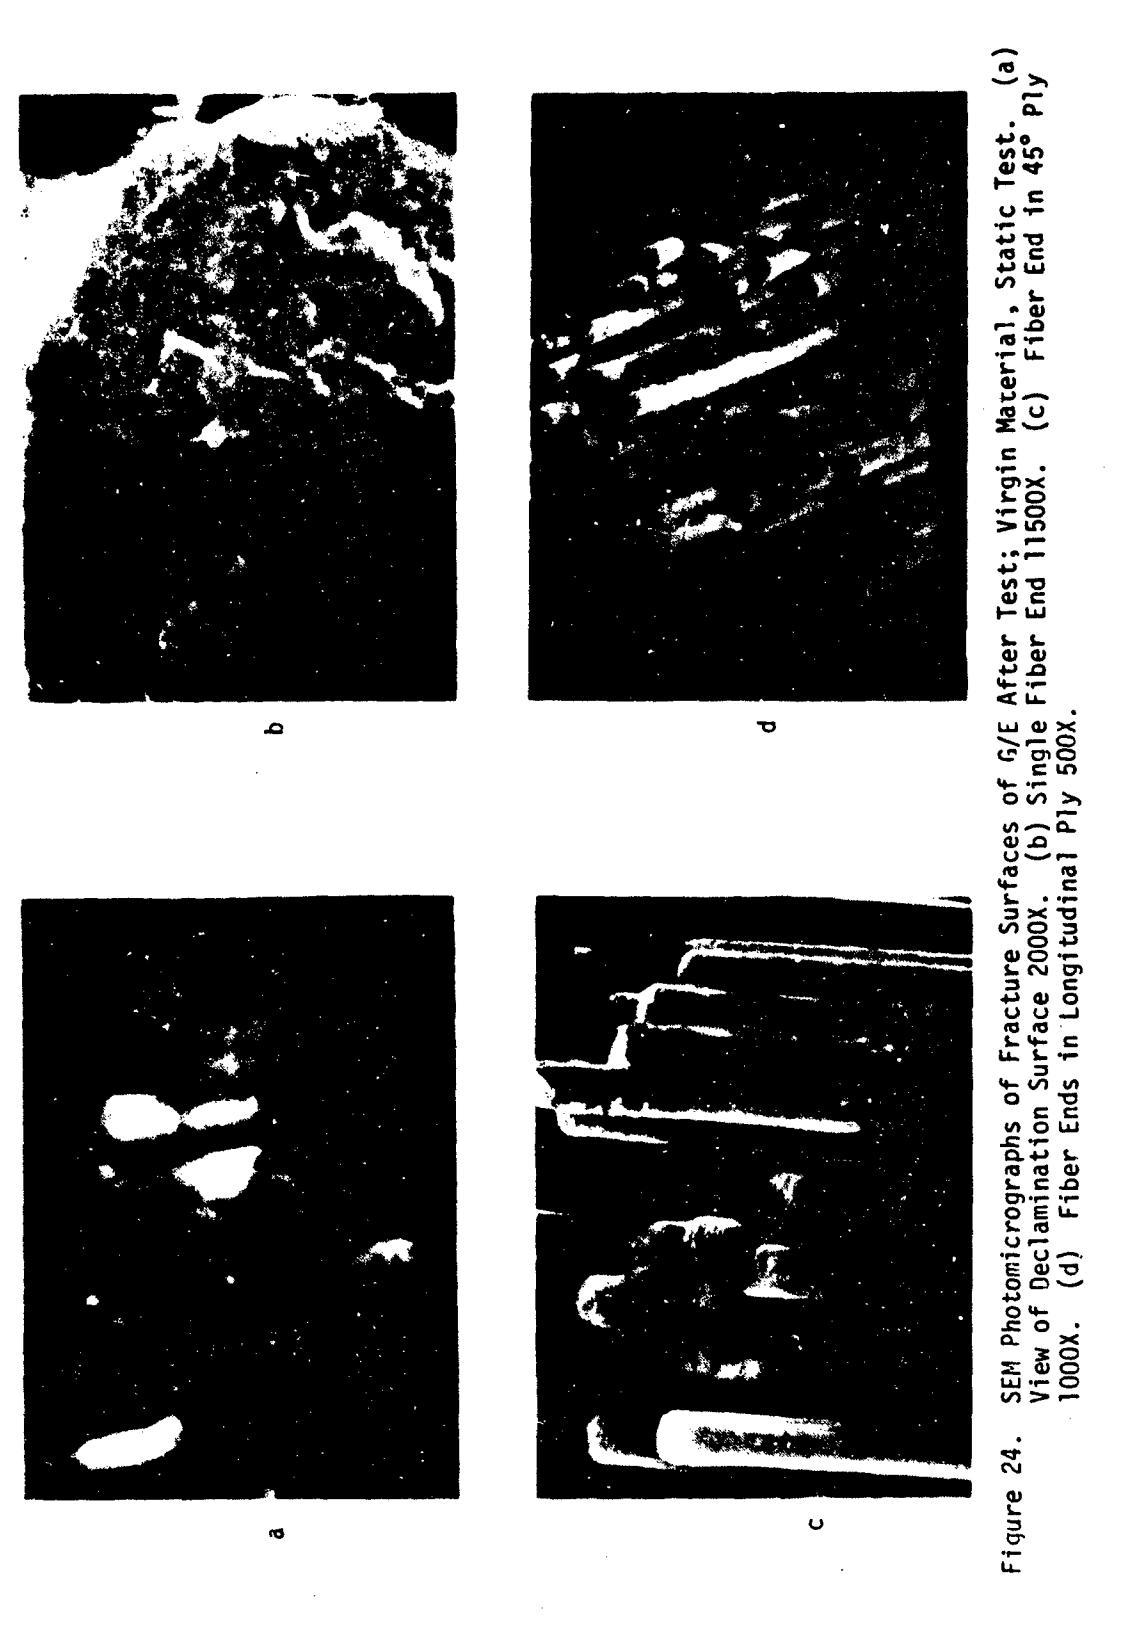
(a) SEM Photomicrographs of Fracture Surfaces of G/E After Test; Virgin Material, Dynamic Test. (View of Delamination Surface 2000X. (b) Single Fiber End 11,500X. (c) Fiber Ends in 45° Ply 1000X. (d) Fiber Ends in Longitudinal Ply 500X. Figure 25.

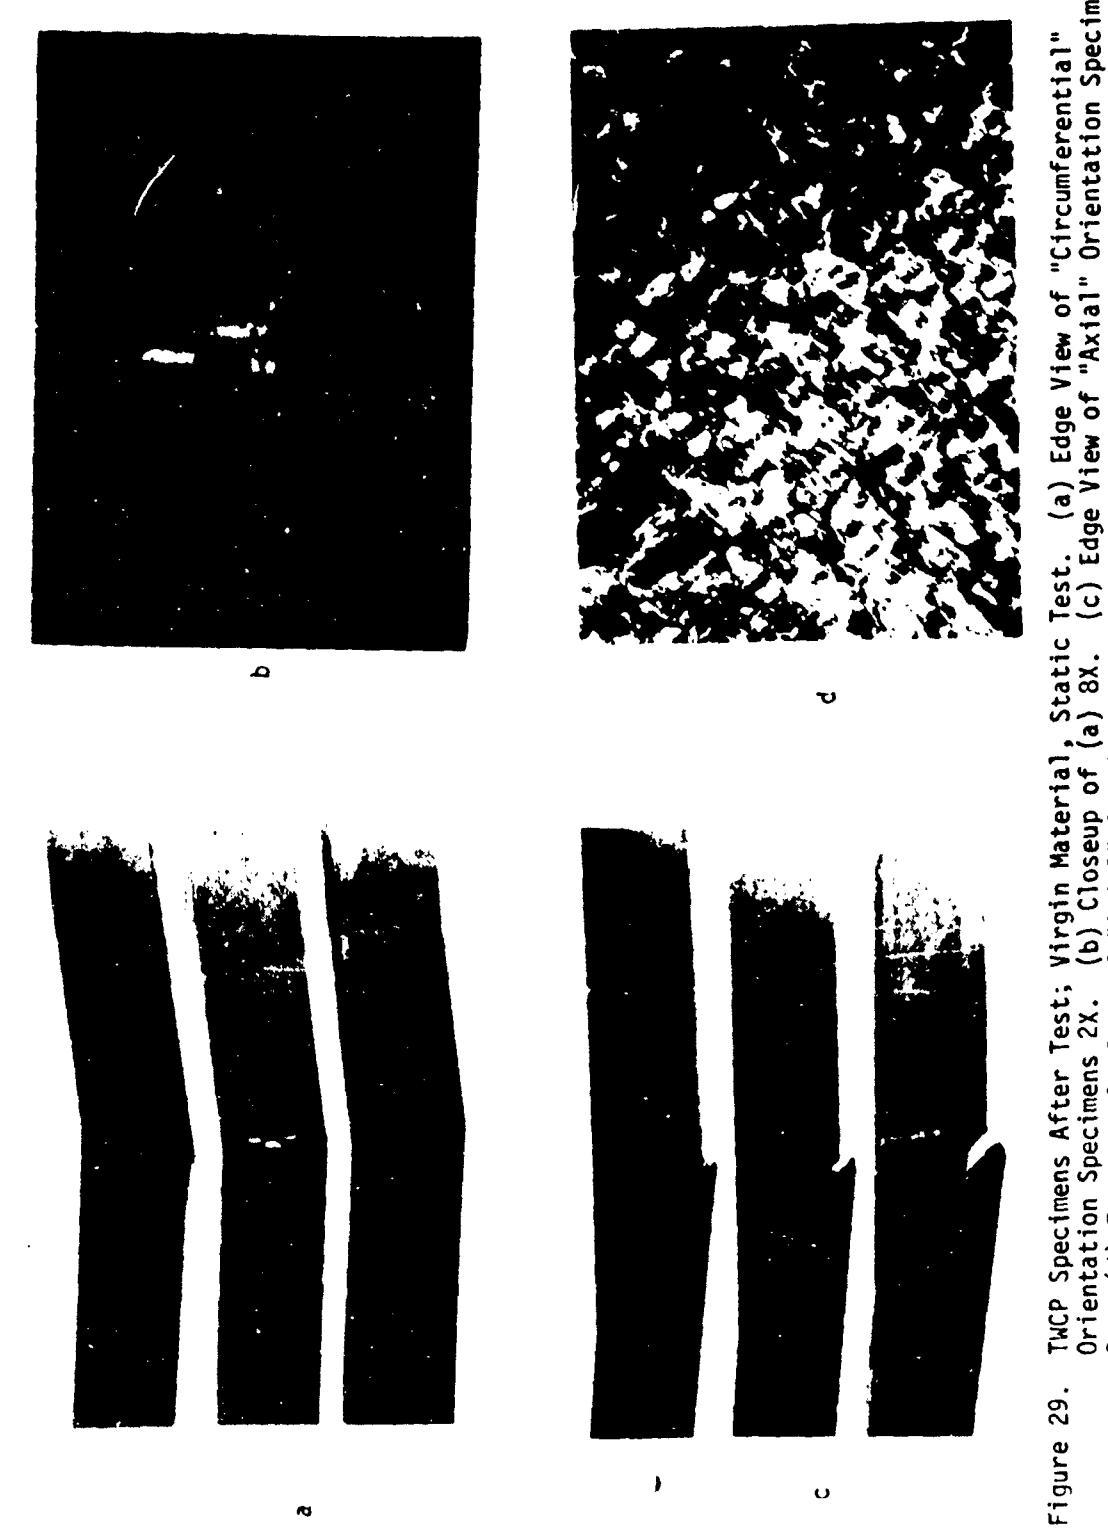
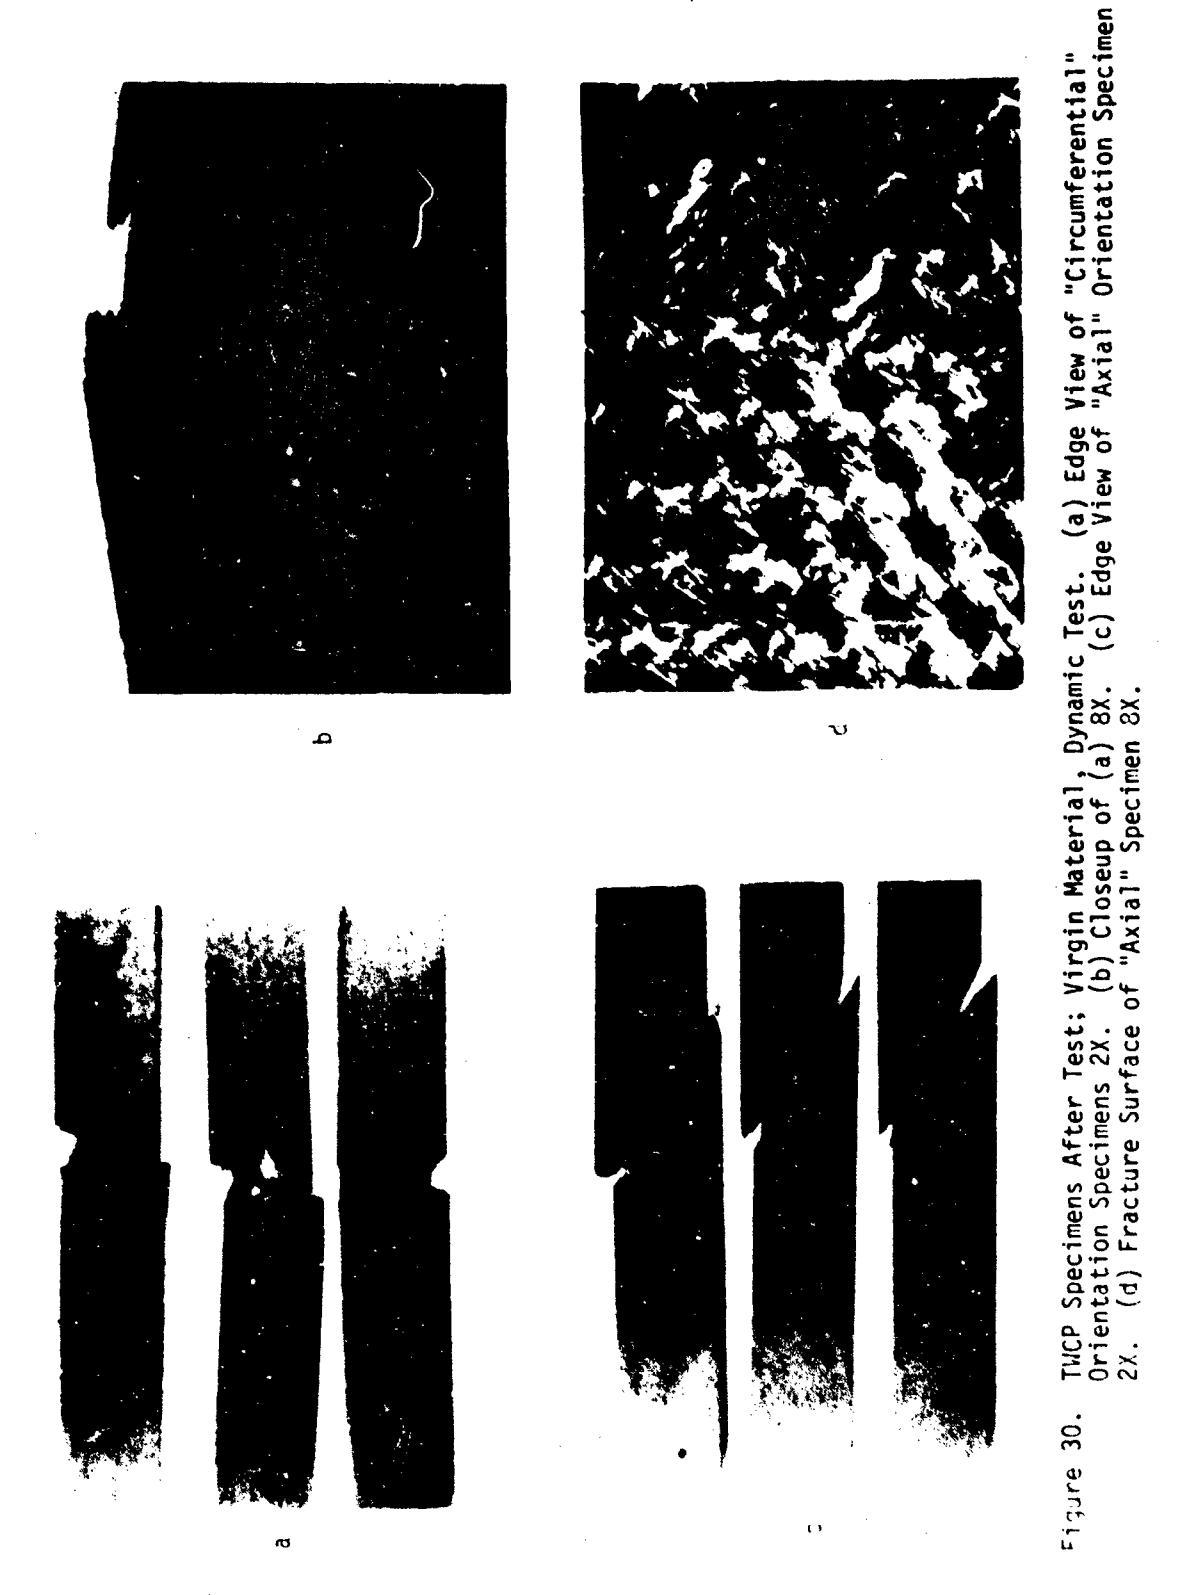
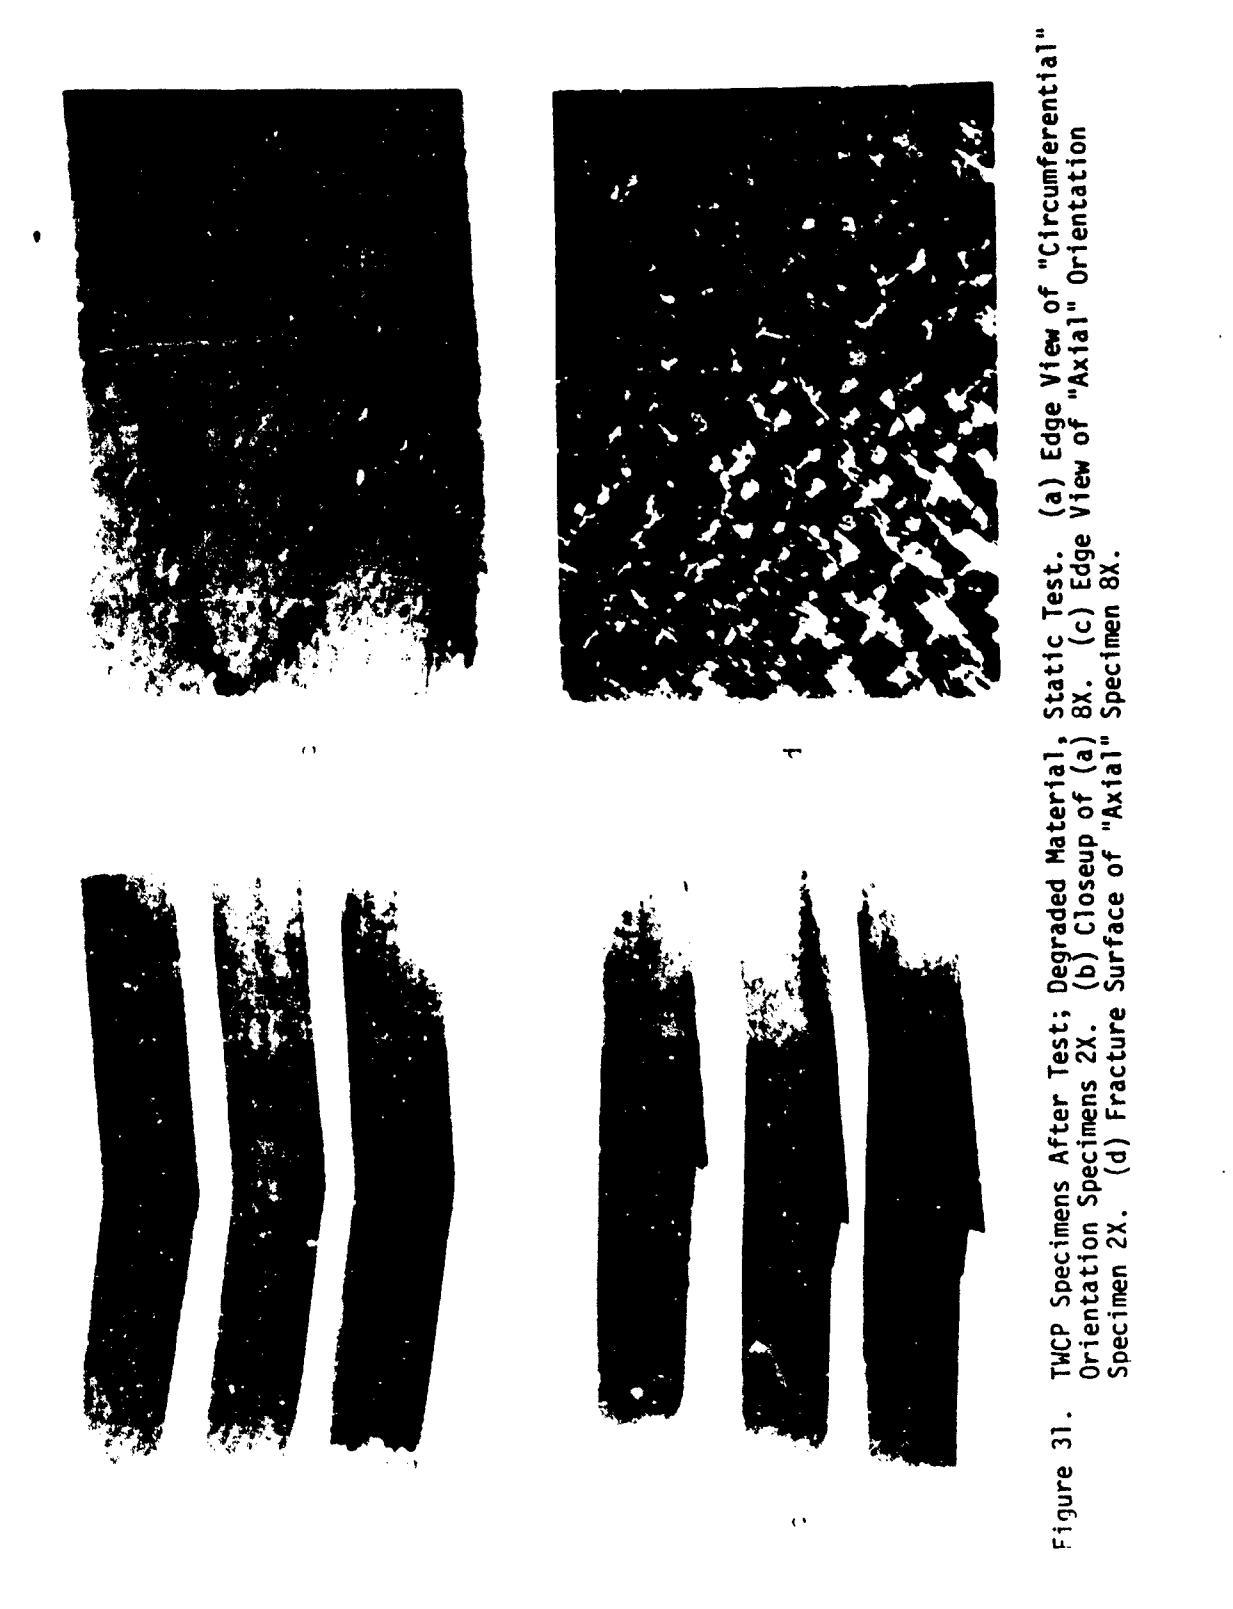
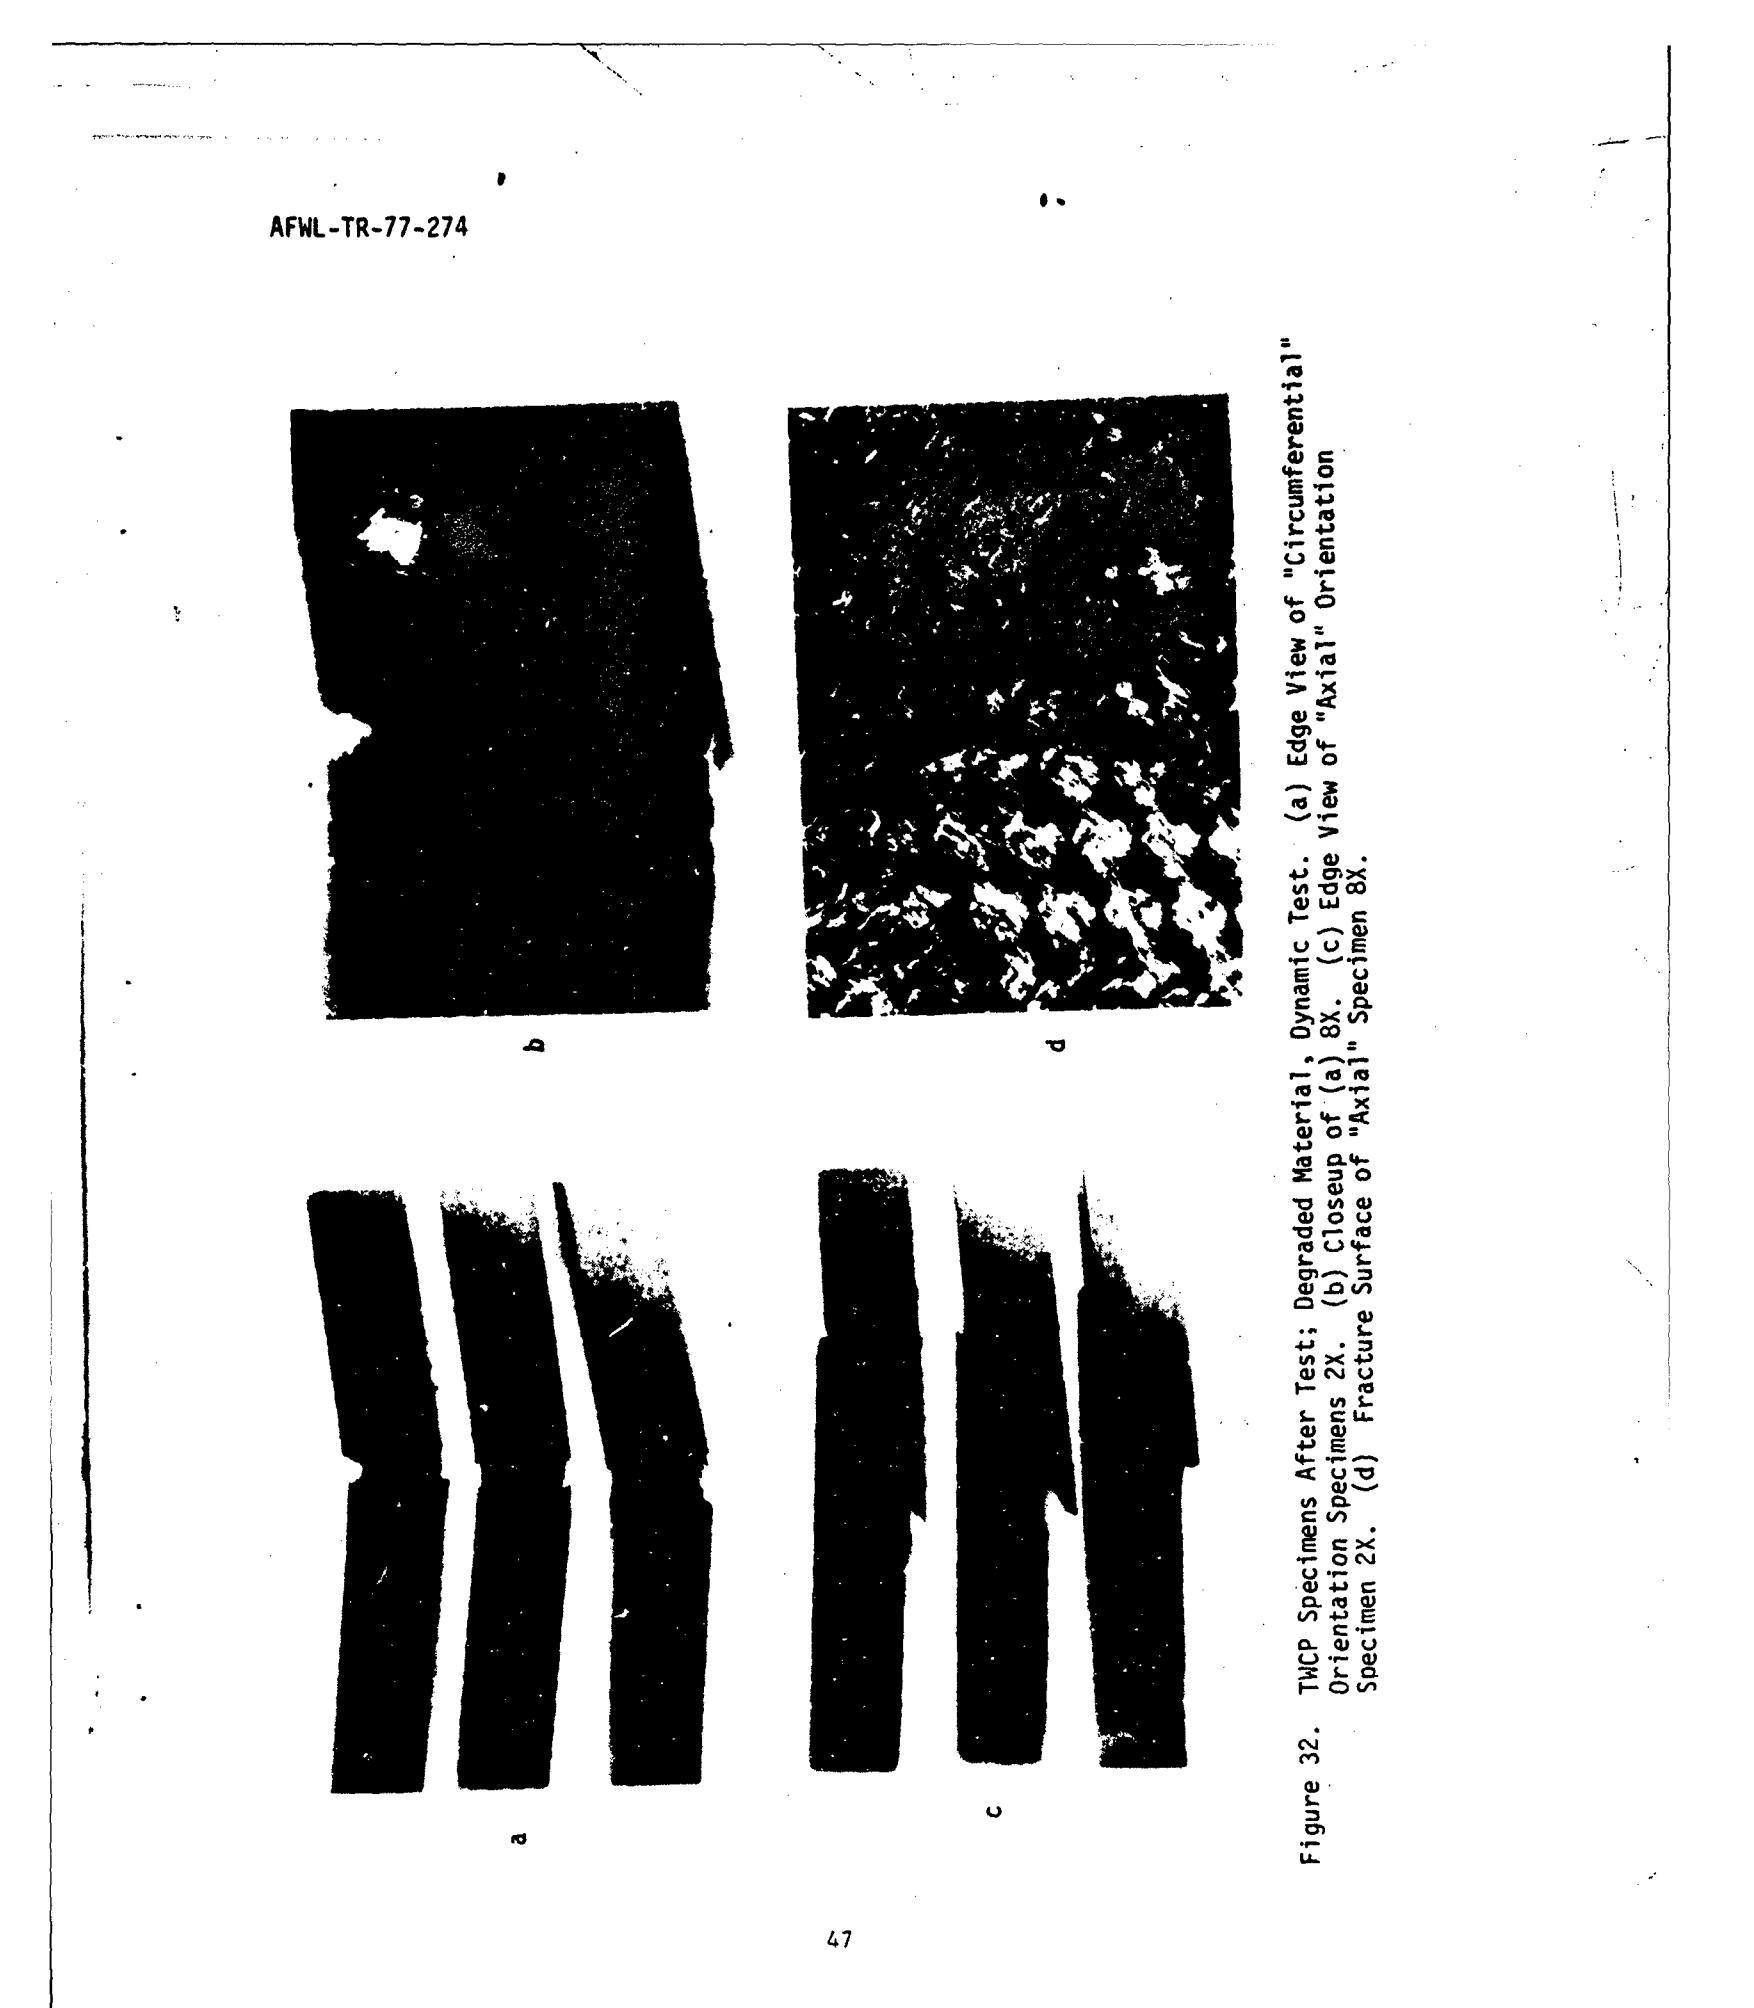
Photographs of the fractured TWCP specimens are shown in figures 29, 30, 31, and 32. As can be seen by comparing figure 29 with figure 30 or comparing figure 31 with figure 32, there is no apparent macroscopic difference between the statically tested and dynamically tested specimens. However, if one compares figure 29c with figure 31c or figure 30c with figure 32c, it can be seen that the fracture path followed a slightly different angle in the degraded material than in the virgin material. The angle (to the axis of the specimen) of the fracture path of the virgin material was 29 to 30° whereas the angle in the degraded material was 23° to 24°.

This difference in fracture angle between the virgin material is probably due to the presence of microcracks in the degraded material. Pre-test examination of the degraded material revealed microcracks in a majority of the specimens and it is felt that had the specimens been polished more an/or examined at higher magnification, microcracks would have been observed in all of the specimens. This material was laid up at a 20° angle of the plies to the axis ind the interlaminar strength is the weakest. Thus, the angle of weakest material is 20°, but the angle of maximum stress in a three point bend test is 90° to the axis. Thus, the actual fracture path occurs somewhere between these two extremes and apparently resolved itself to approximately 30° for the virgin material. In the degraded material, on the other hand, microcracks formed on the interlaminar planes as a result of the one-dimensional shock loading from the simulated X-ray exposure. These microcracks made the already weakest plane

still weaker. Thus, the fracture path would be expected to follow a path closer to the layup than it did in the virgin material. This agrees with the observed value of 23° to 24° for the degraded compared with 29° to 30° for the virgin material.
