USARTL-TR-78-48

ICING TESTS OF A UH-IH HELICOPTER WITH AN ELECTROTHERMAL ICE PROTECTION SYSTEM UNDER SIMULATED AND NATURAL ICING CONDITIONS

R. H. Cotton LOCKHEED-CALIFORNIA CO. P.O. Box 551 Burbank, Calif. 91520

April 1979

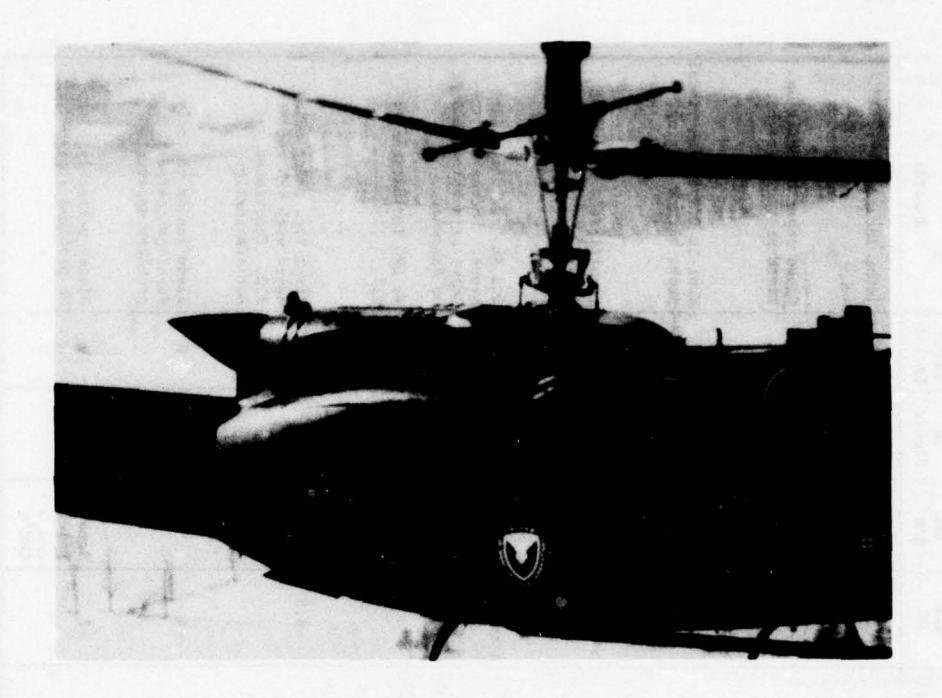
Figure 9. Test Aircraft Following Exit From Natural Icing Cloud on Flight 180, Showing Icing on Engine Air Inlet R.H. Screen.

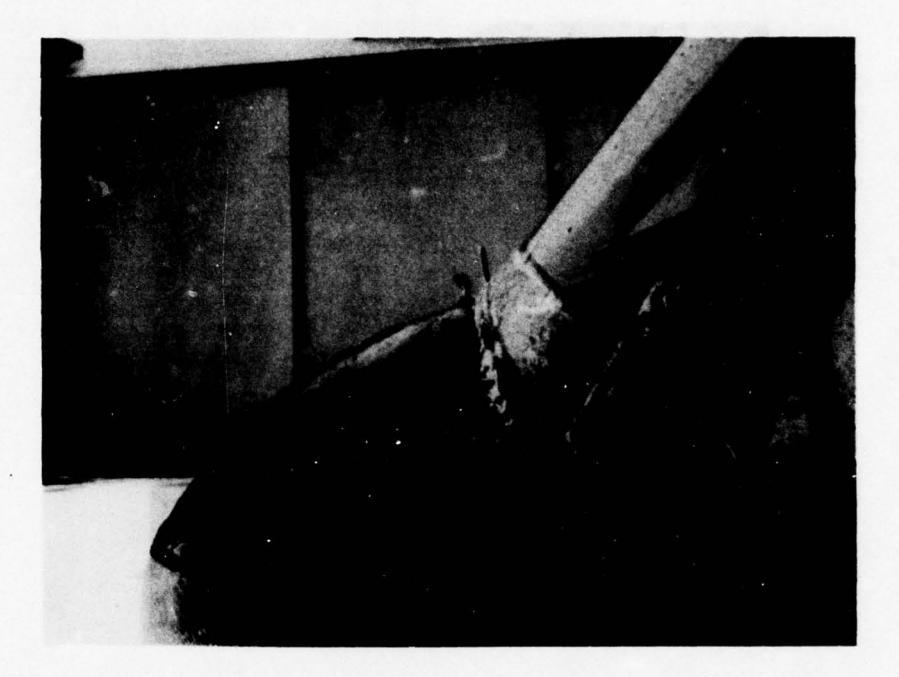
Figure 11. Aircraft Nose and Windshield After 30-Minute Flight in Light Freezing Rain (OAT -2°C).

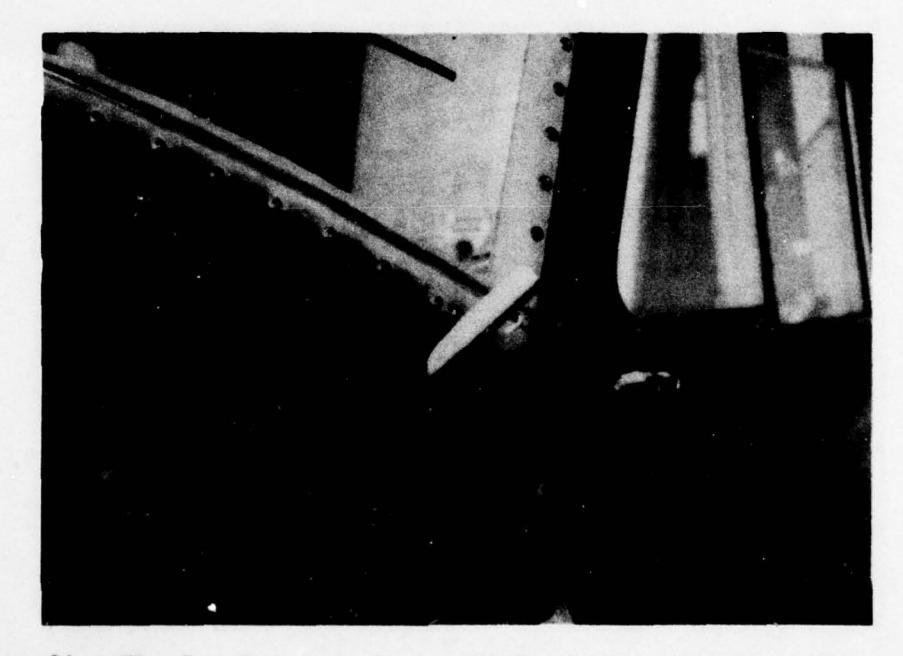
Figure 24. The Ice Detector Survey Probe Located Ahead of the Lower LH Corner of the Copilot's Windshield Following a Spray Rig Flight (OAT =  $-6.5^{\circ}$ C).

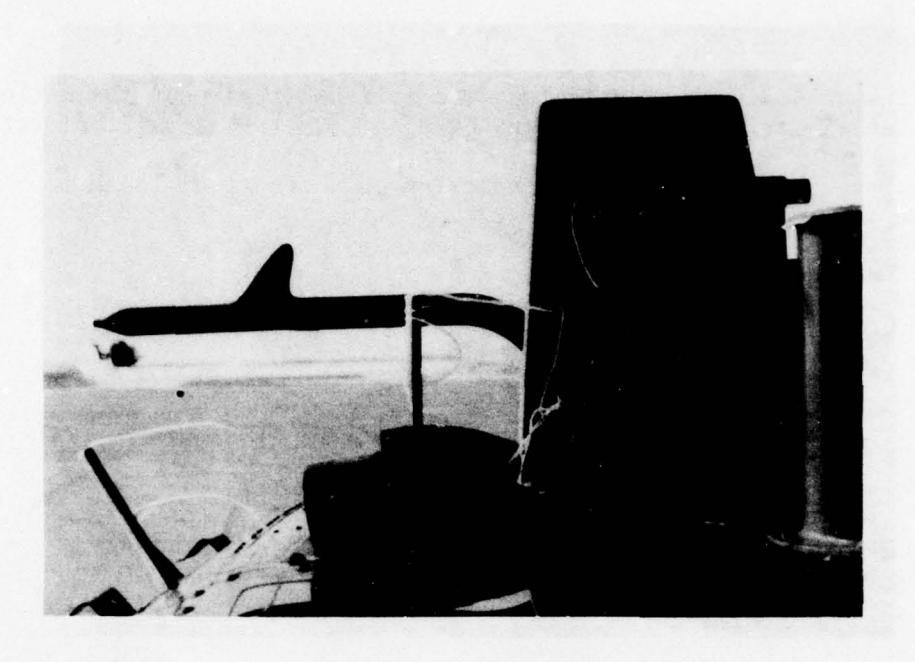
Figure 25. Close-Up of the Ice Detector Location Survey Probes Located on the Cabin Roof, Following a Natural Icing Flight.

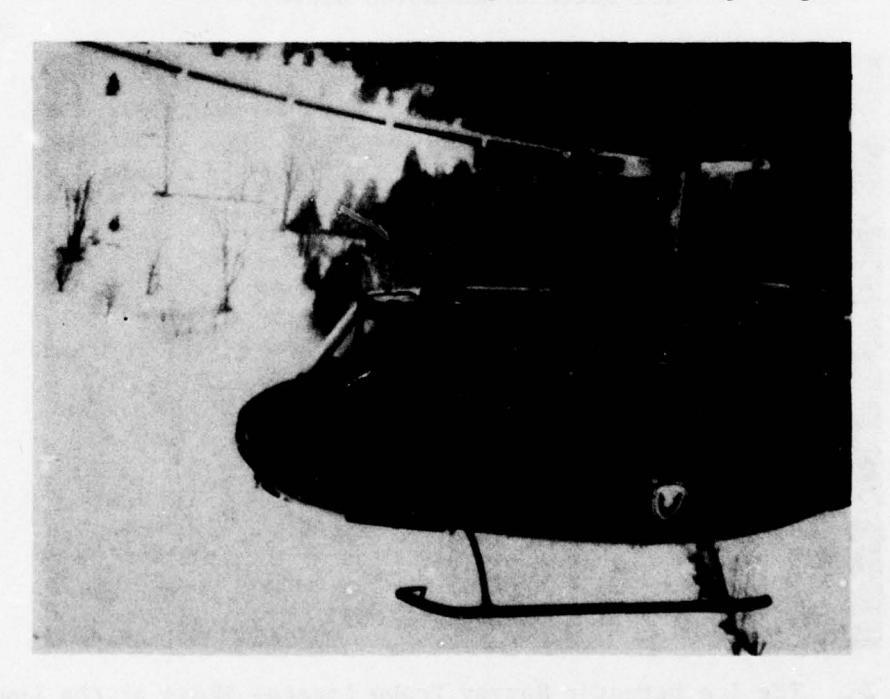
Figure 26. In-Flight Photo Following Natural Icing Cloud Exit (note ice on the UHF antenna and the ice detector pylon).

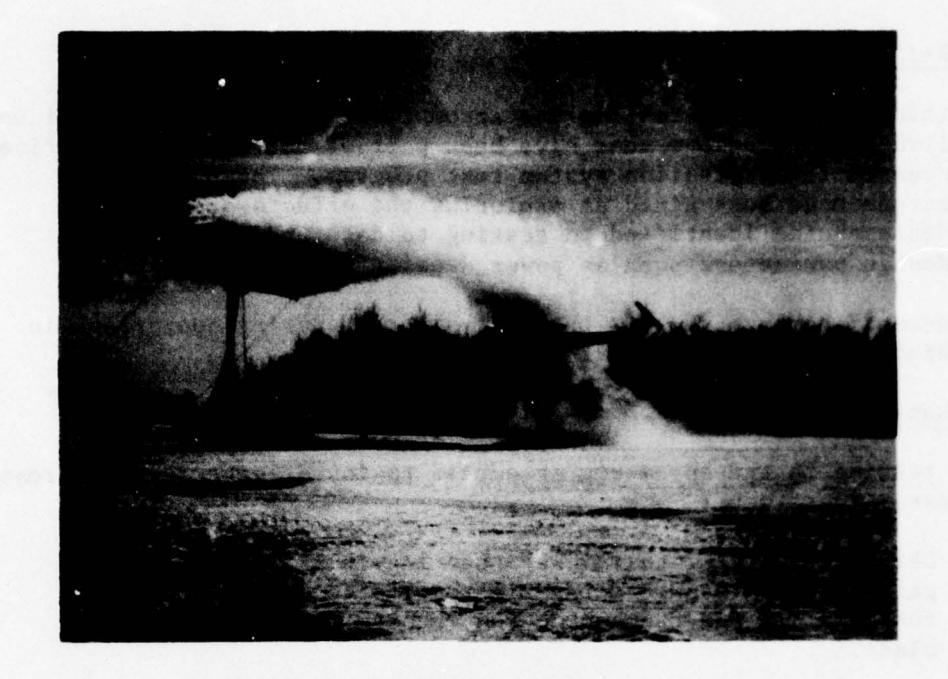
Figure 27. UH-1H Operating in the Spray Rig With 0.7 g/m<sup>3</sup> Cloud at  $-7.0^{\circ}$ C with 9-10 mph East Wind (heavy inlet screen icing was experienced).

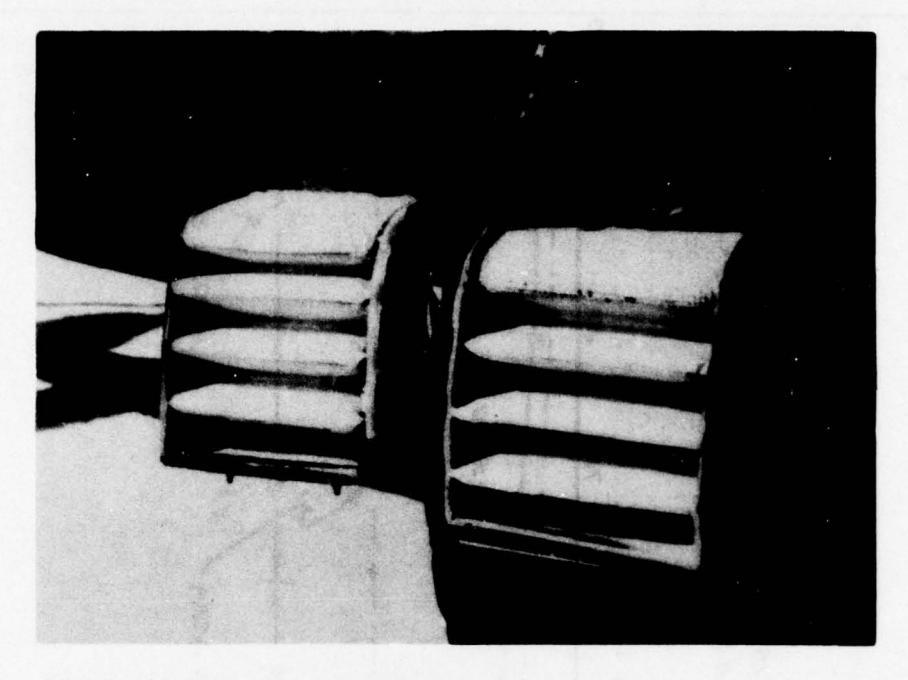
Figure 31. Right and Left Side Engine Air Inlet Screen Icing that Produced 10 inches  $H_20\Delta P$  - Spray Rig Cloud 0.7 g/m<sup>3</sup> at -7°C.

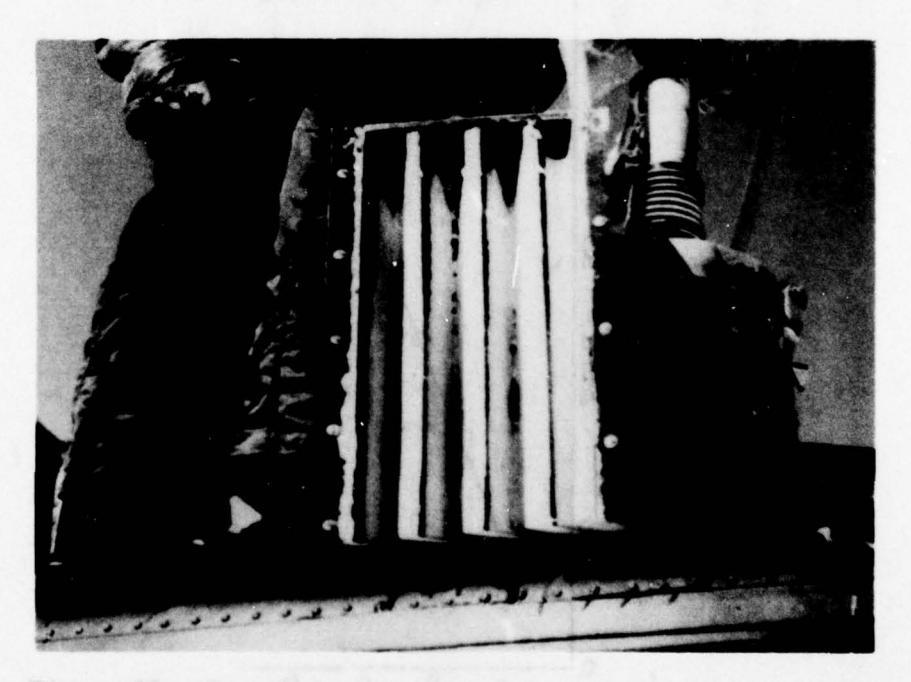
Figure 32. Top Engine Air Inlet Screen Icing from Same Spray Rig Run (30 minutes) as Above.

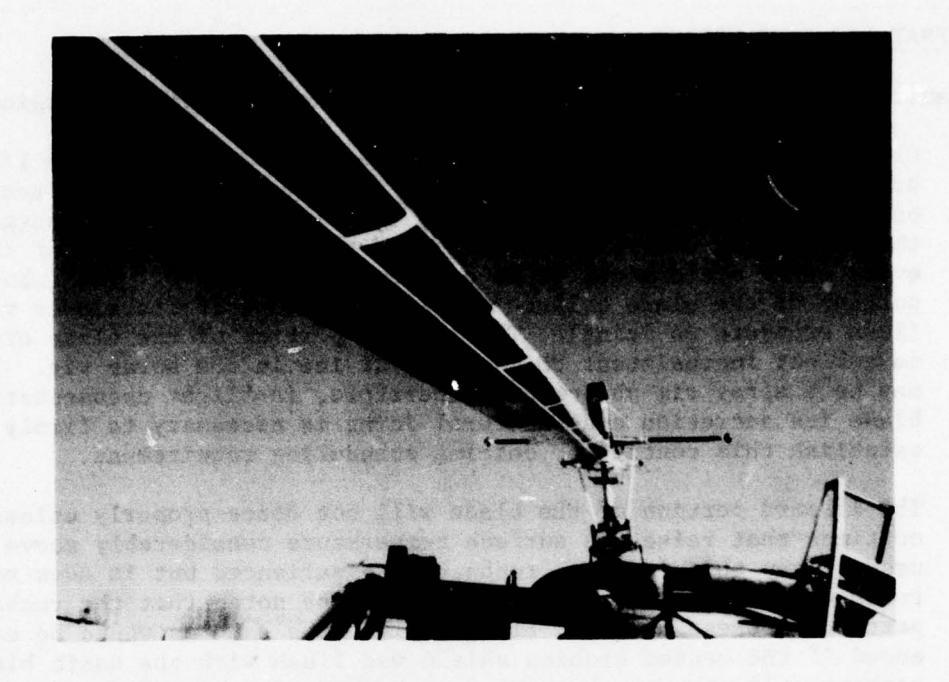
Figure 34. Typical Chordwise Ice Distribution From Spray Rig Operations (0.55  $g/m^3$  at -11.8°C).

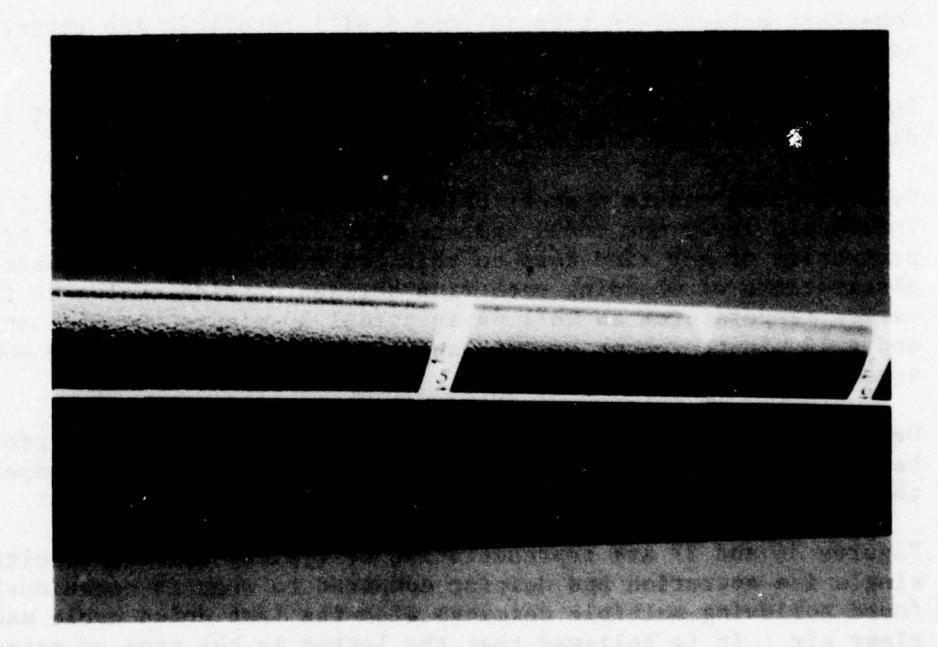
Close-Up of Blade Ice Density and Texture at 0.55 g/m<sup>3</sup> at  $-11.8^{\circ}$ C (note the double horn leading edge ice formation shape). Figure 35.
