ESD-TR-79-142

POST-TEST ANALYSIS OF BRUNSWICK MOD SHELTER TESTED IN DICE THROW

JULY 1979

MTR-3761

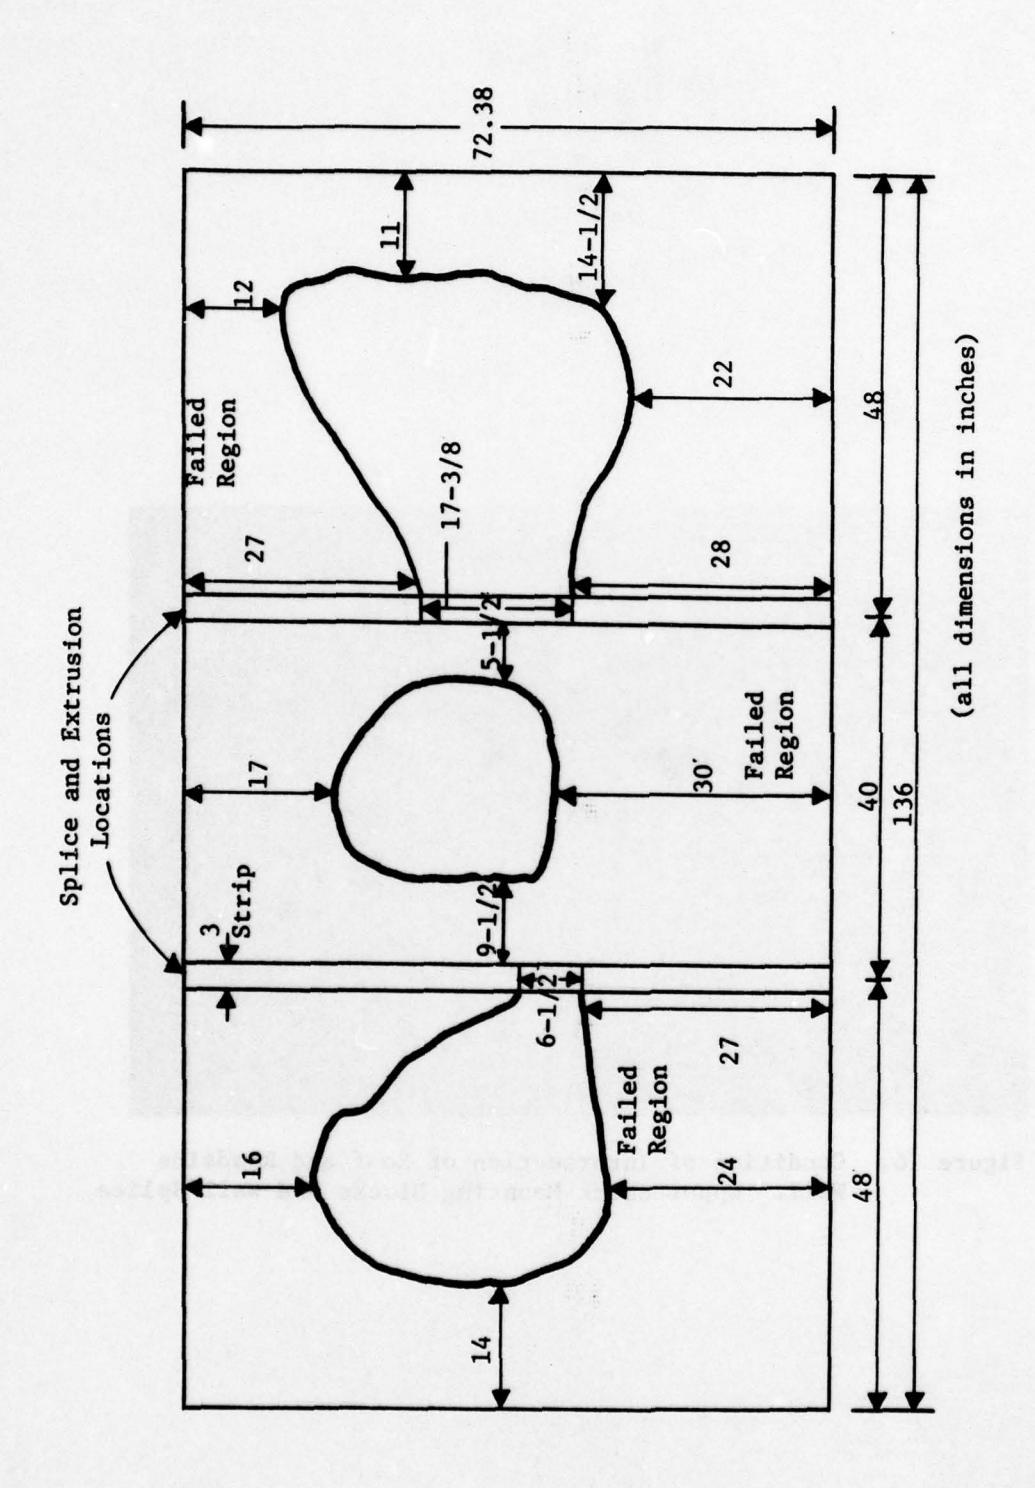
Figure 17. Internal Failure Regions - Roadside Wall

Careful tapping of the wall surfaces with a light hammer identified regions where some type of internal panel failure had occurred. These regions, which are shown in Figures17, 18 and 19, originated typically near the wall panel edges and the vertical extrusions. When panel sections were subsequently cut out from the shelter, it was seen that in these "failed" regions the honeycomb core had either ruptured in shear or otherwise separated or delaminated from the panel facing sheets. The cut-up sections indicated that the hammertapping technique had identified the regions of internal panel failure in Figures 17, 18 and 19 rather accurately.

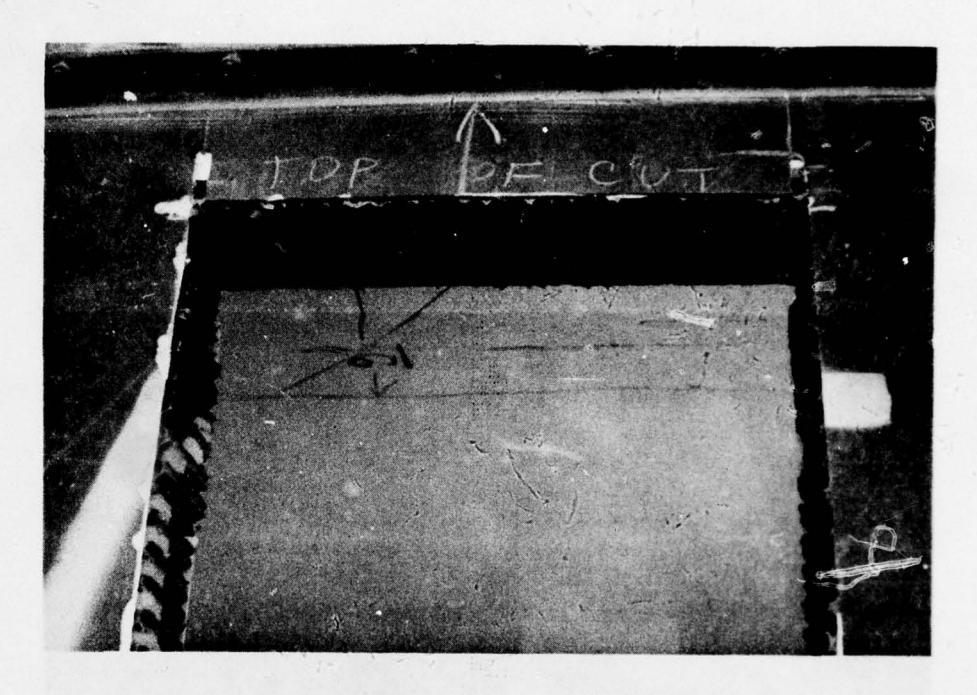
Figure 23. Roadside Wall Cut, Exterior View

Views of the upper portion of the roadside wall-cut are shown in Figures 21, 22, 23, and 24. Internal panel failure occurred as a result of shear failure of the core on the right side of the cut and at the top of the cut. The shear failure is distinctly visible in Figures 22 and 24, running in planes that are approximately 45 degrees with respect to the plane of the panel. The core failure at the top (Figure 23) extends the width of the cut and probably continues along a considerable portion of the roof edge extrusion.

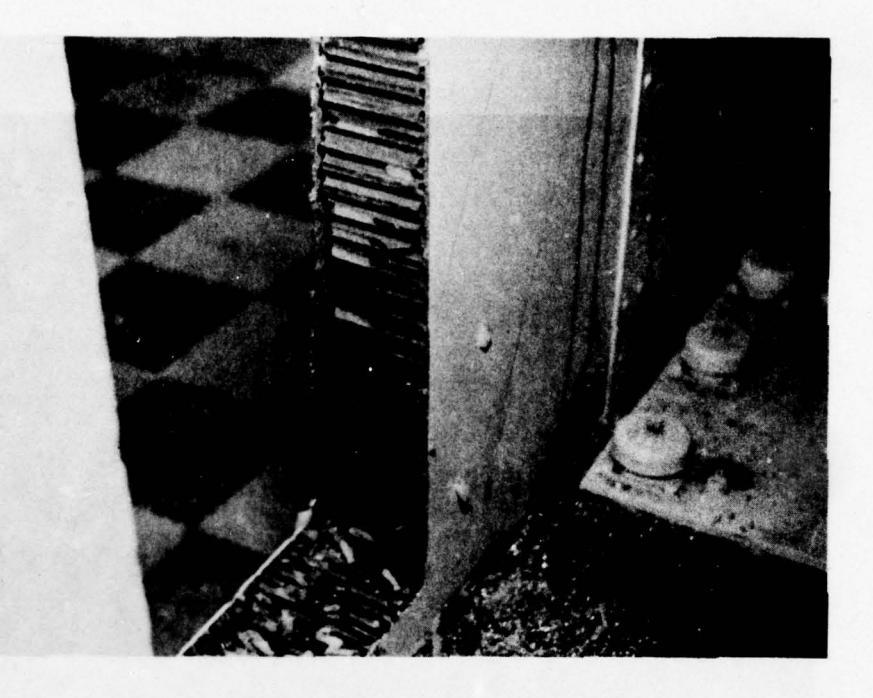
Figure 27. Roadside Wall Cut, Interior View Toward Front End Wall. Equipment Rack Shock Isolators

At the top left portion of the roadside-wall cut (Figure 21) and at the sides of the base (Figures 25, 26, 27 and 28), the core had separated from the outside facing sheets. In some places, this separation was due to core failure at the adhesive surface since parts of the core material remained imbedded within the adhesive. In other areas, the adhesive had failed at the facing sheet surface. The delaminated region extended considerably from the base extrusion on the roadside wall (Figures 25 and 26). At the base of the cut (Figure 28), the core fractured by shear over its full width, similar to the failure at the top of the cut.

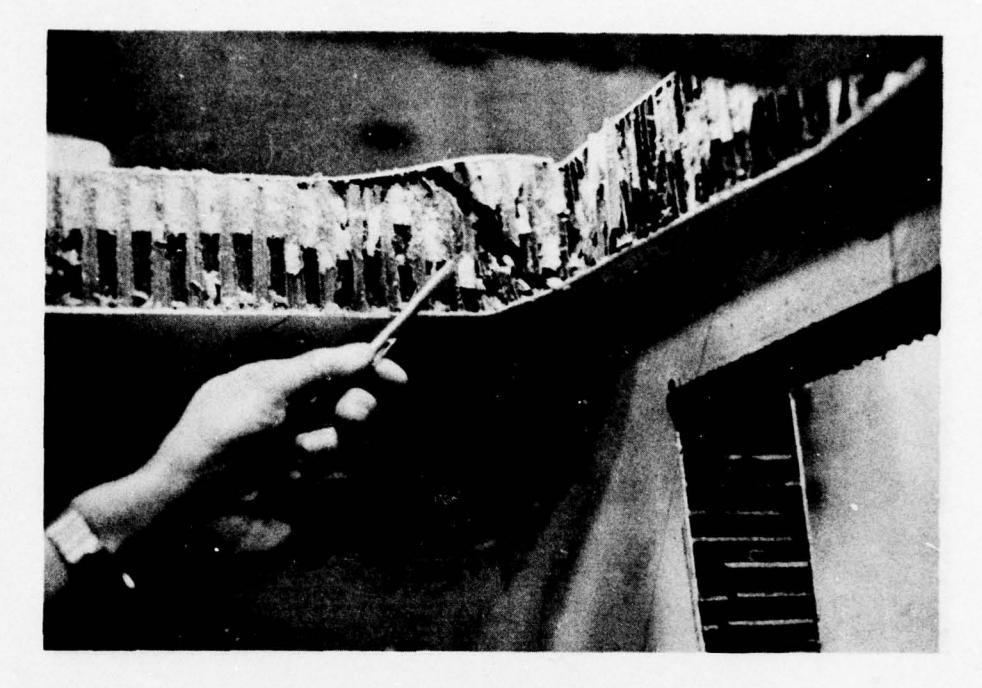
Figure 38. Roof Cut Near Roadside Wall, View Toward Door End Wall

Figures 36, 37, 38, 39, 40 and 41 show the roof cut and corresponding core failures. A good indication of the roof deformation mentioned earlier, showing the edge depressions and the flat central region, is given in Figure 36. The internal failure in the roof cut (Figures 37, 38, 39, 40, 41 and 42) was clearly shear failure of the core near the panel edges due to the downward overpressure loading. The classical 45 degree shear failure planes are evident in the photographs. The shear failure was present on all faces of the roofside cut, away from the central flat portion where no failure of any type occurred. No delaminations were present as in the roadside cut. The foaming adhesive had failed at the curbside end of the roof cut. Figures 37, 38 and 41 show the shear deformation beginning along the edges of the upper shock-isolation mounts. A view of the section removed from the roof is shown in Figure 42.

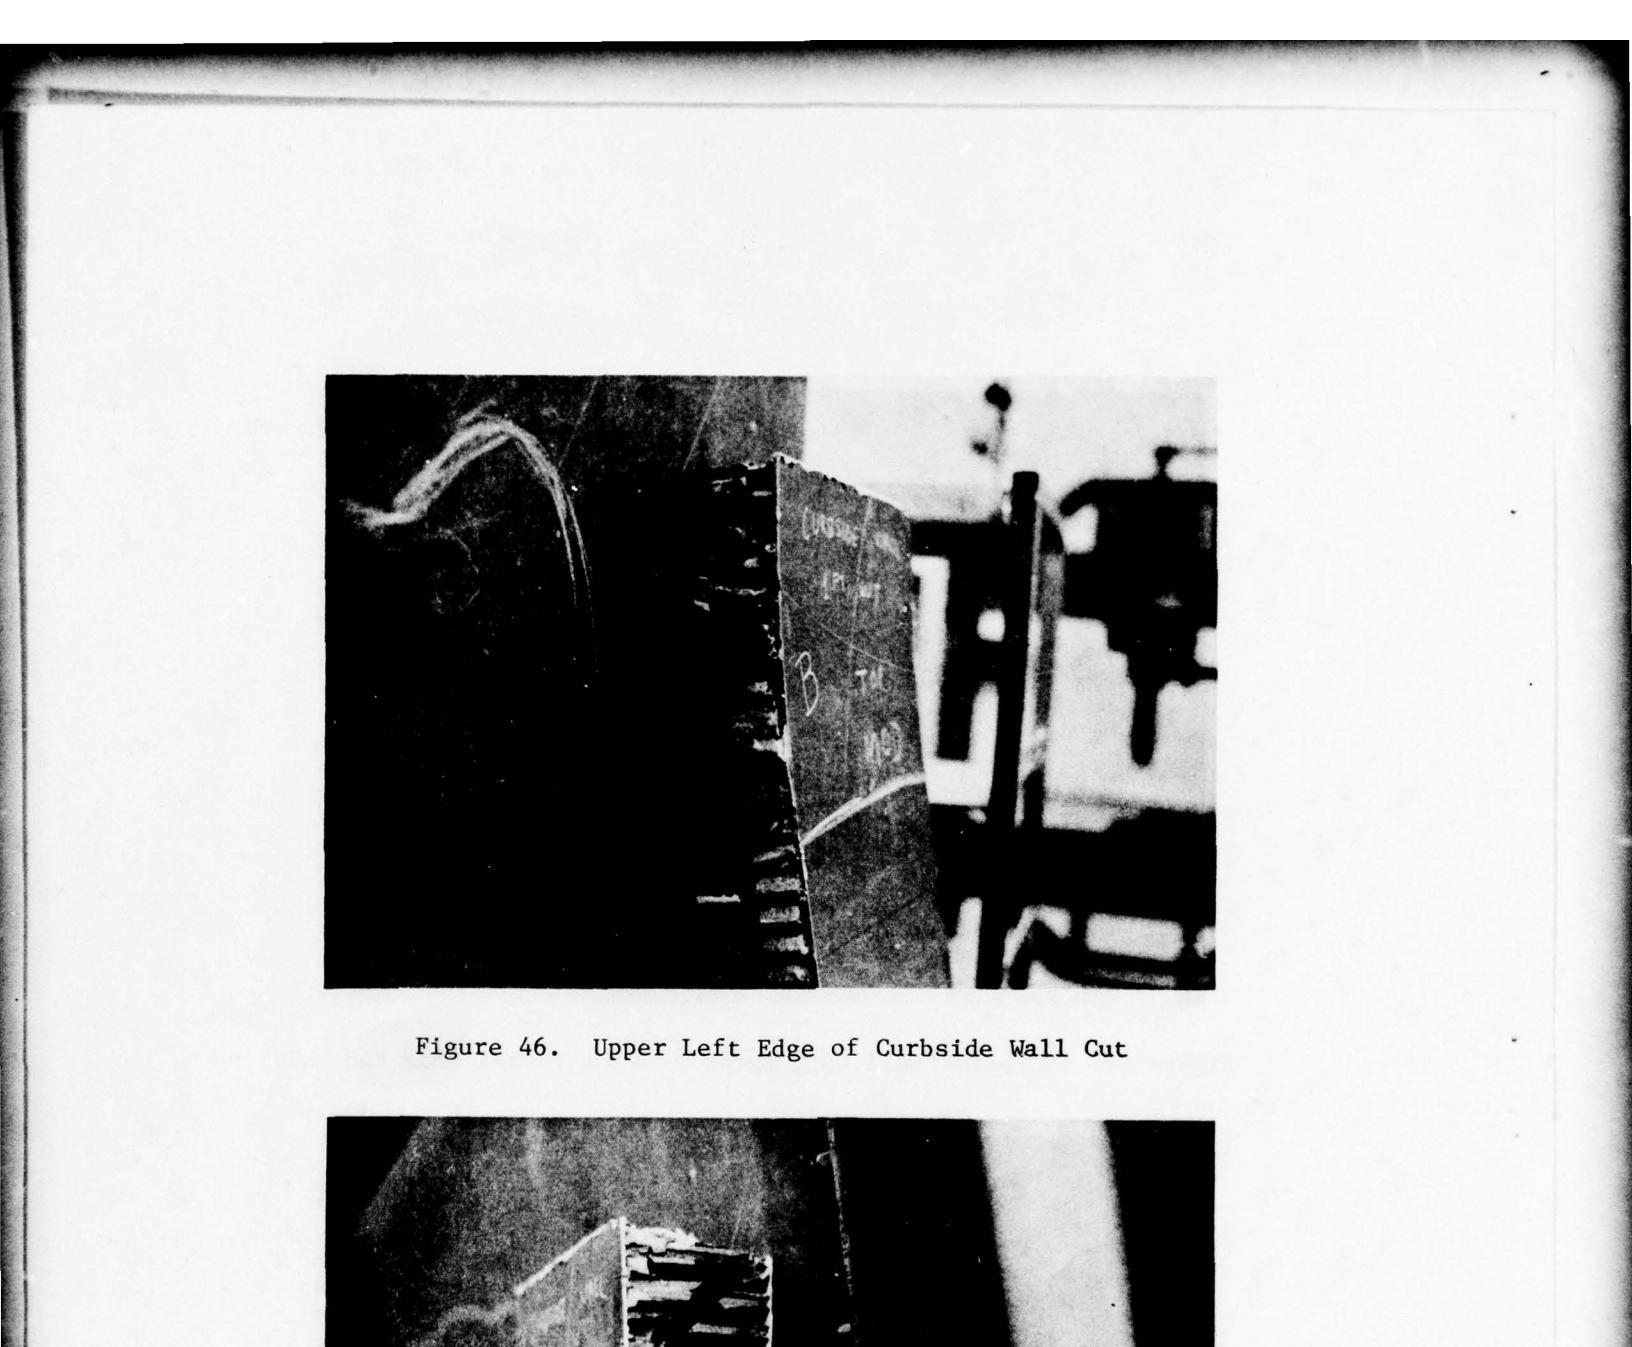
Figure 47. Upper Right Edge of Curbside Wall Cut

Failures in the curbside wall-cut are shown in Figures 43, 44, 45, 46 and 47. The upper surfaces of the cut showed shear failure of the core. Extensive core damage resulted at the upper part of the cut (Figure 45) as well as failure of the thermal barrier and the foaming adhesive. At the base of the cut and the sides, Figure 43, delamination occurred, again with some evidence of adhesive failure and core failure at the adhesive surface.
