Report to the Test Director

RESPONSE OF DUAL-PURPOSE REINFORCED-CONCRETE MASS SHELTER

Ammann & Whitney New York, New York April 1961

Project 30.2 was conducted to test a reinforced-concrete dual-purpose underground parking garage and personnel shelter designed for a long-duration incident pressure of 40 psi. The shelter was exposed to shot Priscilla, an approximately 37-kt 700-ft balloon burst (June 24, 1957), at a ground range of 1600 ft (predicted 35-psi peak incident-pressure level). The recorded peak incident pressure at the shelter was approximately 39 psi.

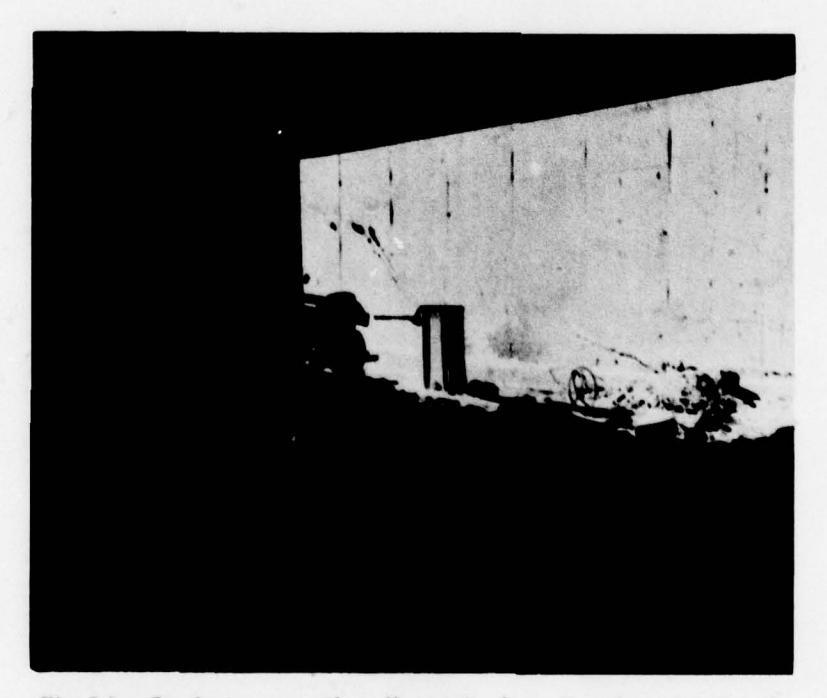
The exposed wall of the garage withstood the blast with no damage. The ramp wall at column line F had several large cracks between the end wall and a point about 30 ft up the ramp (Fig. 3.1). The top of the ramp side wall opposite the door entrance was pushed into the earth about 1 ft at the end. The top edge of the ramp wall farther up the ramp showed little

Fig. 3.1—Cracks in ramp side wall opposite door. View from interior of garage through door opening (postshot).

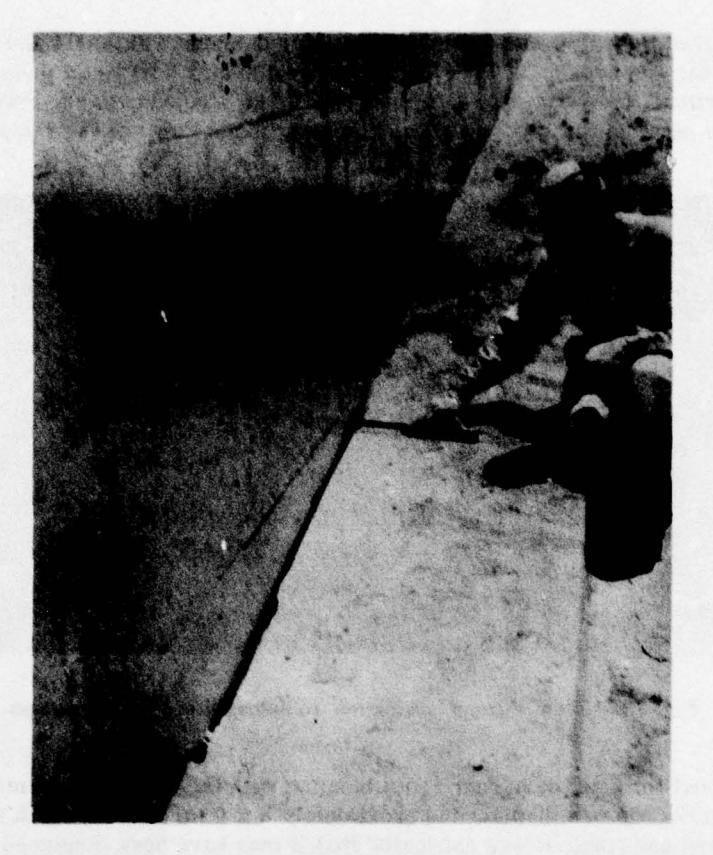
apparent displacement. Although there was no visible damage to the ramp slab, the slab was separated up to $\frac{1}{2}$ in. from the main garage structure at the expansion joint (Fig. 3.2), and the $\frac{1}{2}$ -in. joint filler was blown down or out. Gravel backfill was sucked through the weepers onto the ramp (Fig. 3.3). More gravel was found opposite the weepers at the mid-length and toward the top of the ramp than opposite the weepers at the lower end.

Fig. 3.2-Open joint between ramp slab and wall of main garage structure (postshot).

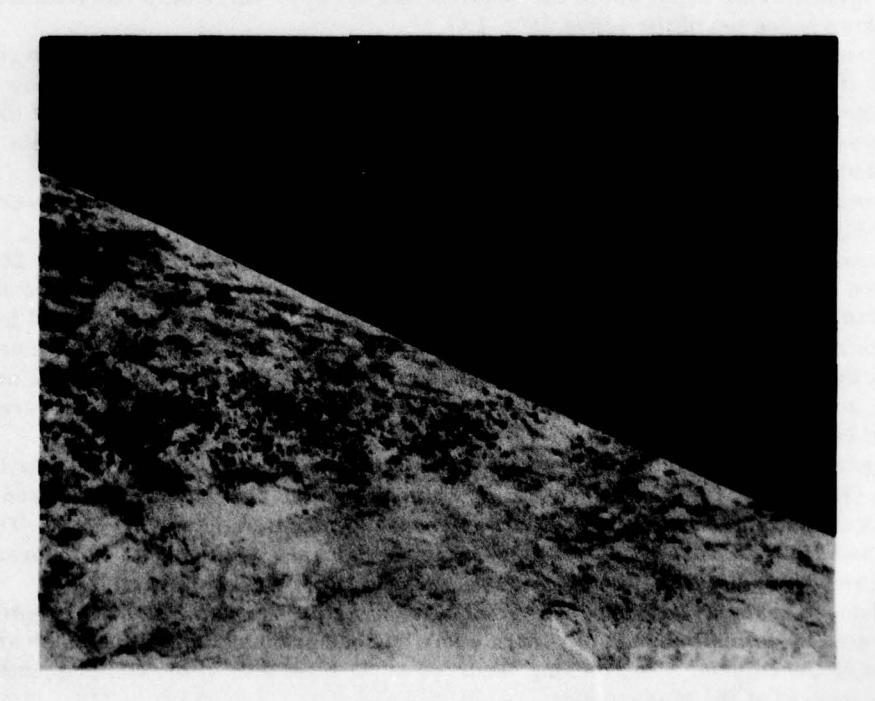
Fig. 3.3-Gravel backfill at weepers (postshot).

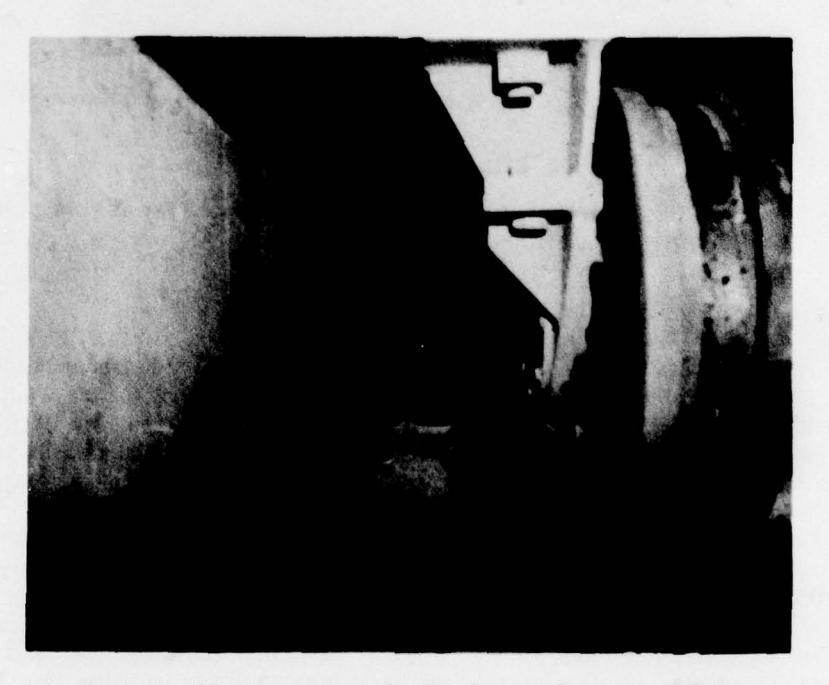
Fig. 3.10-Wheel assembly and rails, door partly open (postshot).
