SEPTEMBER, 1979

Name Of Dam:MOSS NO. 1 DAMLocation:DICKENSON COUNTY, VIRGINIAInventory Number:VA. NO. 05102

PHASE I INSPECTION REPORT NATIONAL DAM SAFETY PROGRAM

BY SCHNABEL ENGINEERING ASSOCIATES, P.C./ J. K. TIMMONS AND ASSOCIATES, INC. 79 11 15 088

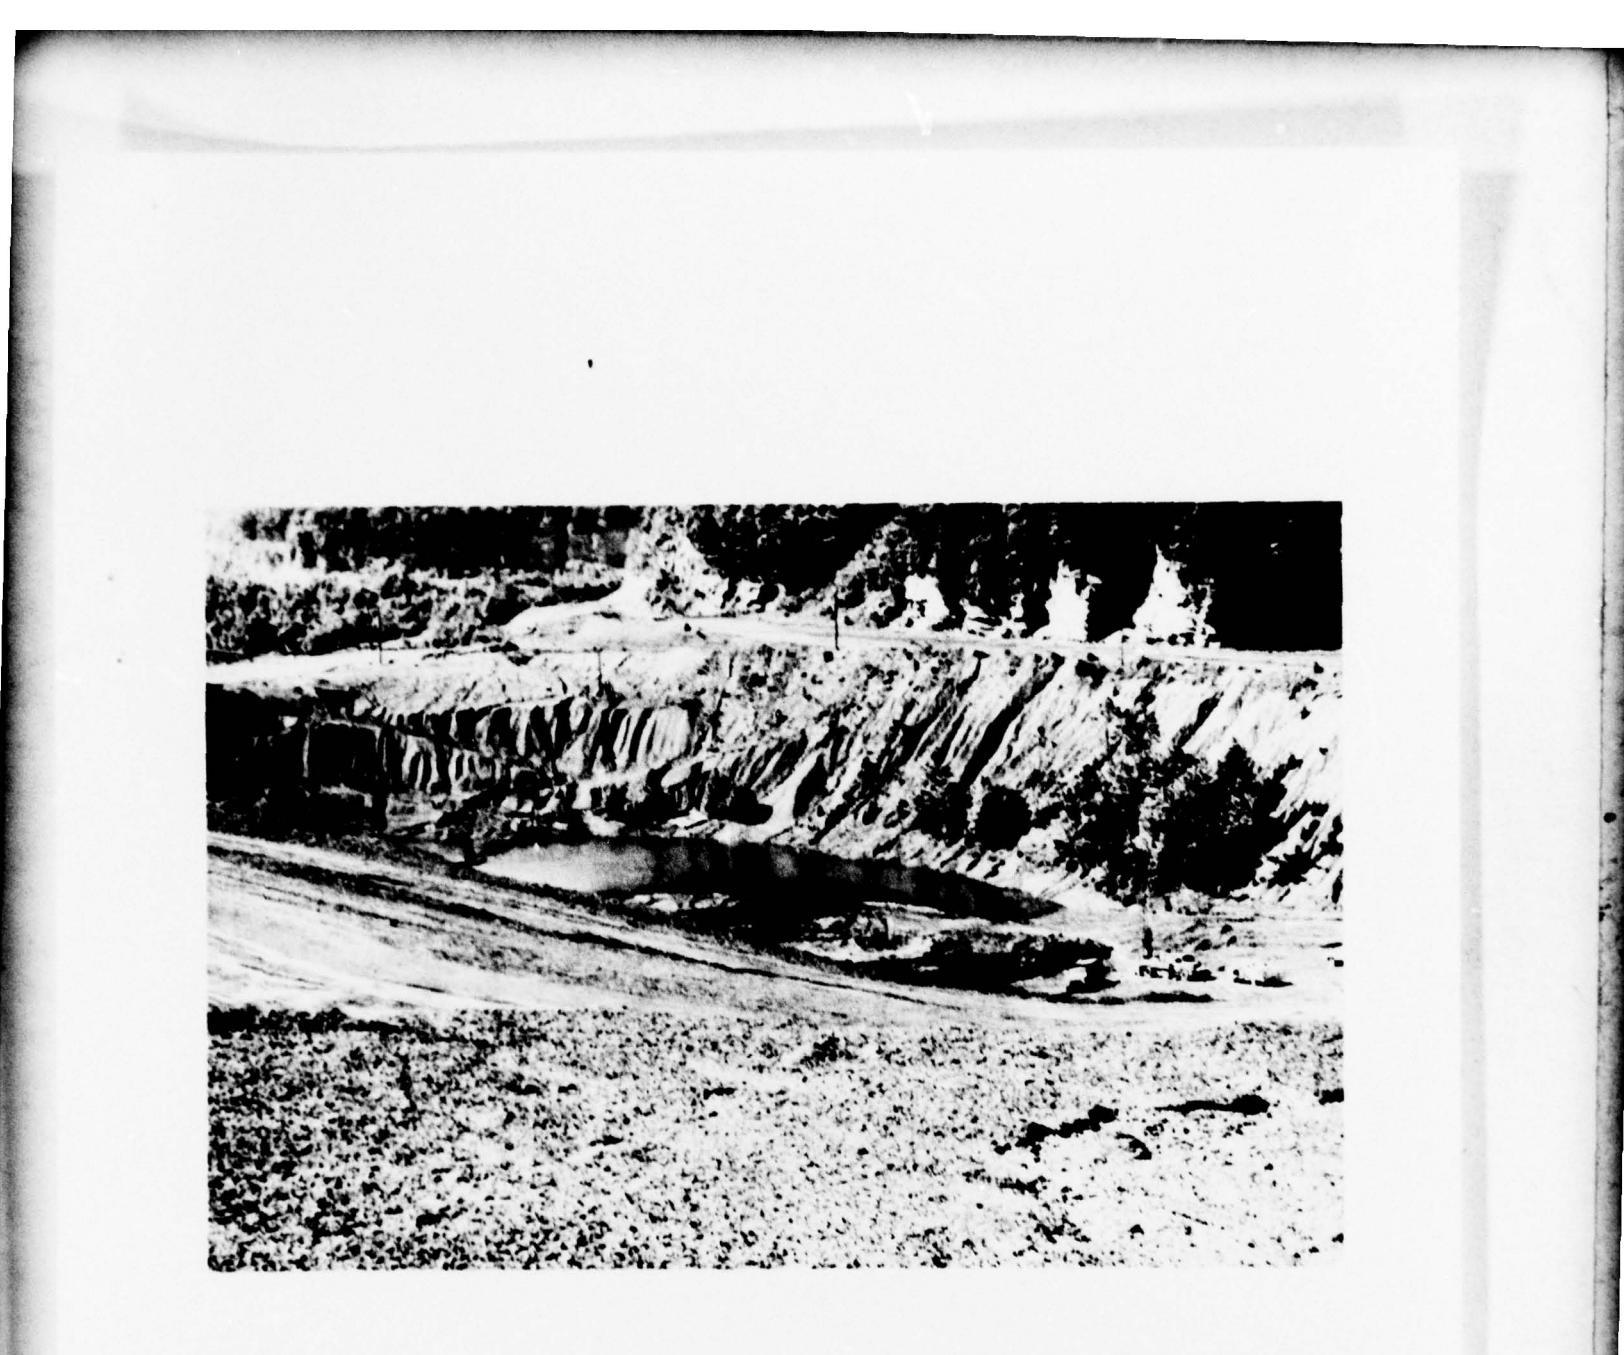
VIEW FROM TOP OF IMPOUNDMENT LOOKING TOWARD FRESH WATER POND AT BASE OF MOSS MINE NO. 1 IMPOUNDMENT.

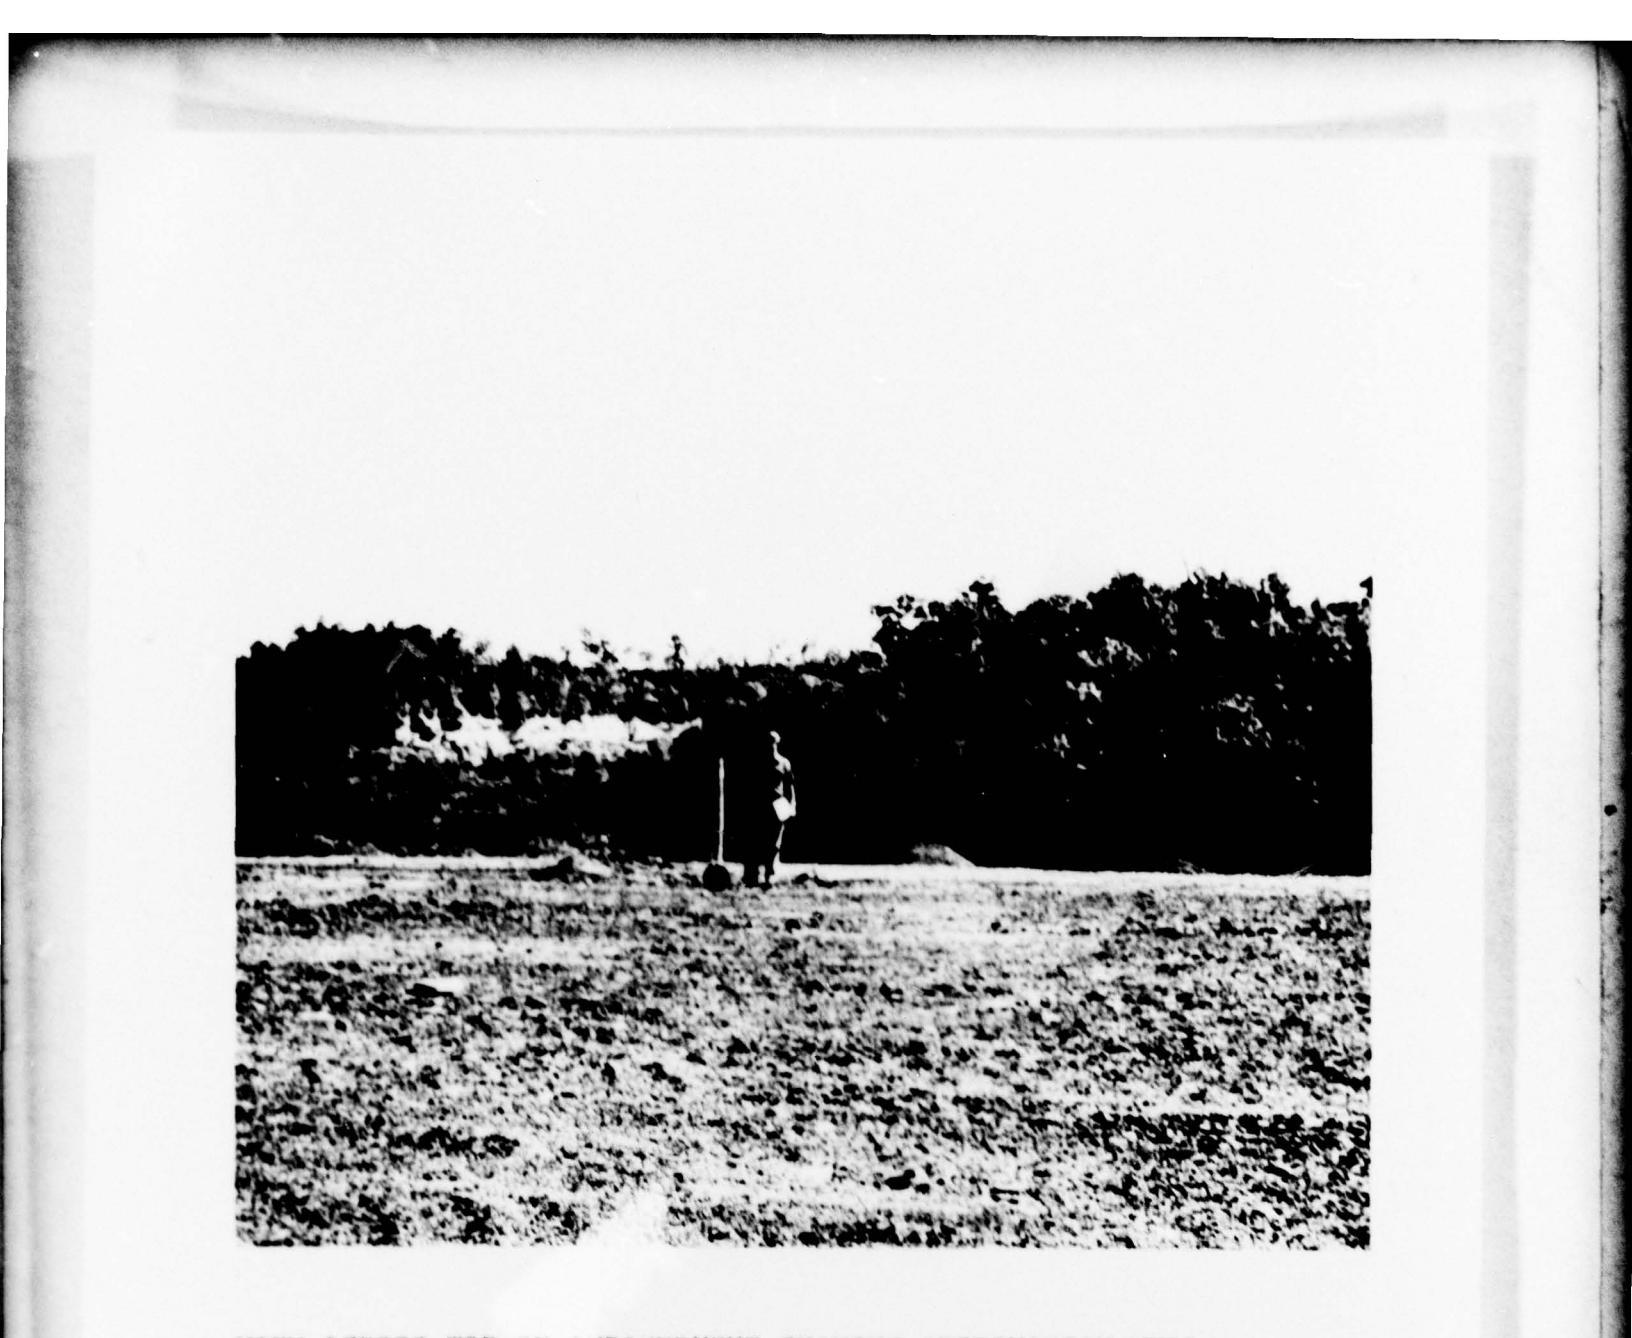
VIEW ACROSS TOP OF IMPOUNDMENT SHOWING OBSERVATION WELL

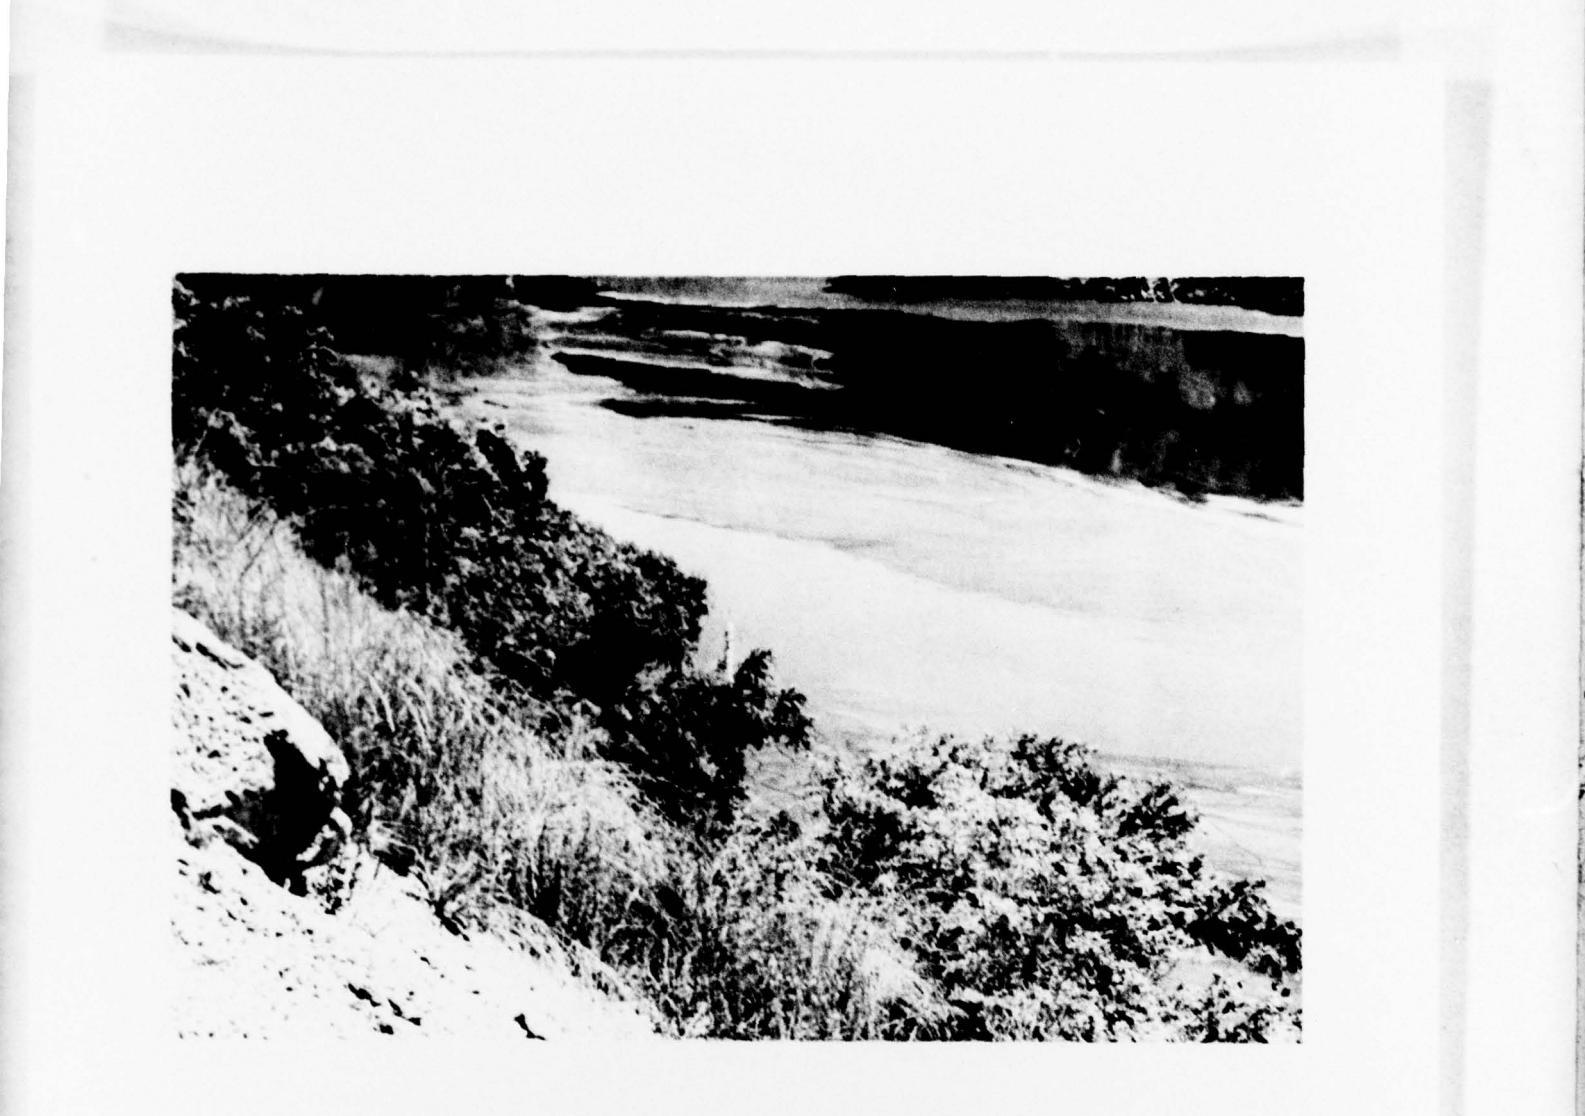
STAFF GAGE AND SIDE SLOPES OF RESERVOIR
