BRIER CREST WOODS DAM

NDI ID No. PA-00879 DER ID No. 45-245

PHASE I INSPECTION REPORT

FEBRUARY 1980

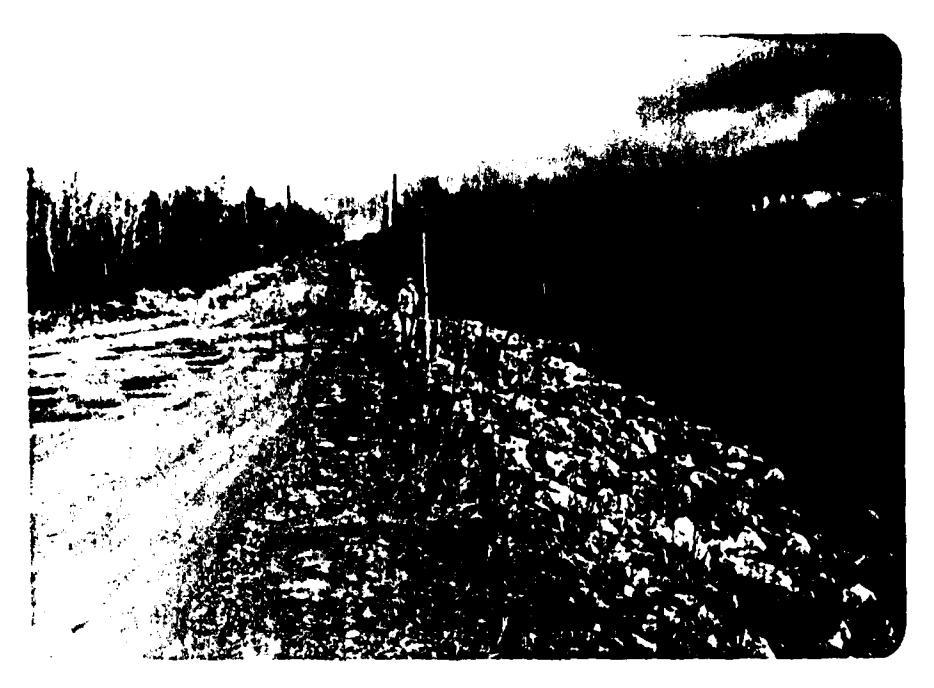
A. Upstream Slope

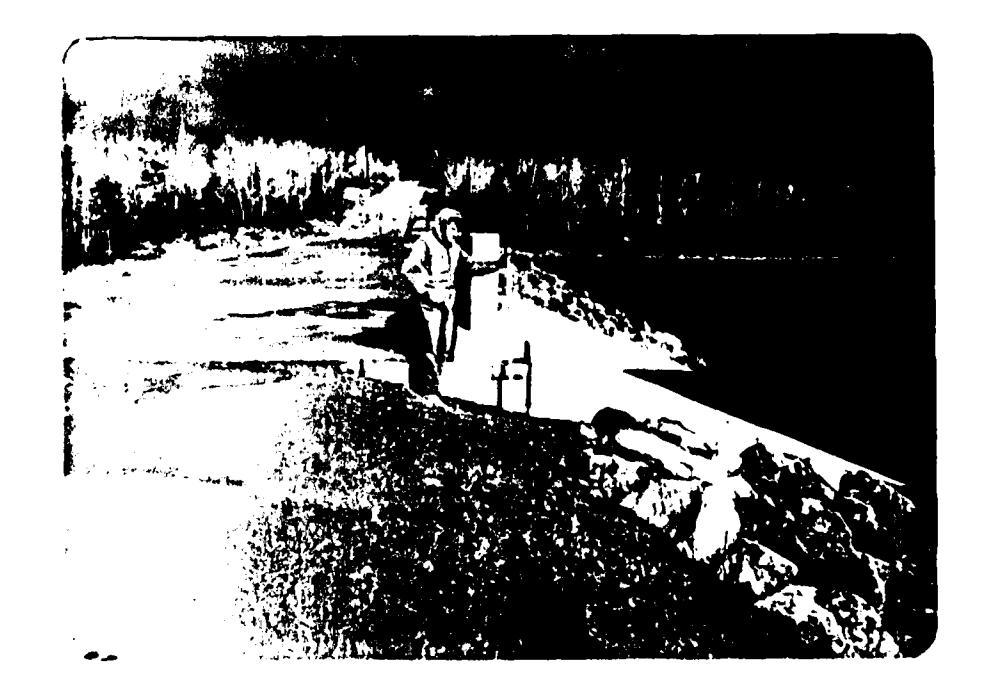
D. Spllway Bridge

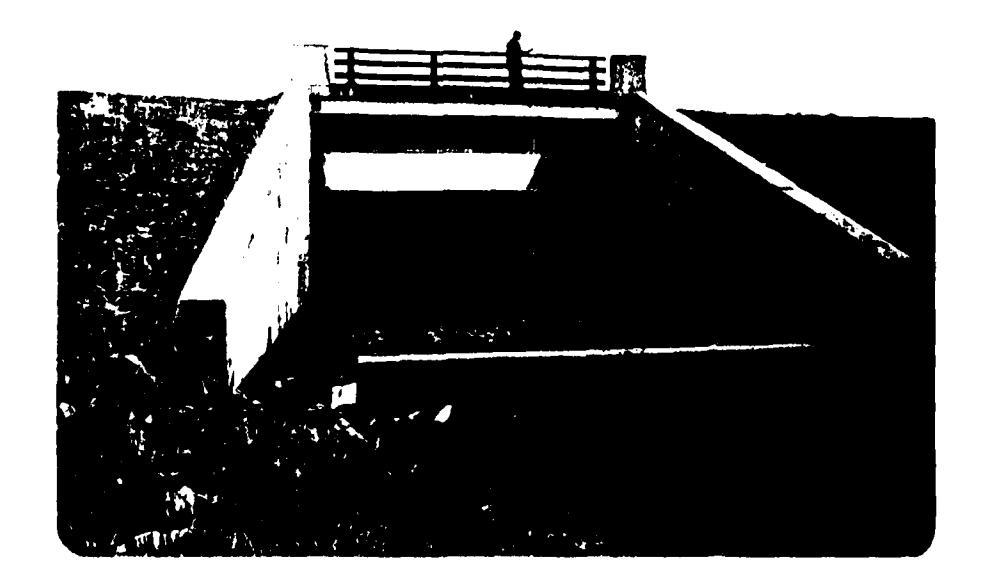
c. <u>Appurtenant Structures</u>. The spillway is in good condition. No deficiencies were observed at either the weir or the exit channel apron. The sidewalls of the exit channel apron, which also act as the bridge abutments, have a shrinkage crack on each side approximately coincident with the axis of the dam. The weep holes in these walls were trickling (Photograph F). The bridge deck is in good condition.

(3) <u>Appurtemant Structures</u>. The shrinkage cracks in the exit channel walls are not a hazard at present; they do have the potential to eventually start spalling. The minor flow from the weep holes indicates that they are probably functioning correctly.

F. Spillway
