This report is prepared under guidance contained in the <u>Recommended</u> <u>Guidelines for Safety Inspection of Dams</u>, for Phase I Investigations. Copies of these guidelines may be obtained from the Department of the Army, Office of Chief of Engineers, Washington, D.C. 20314.

SAMPLE RUN DAM NDI I.D. PA-284 NOVEMBER 30, 1979

PHASE I REPORT NATIONAL DAM INSPECTION PROGRAM SAMPLE RUN DAM NDI I.D. PA-284 DER I.D. 32-14

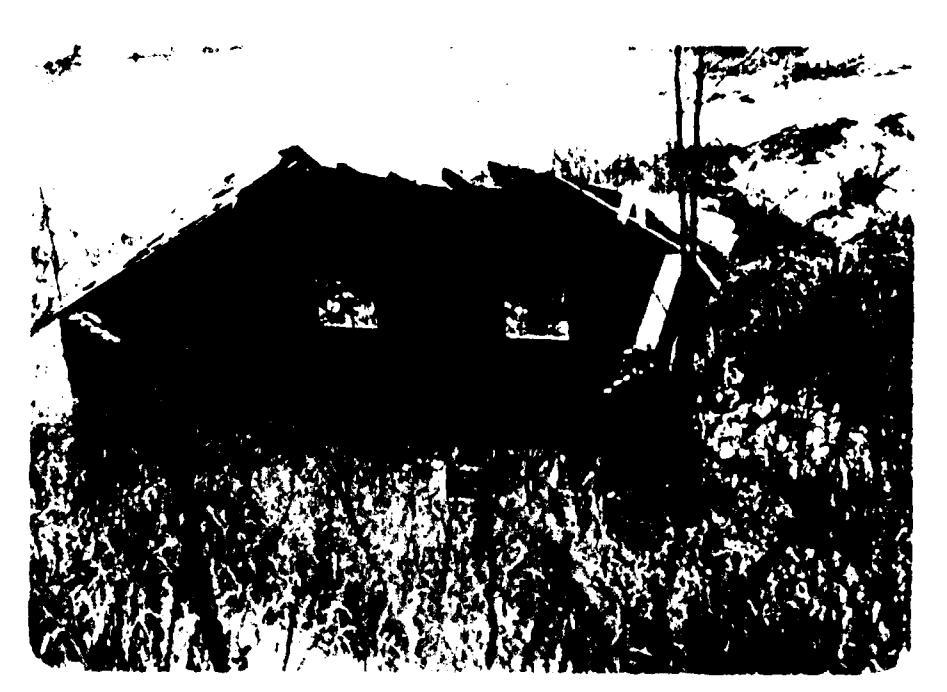
Most of the operating facilities in the valve house are buried beneath the rubble of the collapsed wall and the roof of the valve house. Visible portions of the operating equipment indicate that the operating equipment is seriously corroded and leaking.

Photograph No. 5 Valve house (collapsed).
