EXPOSURE

vol. 8 no. 3

Transmittance and Temperature Sensor Flow Step Response

Tape Fouling Problem:

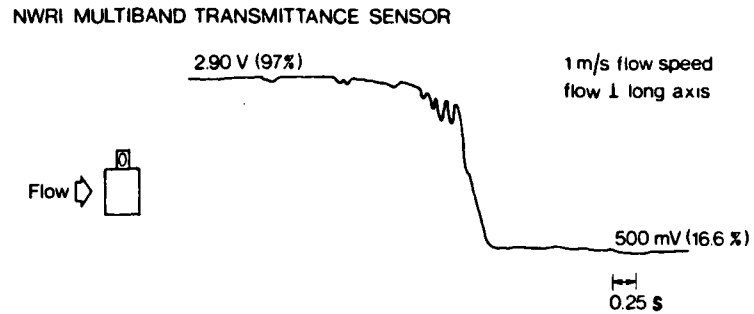
FIGURE 2.

This procedure was done for two sensor orientations: one with the flow perpendicular to the ports and the long axis of the sensor, and the other with the flow parallel to the ports and to the long axis of the sensor. As expected, the first orientation had better flow characteristics for clearing the active volume. The time required to 63 percent of final reading was 0.34 seconds and to 98 percent was about 1.7 seconds. This was repeated at a tow speed of 0.5 m/s with nearly identical results. The second orientation times are 1.4 seconds and 5 seconds, respectively, for the 63 percent and 90 percent values. See Figure 2.

Care should be taken when extrapolating these time constants to other speeds because the hydrodynamic flow past the sensing volume may very well be nonlinear. Also, the curves presented do not exactly follow a classical single pole response. One can make the conclusion, however, that these time factors can result in delay and distortion in the profile, particularly in areas of high transmittance variation with depth.

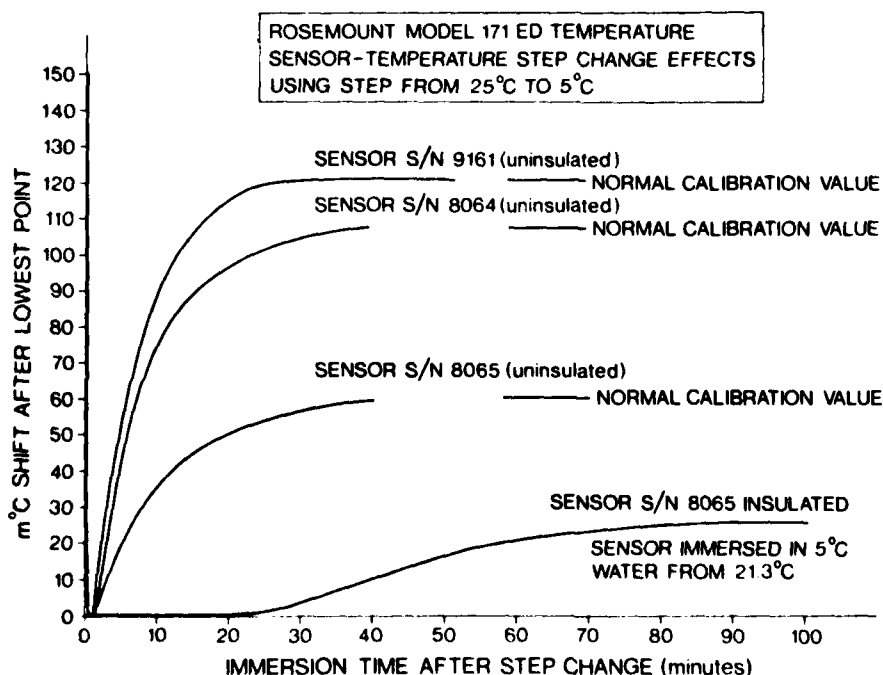
FIGURE 4.

It was found that the temperature compensation of the model 171 ED electronics varies considerably and can affect profile readings. Three of these sensors were taken from a 25°C fluid and immersed in a cold water bath, which has a short term instability of 2 to 3 m°C. A 60 m°C, 110 m°C, or 120 m°C overshoot

was observed for a 20°C step--the amount of overshoot depending on the sensor. This overshoot returned to the nominal value after about 30 minutes. The amount of overshoot is linear with the temperature differential between the two baths. A reverse of this overshoot was also observed going from a cold bath to a 25°C fluid. To confirm that it was indeed the amplifying electronics and not the platinum element causing the effect, the element alone was immersed. The magnitude of the effect was substantially reduced. A residual error was observed, probably due to conduction between the element and the electronics body. To reduce this electronic drift, 1/2 inch (12 mm) neoprene was wrapped around the electronics body. Syntactic foam could also be used should the sensor be used at great depth. Figure 4 shows the substantial reduction in the temperature shift when the neoprene was used. The magnitude of the peak to nominal error was reduced

from about 60 m°C to about 25 m°C presumably because the rate of heat loss/gain had been reduced and the self heat of the electronics maintained a more stable electronics temperature. It is instructive to point out that the immersion time of the transducer should be specified when the transducer is insulated and it is to be used for profiling. The sensor should not be immersed for more than 20 minutes for maximum relative accuracy. If a fixed position, long-term measurement is wanted, the sensor should be immersed for at least 1.5 hours for maximum absolute accuracy. It should also be pointed out that if the temperature sensor is used with another profiling instrument, say for example a transmissometer, for maximum accuracy the sensor should be placed well away from obstructing elements such as the transmissometer or a protective cage. Moreover, the transmissometer and cage should be thermally insulated to prevent heat from these bodies affecting the temperature measurement. Ship heat, solar radiation, and flow drag would also have to be considered should these accuracies be needed. It is indeed fortunate for us that accuracies of better than 100 m°C are rarely required for routine limnological profiles.
