CORPS OF ENGINEERS OMAHA NE  
HARDENED WALL TESTS.(U)  
APR 78

(6) HARDENED WALL TESTS.

Corps of Engineers ✓

(11) 21 Apr 1978

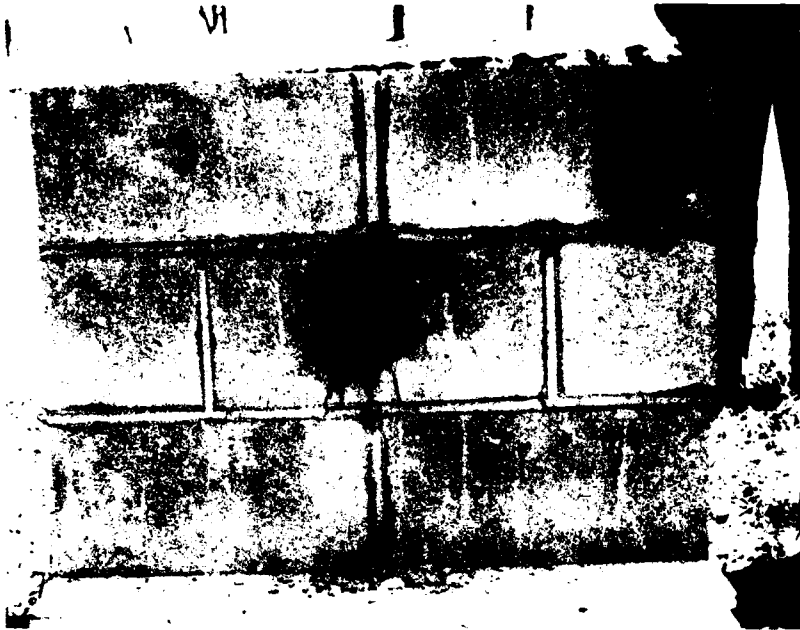
1-20

1-20. Wall #8.  
4-shot burst  
penetrated  
first CMU and  
face shell of  
second CMU. Did  
not penetrate  
back shell of  
second CMU.

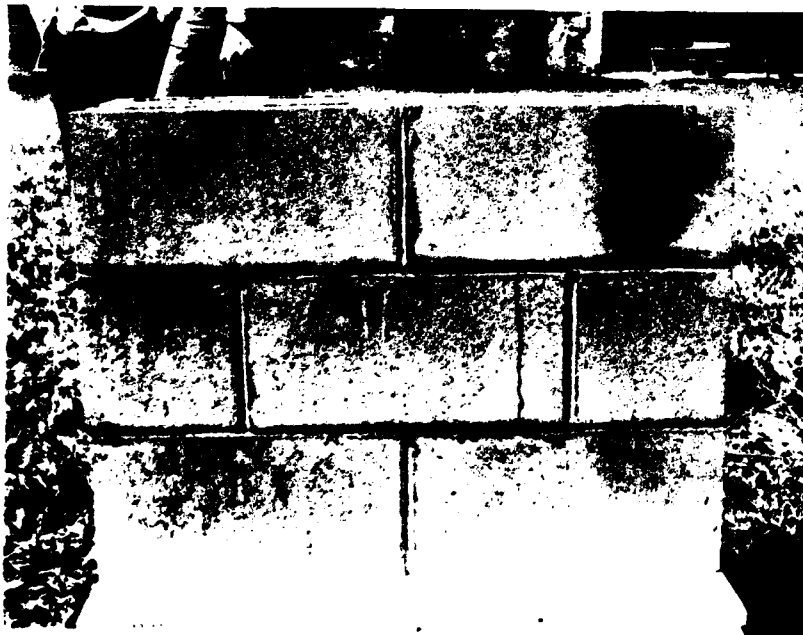
1-19

1-19. Wall #8. 4-shot  
burst shows  
crack in back  
shell of second  
CMU.

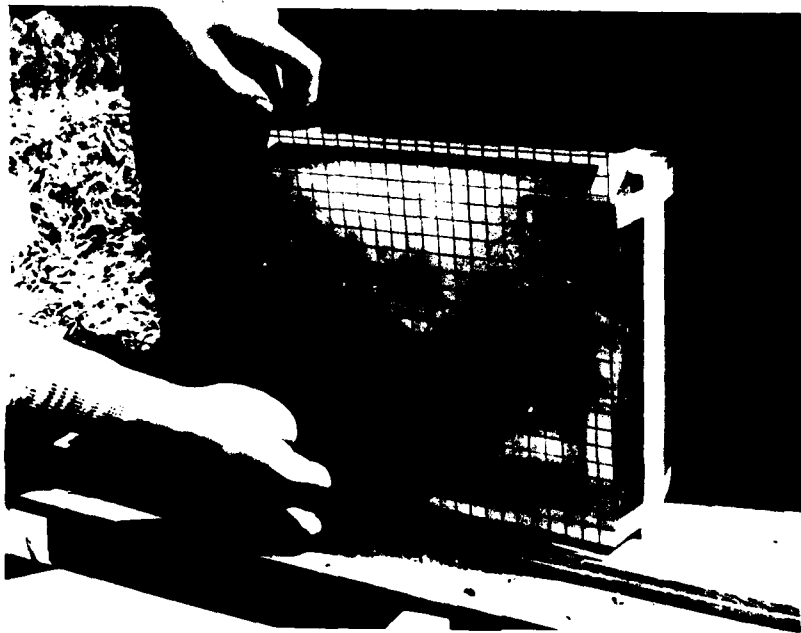
2-4 Glass Sample.  
First shot.  
Penetrated approx.  
0.7 inch. Spall,  
3-inch. Hole,  
2-inch. Back of  
glass was spalled  
off.

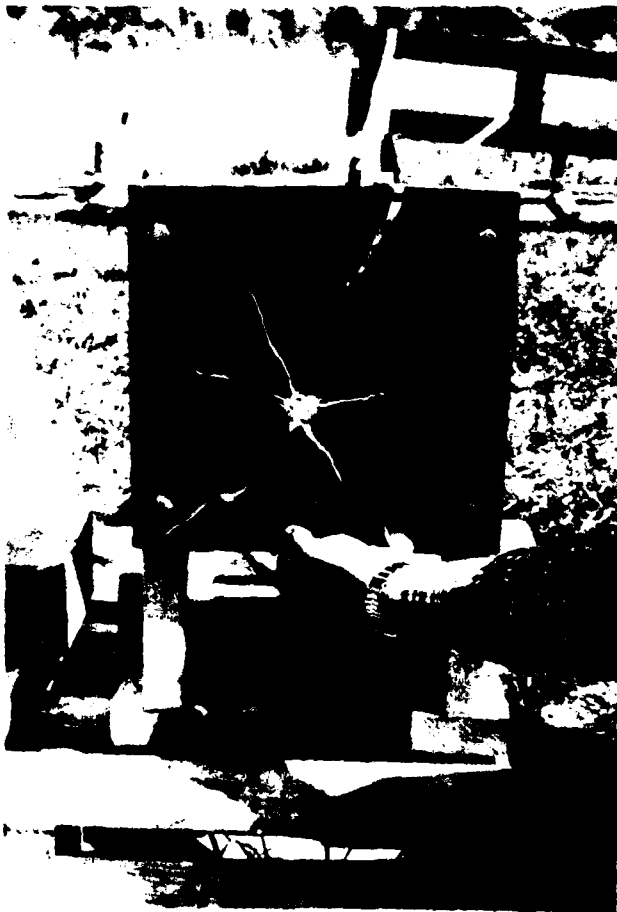
1-36  
(colored)

1-36 (colored).  
#19, shows bullet  
went through.

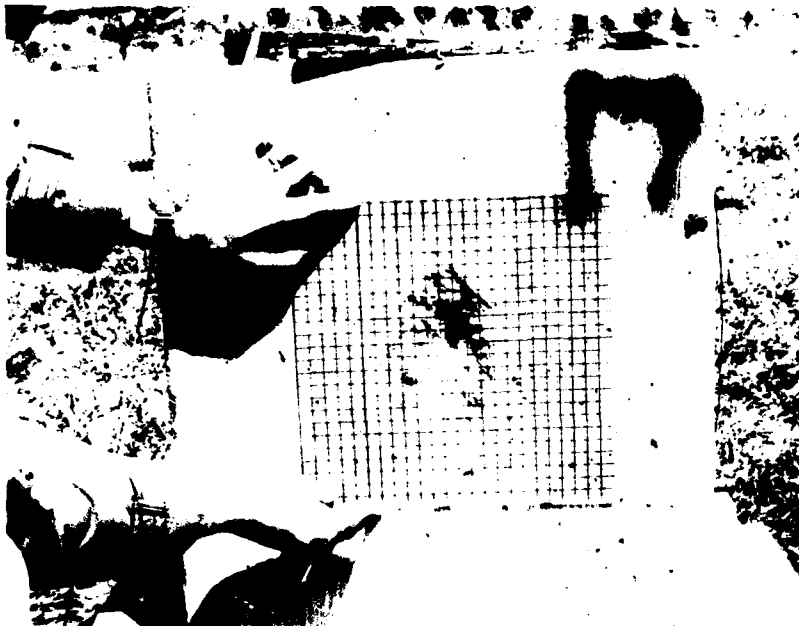
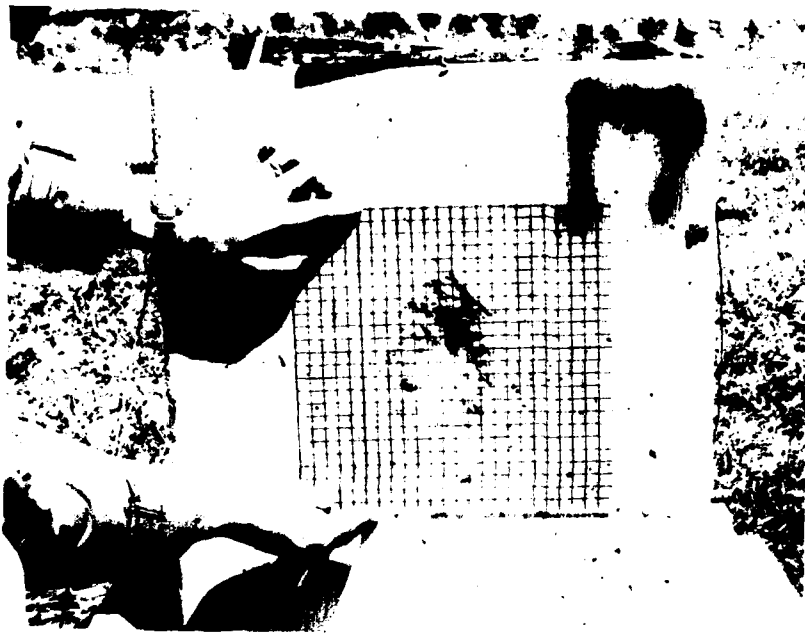
3-6

3-6. Wall #17. Single shot. Did not penetrate. Spall, 6 inches. Depth, 1.601 in.

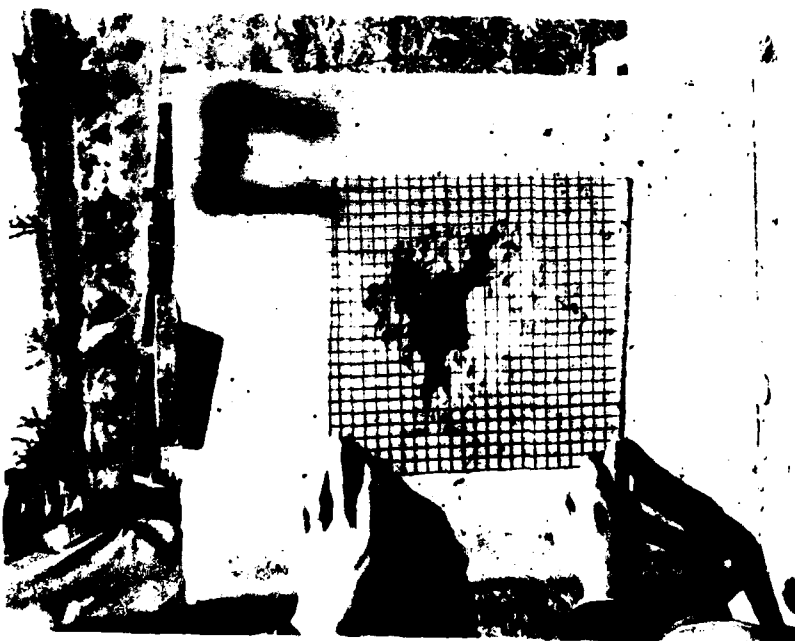
3-7

3-7. Wall #17. 4-shot burst. Did not penetrate. No cracks in rear face. Depth of penetration, 2.775 inches.

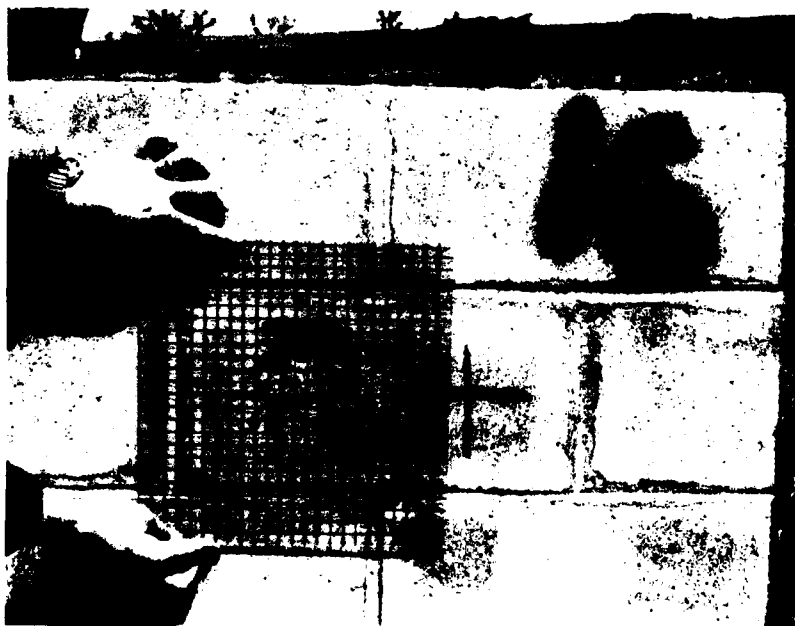
3-11

3-11. Wall #16. Single  
shot. Penetrated  
face shell. Did  
not penetrate back  
shell. No cracks  
in back of wall.

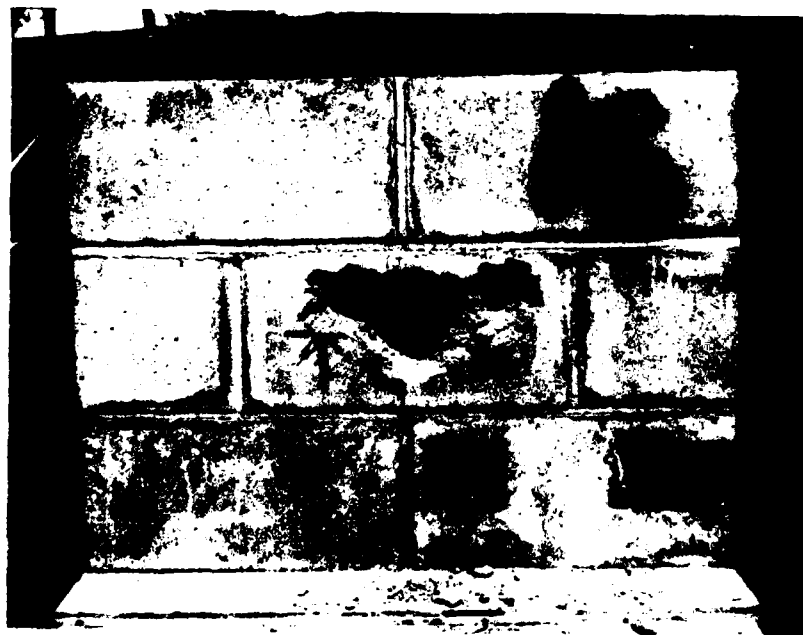
3-14

3-14. Wall #16.  
4-shot burst.  
Penetrated  
entire wall.

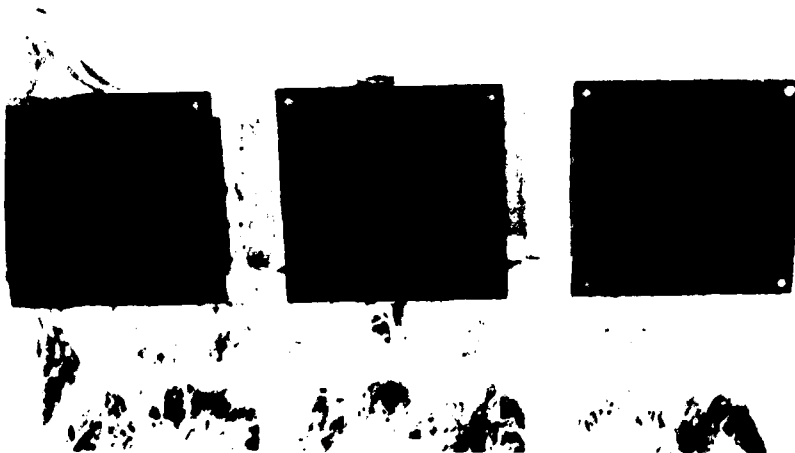
4-2

4-2. Shows double plates above with a single shot at each plate. Single shot went through the first plate and did not penetrate the second plate in all cases.

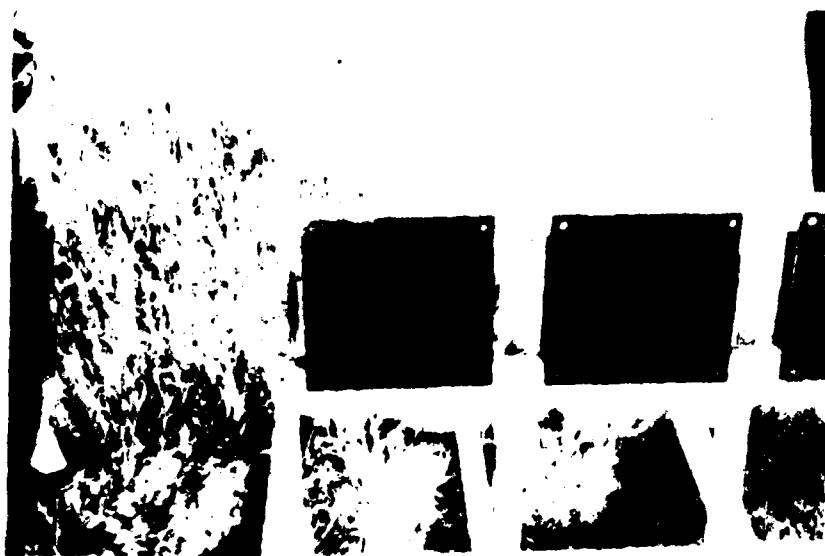
4-4

4-4. Second shot at the 1/4-in. double plate. Same results as first shot. Shots were approximately 2 inches apart.

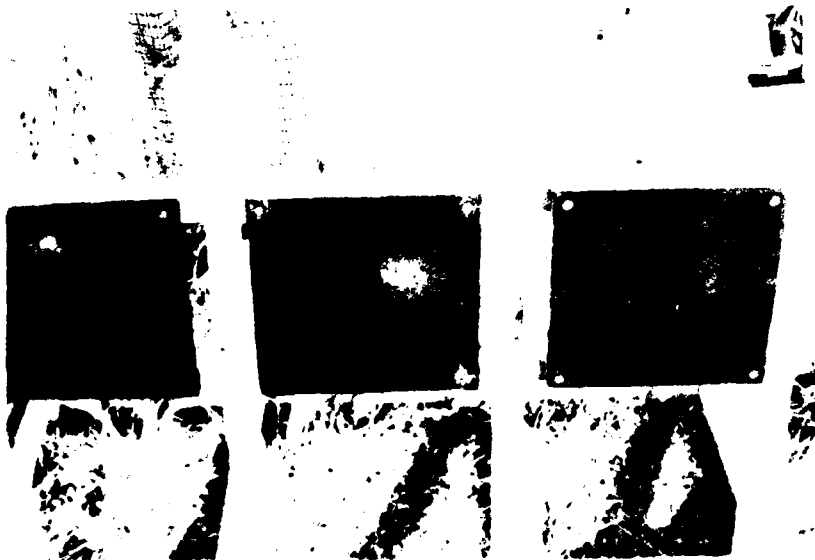
5-1

5-1. View of single plates with a single shot fired at each. Left-most plate is 1/4-in. hardened steel (Astralloy) Brinell Hardness = 356. Single shot did not penetrate plate. It put a bulge in back side of plate. Center plate is 3/8-in. hardened steel (Astralloy) Brinell Hardness = 299. It

did not penetrate or put a bulge in back side. Right-most plate is 5/8-in. A-36 steel. Single shot did not penetrate, but did put a large bulge in back side of plate. Appeared to come very close to penetrating.
