PHASE I INSPECTION REPORT NATIONAL DAM INSPECTION PROGRAM

SYNOPSIS OF ASSESSMENT AND RECOMMENDATIONS

NAME OF DAM: STATE LOCATION: COUNTY LOCATION: STREAM

Treated Water Pond Pennsylvania Washington Unnamed tributary to Sawmill Creek. 7 May 1980 Lat. 40°11'24", Long. 80°00'16"

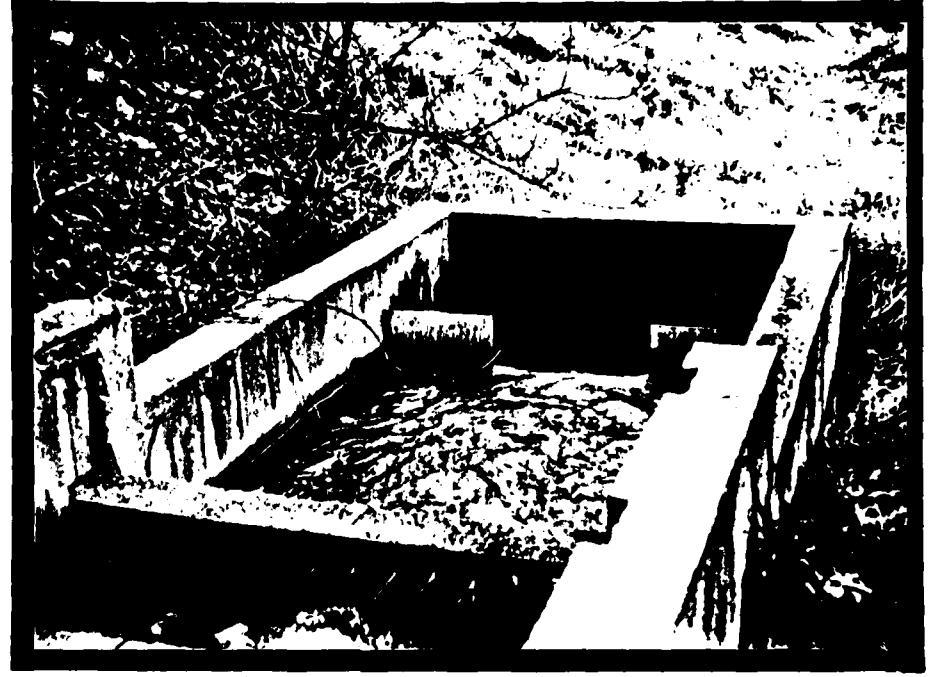
(4) <u>Condition</u>: All visible components of the active outlet works were in good condition except the energy dissipator box which contained a large hole that appeared to have been intentionally broken through the upper downstream side of the box. The hole did not affect the performance of the structure.

Photo 5 Active Outlet Works Outlet Structure showing baffles sharp crested weir flow control.

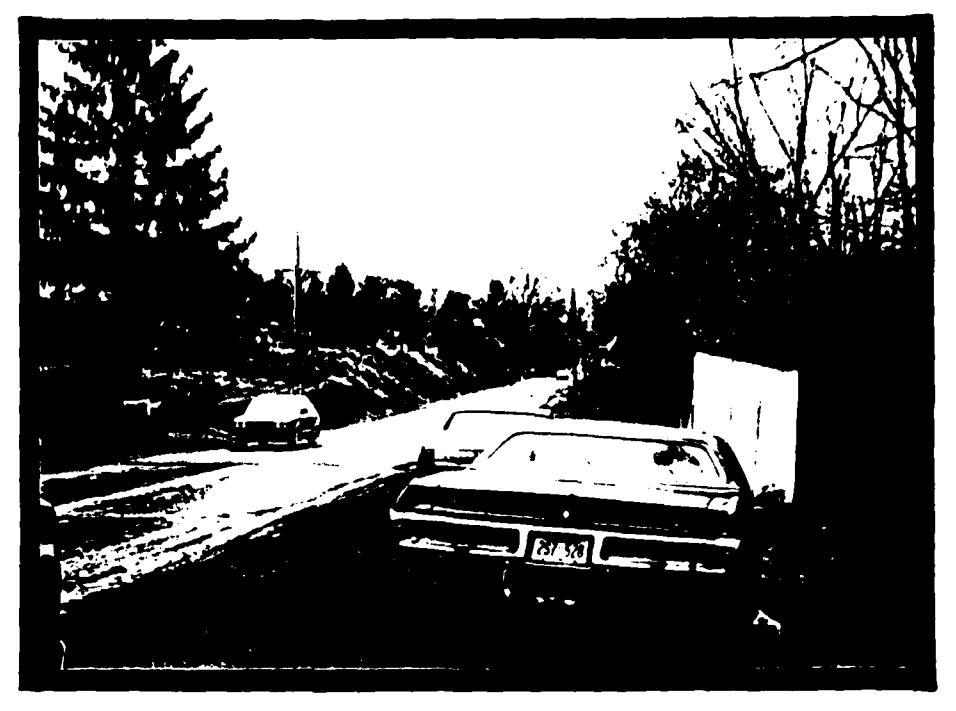
d. <u>Hazard Classification</u>: The Treated Water Pond is classified as a "high" hazard dam. In the event of a dam failure, at least 8 inhabited dwellings and State Route 917 could be subjected to substantial damage and loss of life could result.

Photo 11 Downstream Hazards.
