WORK SYSTEMS PACKAGE/PONTOON IMPLACEMENT VEHICLE OPERATIONAL TESTING AT SAN CLEMENTE ISLAND, 1979

Demonstration of a technology for remotely controlled deep-water recovery of objects up to 5 tons from depths to 20,000 ft

Final Report for Period October 1978-September 1979

NAVAL OCEAN SYSTEMS CENTER SAN DIEGO, CALIFORNIA 92152

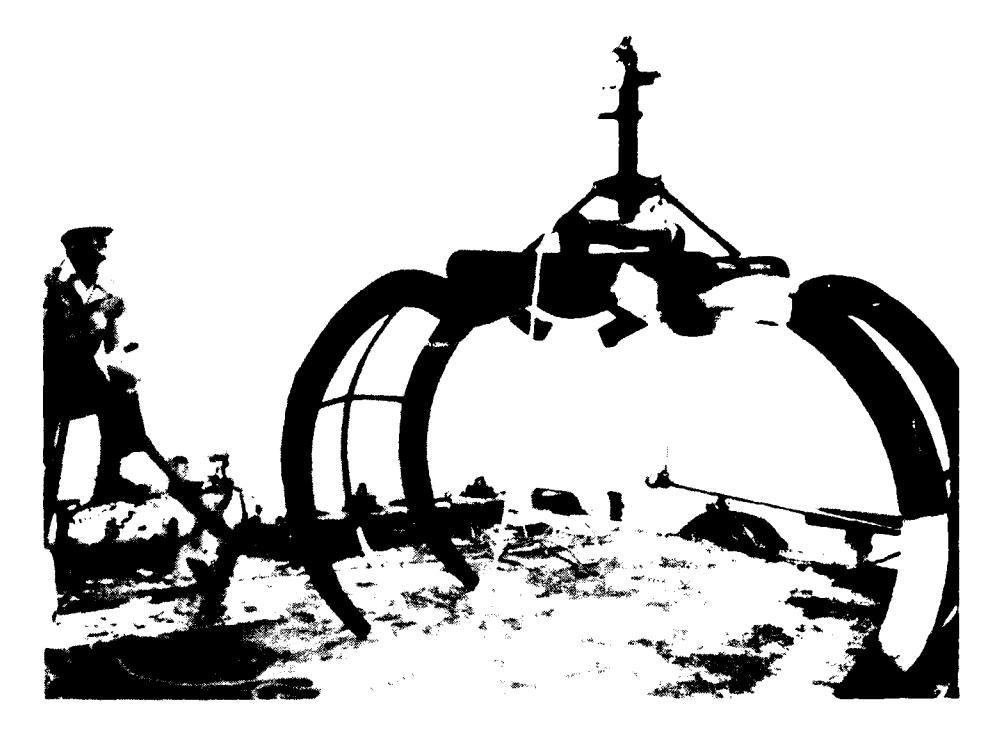
Figure 11. Claw assembly (approximately 5-foot wide opening). (LRO 3430-8-79B)

A successful lift of a jet engine was conducted using the claw assembly as the attachment point. Deficiencies with the original claw design were experienced but did not severely hamper operations.

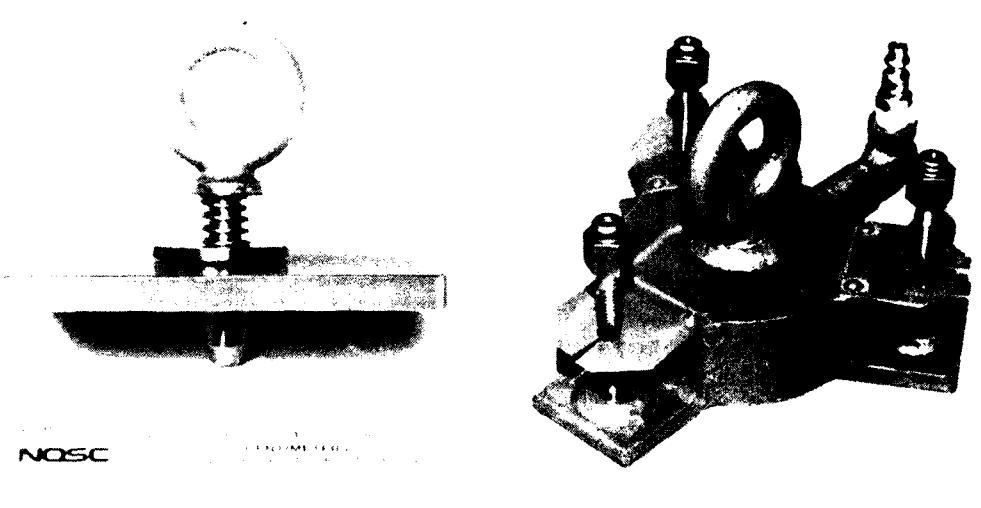
Figure 15. Toggle Bolt padeye. (LRO 2686-6 79B)

A total of two toggle bolt padeyes were successfully inserted and locked into position on the steel plate. Due to delays in diver support and approaching darkness, a lift test of the object was not conducted. Appendix H details observations made during SCI testing

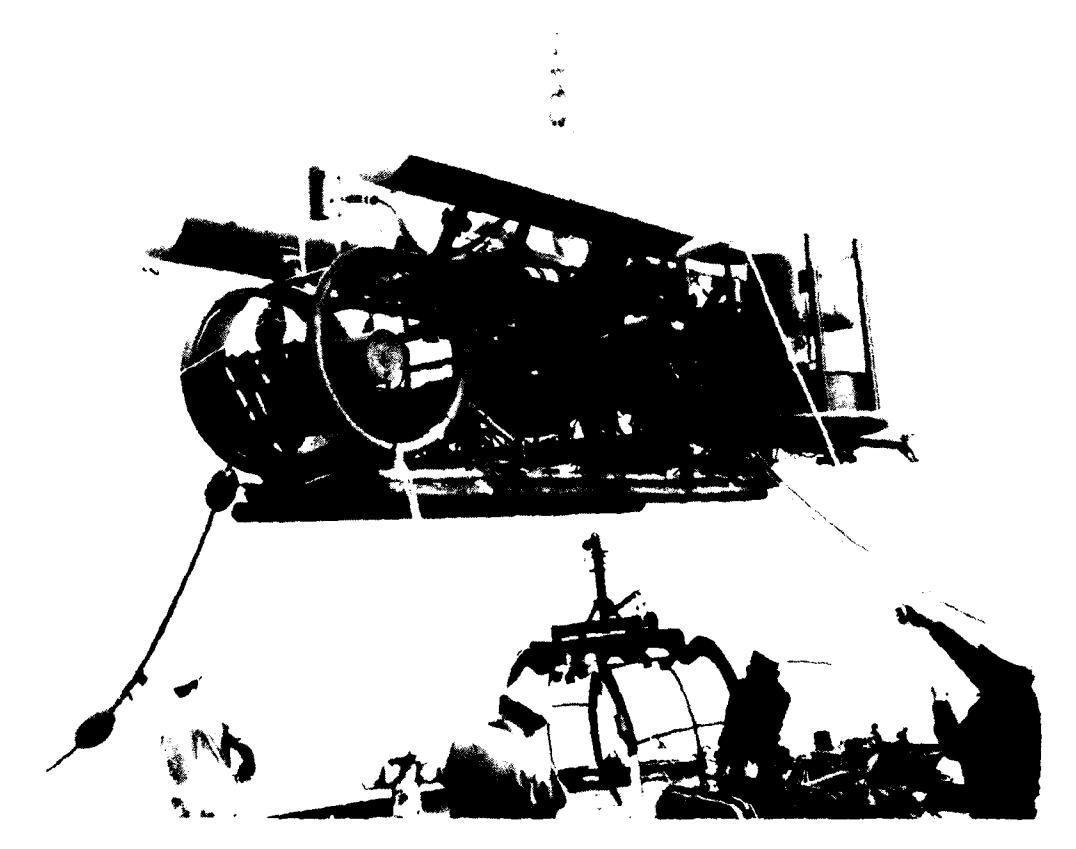
Figure C 1. Mating of claw assembly with PIV. (LRO 3530-8-79B)

- a. Fore and aft movement of the claw during transit to the recovery area was minimal though severe twisting did occur to the mating connection.
- b. Camera placement requires improvement to allow visual display of claw position in relation to the target when attempting capture.
- c. Experienced some difficulties in activation of trip mechanism. Redesign is required to allow operator visual confirmation that claw has been tripped to closed position.
- d. For this task, a master slave manipulator would possibly be beneficial since most of the operation is mid-water which requires quick action. Suggest a time-motion study for comparison purposes.

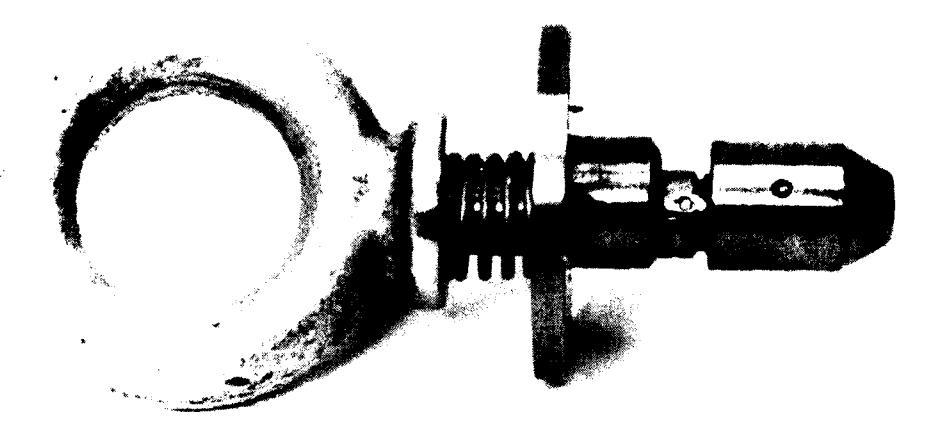
Figure H-1. Toggle bolt padeye in the cocked position for insertion. (LRO 2687-6-79B)

- a. The toggle bolt plate requires marking to allow visual feedback for referencing of the degree of turn to deploy the unit. The zoom lens of the WSP camera was used but was not sufficient.
- b. The toggle could be redesigned to incorporate a self-locking or semi-automatic mechanism

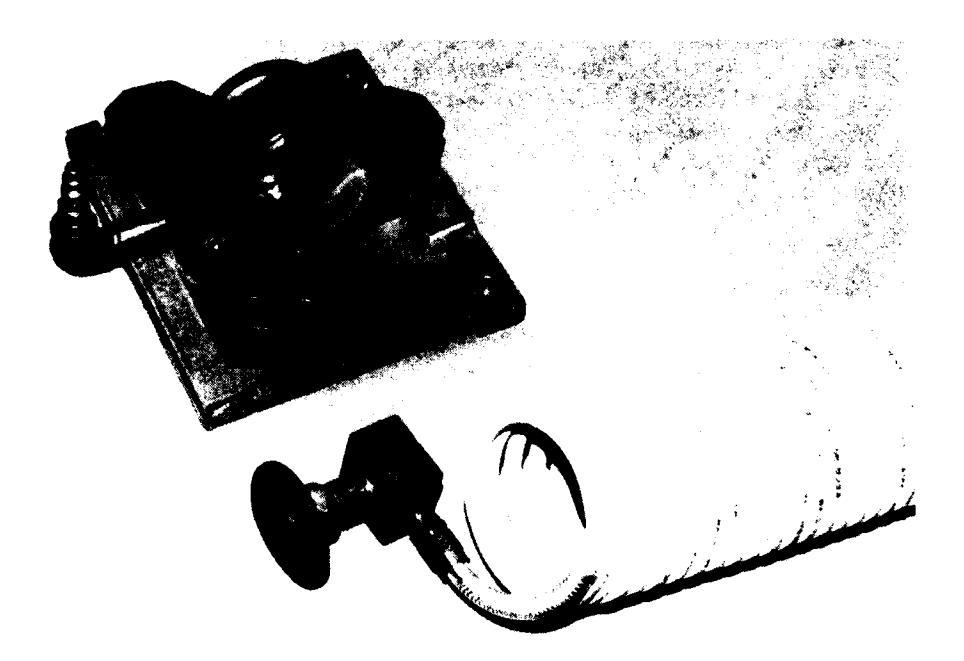
Figure I-1a. DTB padeye mounted in its holding plate and the suction hose and quick disconnect fitting.

- a. The drill-tap-bolt bits used may be too brittle for actual operations (due to fabrication error).
- b. The drill-tap-bolt bits need to be painted for improved visibility when using vehicle cameras for viewing.
- c. A guide to assist in coupling of the quick disconnect for suction was added during the tests to assist the operator in alignment.
- d. A relief valve needs to be installed in the suction pump line to eliminate possibility of pressurization. As a temporary fix, a separate pump was added to the PIV during the sea tests but was not actually used.
