National Dan Inspection Program. ROBINSON DAM (NDI ID DA PA-00165 DER ID NGA" 64-136), LEISURE-LIFE CORP. OF AMERICA Deloward River Basin, Tributary of middle Creek Wayne County, Pennsylvania.

PHASE J INSPECTION REPORT . NATIONAL DAM INSPECTION PROGRAM

4 November 1980

Robinson Dam NDI ID No. PA-00165 DER ID No. 64-136

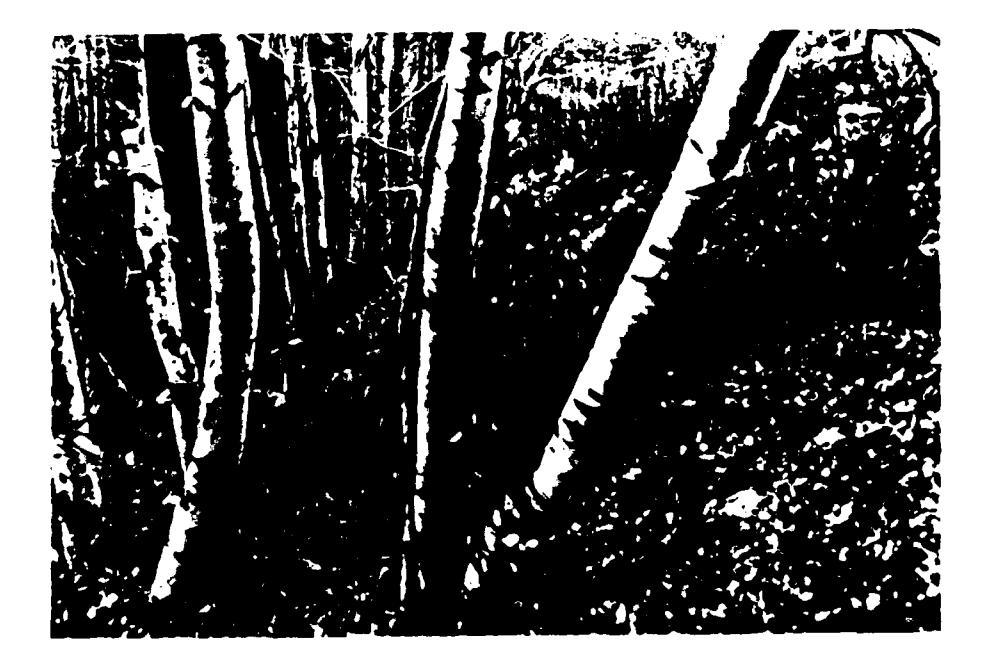
4. Downstream face between spillway and maximum section.
