| 1. REPORT NUMBER 2. GOVT AC DAEN/NAP-53842/NJ00809-81/03 AID-PIIC 4. TITLE (mid Subtritio) Phase I Inspection Report Phase I Inspection Report (AIII) National Dam Safety Program VIIII N.J. No Name Dam No. 53 VIIIIIIIIIIIIIIIIIIIIIIIIIIIIIIIIIIII | 25 DACWG1-79-C-0011 |

CORPS OF ENGINEERS ASSESSMENT OF GENERAL CONDITIONS

NJ NO NAME 53 DAM

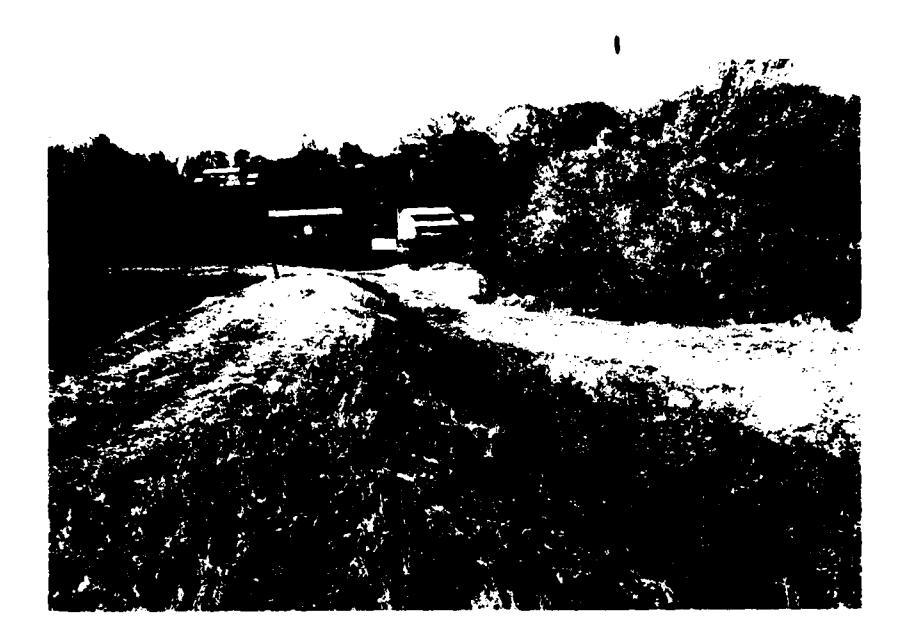
6 November 1980

Upper dam embankment and berm looking west.
