BRUSHY CREEK TAILINGS DAM REYNOLDS COUNTY, MISSOURI MO 30951

PHASE 1 INSPECTION REPORT NATIONAL DAM SAFETY PROGRAM

AUGUST 1979

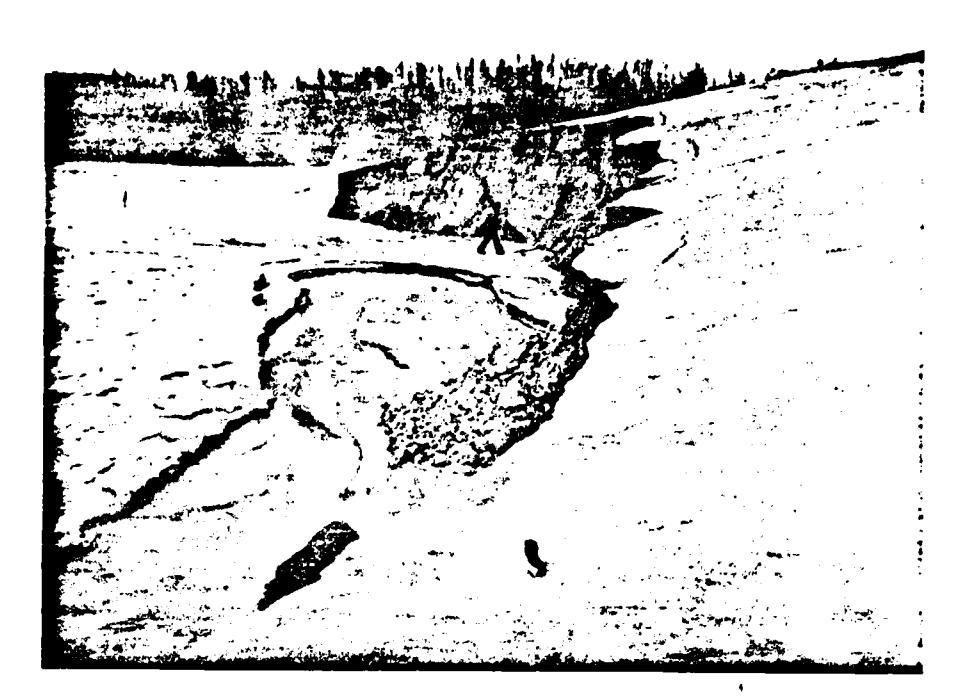
As noted in Section 3.1.e., the hydraulic method of tailings deposition causes severe erosion on the upstream dam face (Photo 5). Efforts to minimize this erosion should be implemented. Additionally, sufficient freeboard between the reservoir water surface and the fine tailings deposition area (See Plate 3) should be maintained to prevent a free pool surface from resting against the upstream dam slope. Without such a precaution, wave erosion may result and the embankment seepage conditions would be altered significantly.

PHOTO 5: Upstream slope with scarp created by erosion due to hydraulic method of tailings deposition
