PERDIDO DAM REYNOLDS COUNTY, MISSOURI MO 31042

# PHASE I INSPECTION REPORT NATIONAL DAM SAFETY PROGRAM

SUBJECT: Perdido Dam (Mo. 31042), Phase I Inspection Report

Name of Dam:Perdido Dam, Missouri Inv. No. 31042State Located:MissouriCounty Located:ReynoldsStream:Unnamed Tributary of East Fork of Black RiverDate of Inspection:October 2, 1978

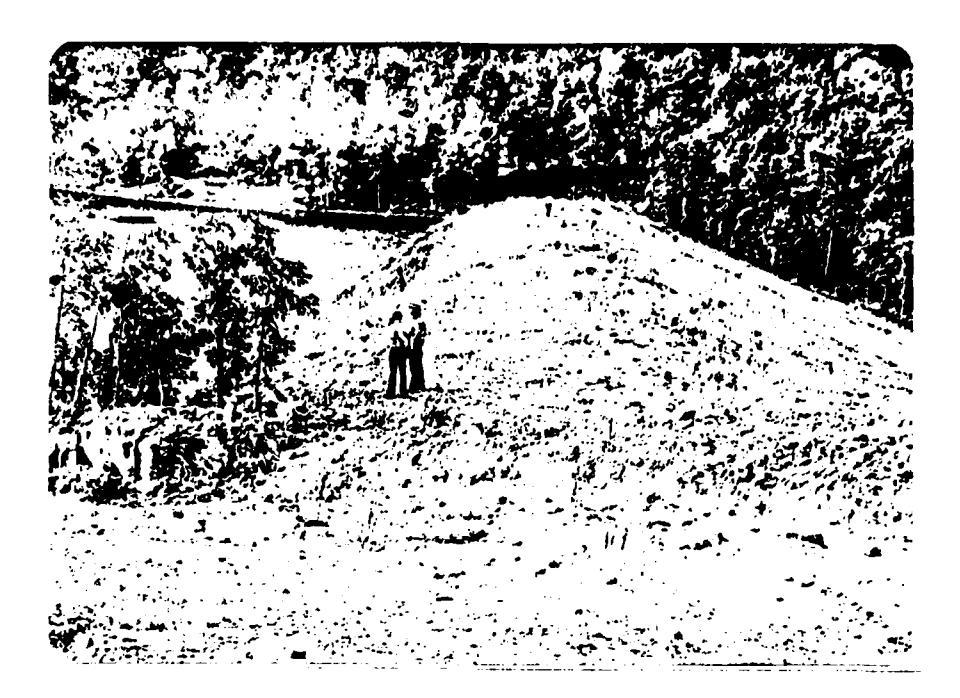
Photo 1 - View along crest of dam taken at right abutment.

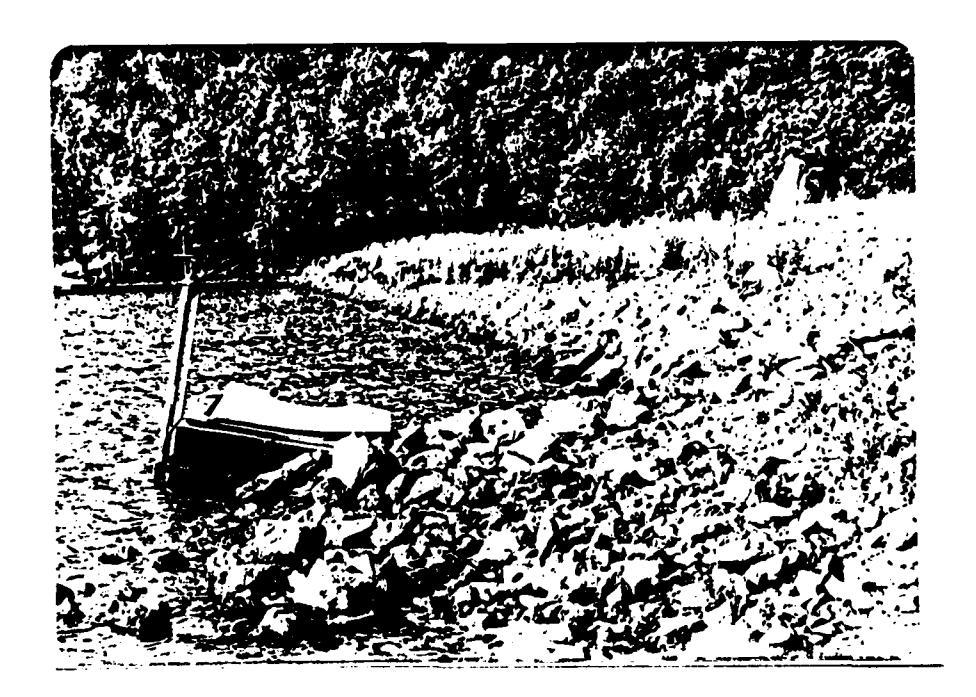
Photo 2 - View along upstream slope of embankment taken from spillway approach channel. Note intake structure for service spillway.

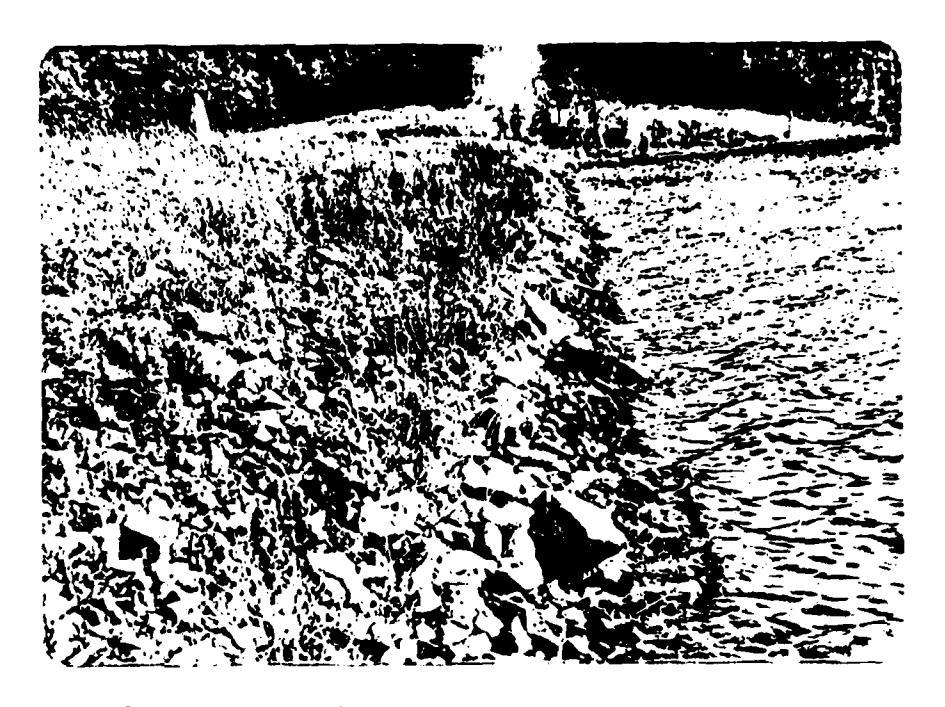
The riprap on the upstream embankment slope is providing excellent protection for the embankment material. No degradation due to weathering of the blocks was observed. Some minor surface erosion is occurring on the downstream

Photo 3 - Close-up of typical section of upstream slope of embankment.

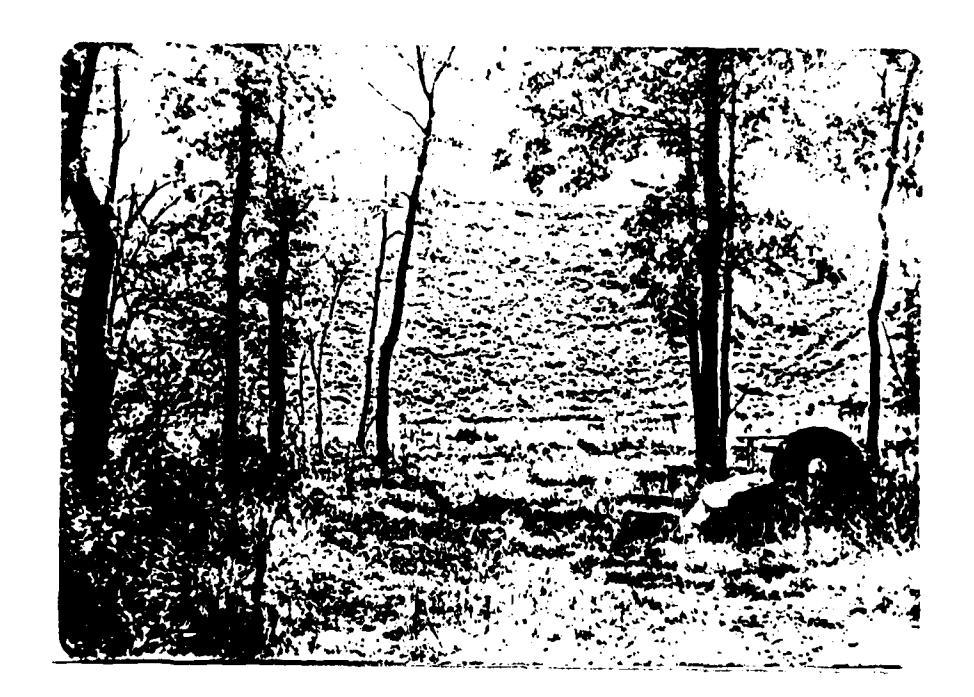
embankment slope. The condition has progressed further at the abutment contacts, but is not serious at this time. A small scarp was observed along the contact of the embankment fill and the ground surface. The embankment material that could be obtained on the downstream slope appeared to be a clay with 20 to 40 percent sands and gravels. The material would be classified as CL by the Uniform Soil Classification System.

Photo 4 - View of downstream slope of embankment taken from downstream of dam.

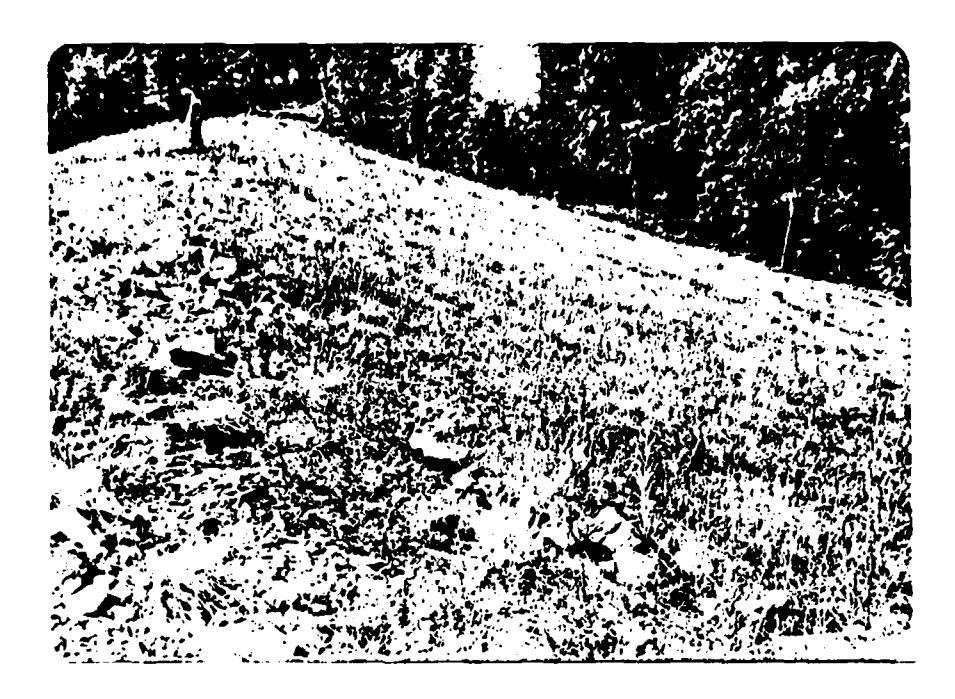
Photo 5 - Picture of downstream slope of embankment taken near right side of dam.

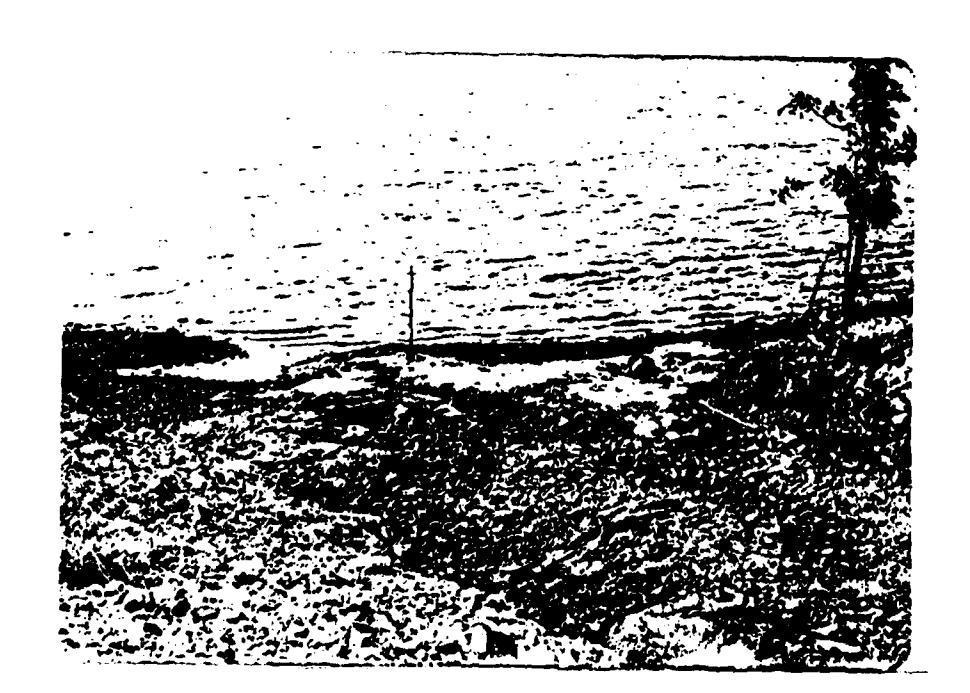
Photo 8 - Approach channel for emergency spillway. Note post for former fence across spillway.

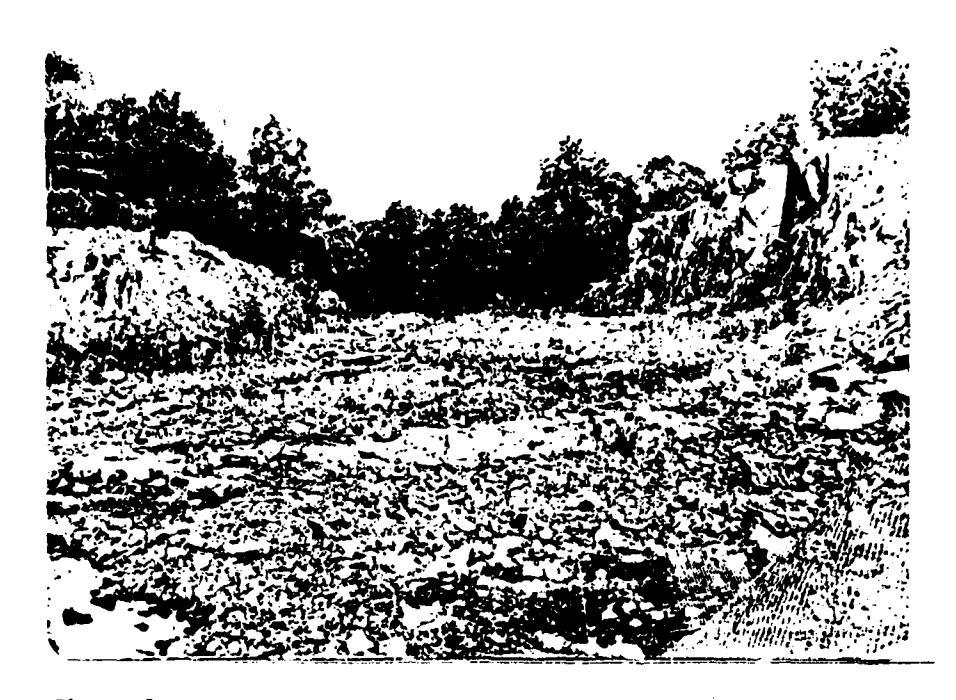
Photo 9 - Picture of emergency spillway channel taken from upstream.

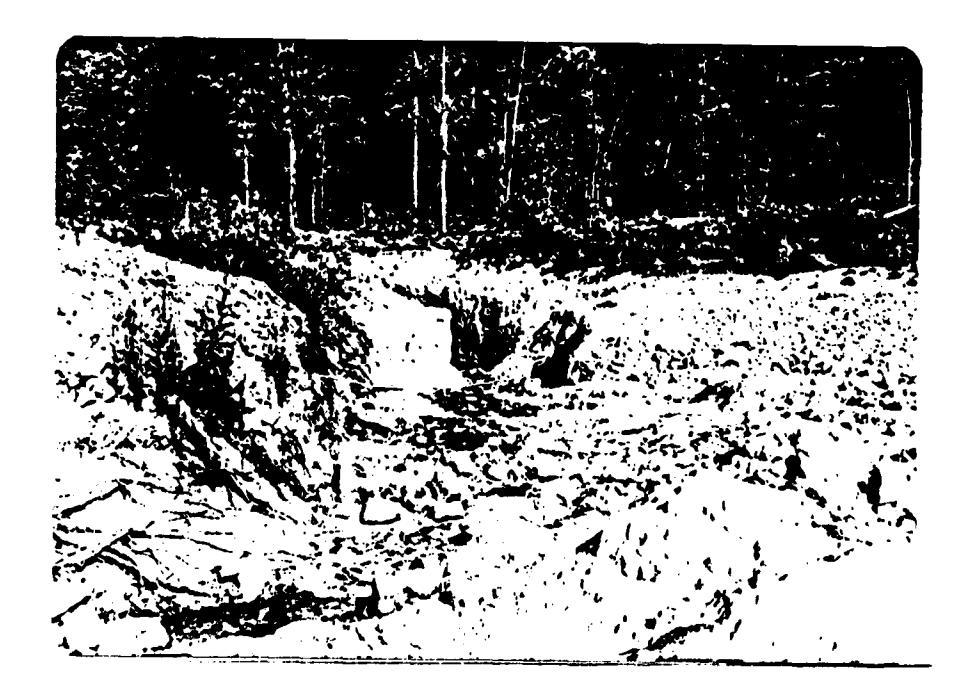
Photo 10 - Picture of downstream channel of emergency spillway taken from upstream.

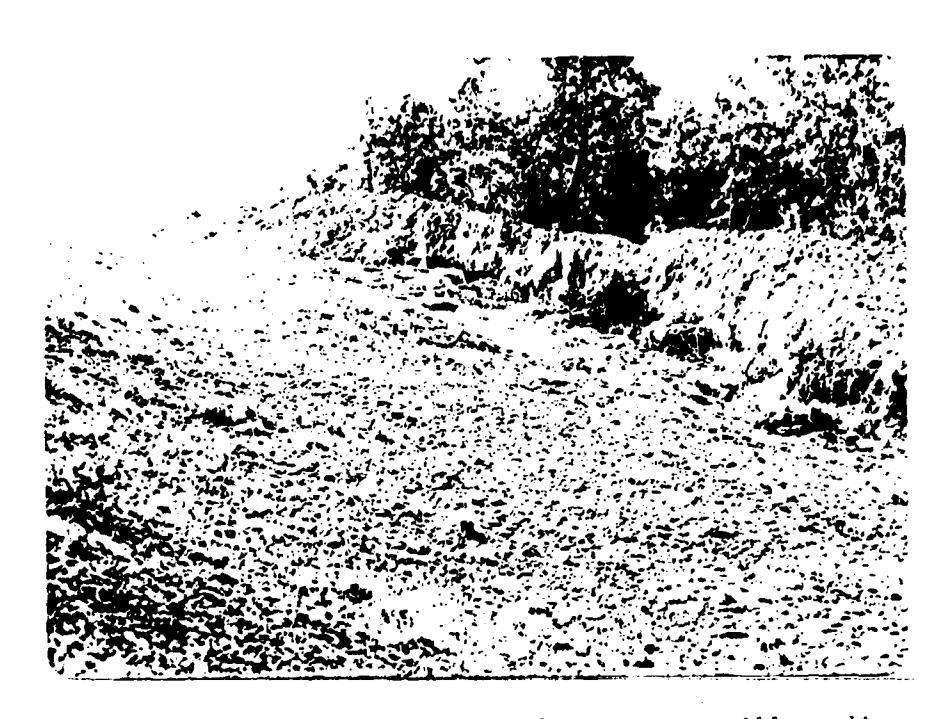
The intake box on the service spillway is tilted approximately  $5^{\circ}$  from its original position. The emergency spillway discharge channel bed is in rock, and is in good condition, except that the left bank of the discharge channel which is badly eroded and shows signs of instability.

The left bank of the emergency spillway channel, approximately 150 feet downstream from the emergency spillway, is in an unstable condition. If this condition is not corrected, future discharges will rapidly erode this bank, allowing water to flow onto and erode the right side of the downstream slope of the dam.

Photo 11 - Picture of left bank of emergency spillway discharge channel. Note eroded bank in center of picture.

crete box inlet in a vertical position, and grouting around the structure to prevent future damage. A trashrack with bars should replace the existing wire mesh cover. The emergency spillway's left bank is in an unstable condition following recent discharges due to flooding. The spillway channel is sloped toward the left bank, causing flow through the spillway to concentrate in this area. It is predicted that future discharges through the spillway channel would rapidly breach the left bank, causing water to flow across the abutment and onto the downstream embankment.
