USAAEFA PROJECT NO. 76-09-1

ARTIFICAL ICING TEST UTILITY TACTICAL TRANSPORT AIRCRAFT SYSTEM (UTTAS) SIKORSKY YUH-60A HELICOPTER

FINAL REPORT

FEBRUARY 1977

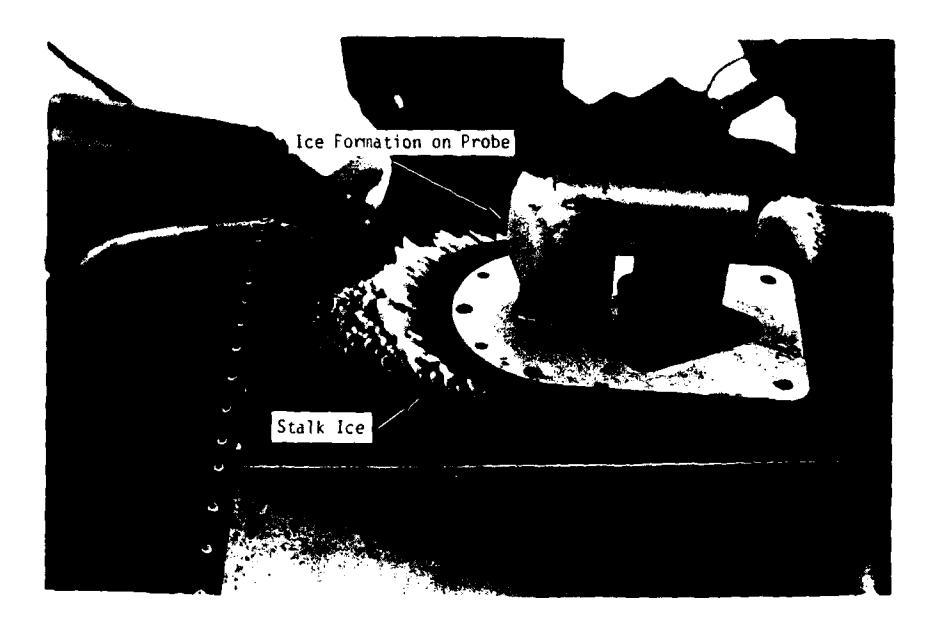
15. After flight 16, visual inspection of the aspirated Rosemount ice detector probe mounted on the No. 1 engine nacelle (photo 1, app H) revealed that the probe had frozen over. A continuity check was made of the heater element circuit, and a broken wire was discovered. The broken wire was repaired and no additional probe freeze-up occurred.

Photo 1. Aspirated Rosemount 851F Icing Rate Detector After Flight 16.

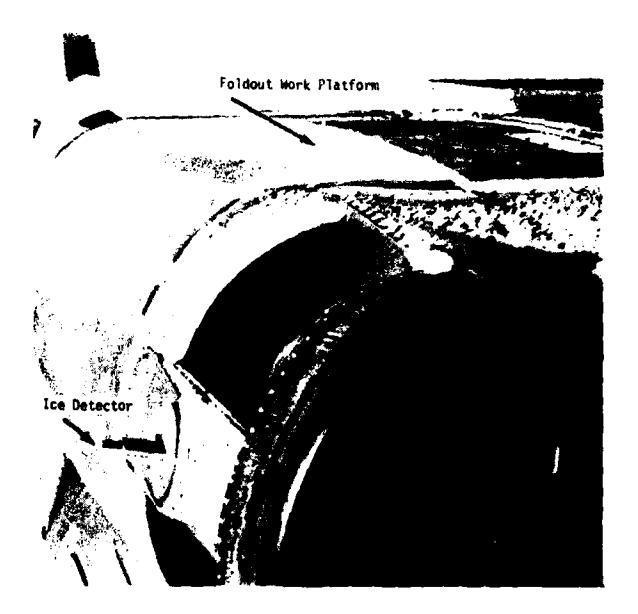
41. Ice accretion patterns around the engine nacelle, similar to that shown in photo 2, appendix H, were observed after each icing flight. The amount accreted varied as a function of time and there was no evidence of natural shedding. Ice also accreted on the wiring and fire extinguisher discharge tube just inside the engine cooling air inlet. The presence of ice and moisture within the engine nacelle is a potential electrical problem, and proper protection should be provided for all moisture-intolerant components in the engine nacelle.

Photo 2. Rosemount 851F Jcing Rate Detector Location. 87
