SILVER STREAM RESERVOIR DAM NY 00511

PHASE I INSPECTION REPORT

NATIONAL DAM INSPECTION PROGRAM

JULY 1981

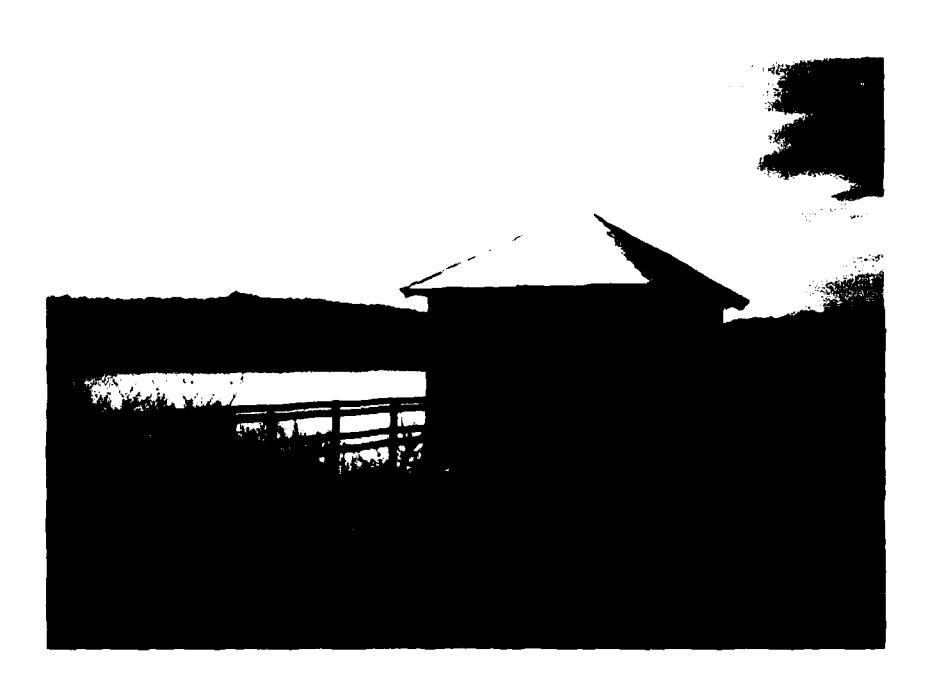
The dam has a concrete intake structure and control tower on the upstream side. On top of the control tower there is a brick gate house with a slate-shingled roof (see Photo A-5A). The intake structure and the majority of the control tower were submerged and unobservable. The gate house and exposed portion of the control tower were inspected and are in good condition.

The service bridge from the top of dam to the gate house is a wood deck supported by steel I beams, with pipe railings (see Photo A-5A). The service bridge is generally in good condition. The bridge railings, however, are lease and the deck is bare wood for the most part.

A-5A Control tower with gate house and service bridge - 4/9/81

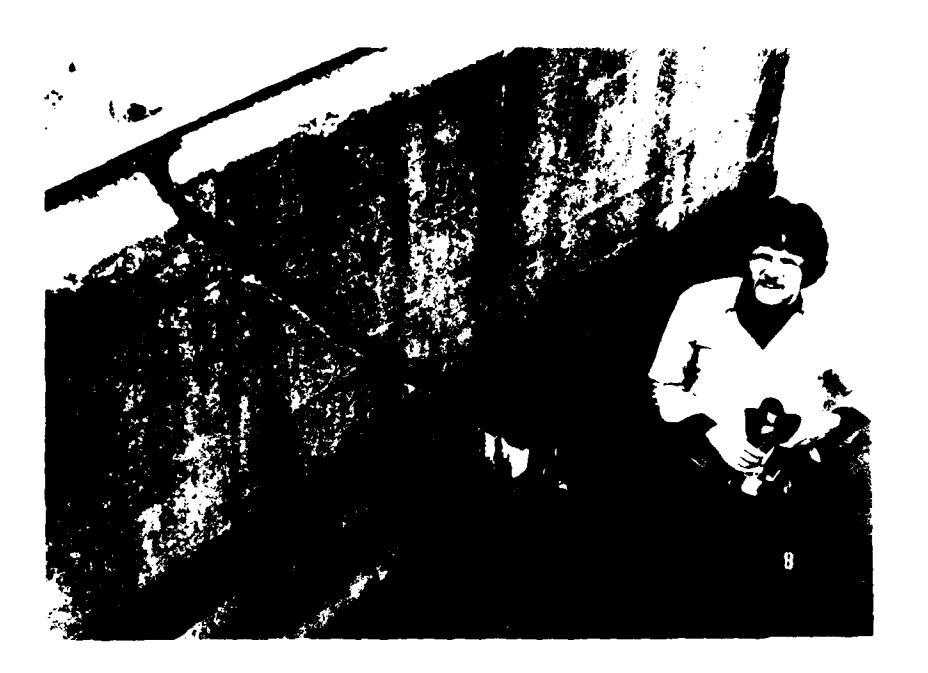
Also in the past, two steel bars were bolted to the left training wall of the outlet pipe discharge channel to prevent the further widening of a large crack. The date of this repair, which appears fairly old, is unknown.

The outlet structure for the outlet pipe is a concrete headwall followed by a concrete discharge channel (see Photo A-6A). The spillway discharge channel intersects this channel at right angles about 16 feet downstream from the headwall of the outlet pipe. The outlet structure for the outlet pipe is in good condition. The outlet pipe discharge channel, however, is in poor condition. The left training wall of this channel, at its junction with the right training wall of the spillway, has a 2-inch-wide diagonal crack (see Photo A-7A). This crack is presently restrained by two steel bars which have been bolted to the concrete on either side of the crack to prevent the wall from collapsing.

A-7A Crack with steel strapping in left training wall of outlet pipe discharge channel - 4/9/81

The training walls and concrete pavement of the outlet pipe and spillway discharge channels should be repaired. The concrete portions of the dike should also be repaired.
