REPORT DOCUMENTAT	TION PAGE	READ INSTRUCTIONS BEFORE COMPLETING FORM
REPORT NUMBER	2. GOVT ACCESSION NO	. 3. RECIPIENT'S CATALOG NUMBER
SD-/TR-83-18	AD- A12800	ki l
. TITLE (and Subtitle)		5. TYPE OF REPORT & PERIOD COVERE
DSCS II LLTWTA Helix Current	Anomaly	Final Report

DSCS II LLTWTA HELIX CURRENT ANOMALY

F047	s 009A2 and 009A3 01-80-C-0022	Accession For
01	March 1983	NTIS GRA&I DTIC TAB Unannounced Justification
Prepared by:	P. H. Fowler	By Distribution/ Availability Codes Avail and/or Dist Special

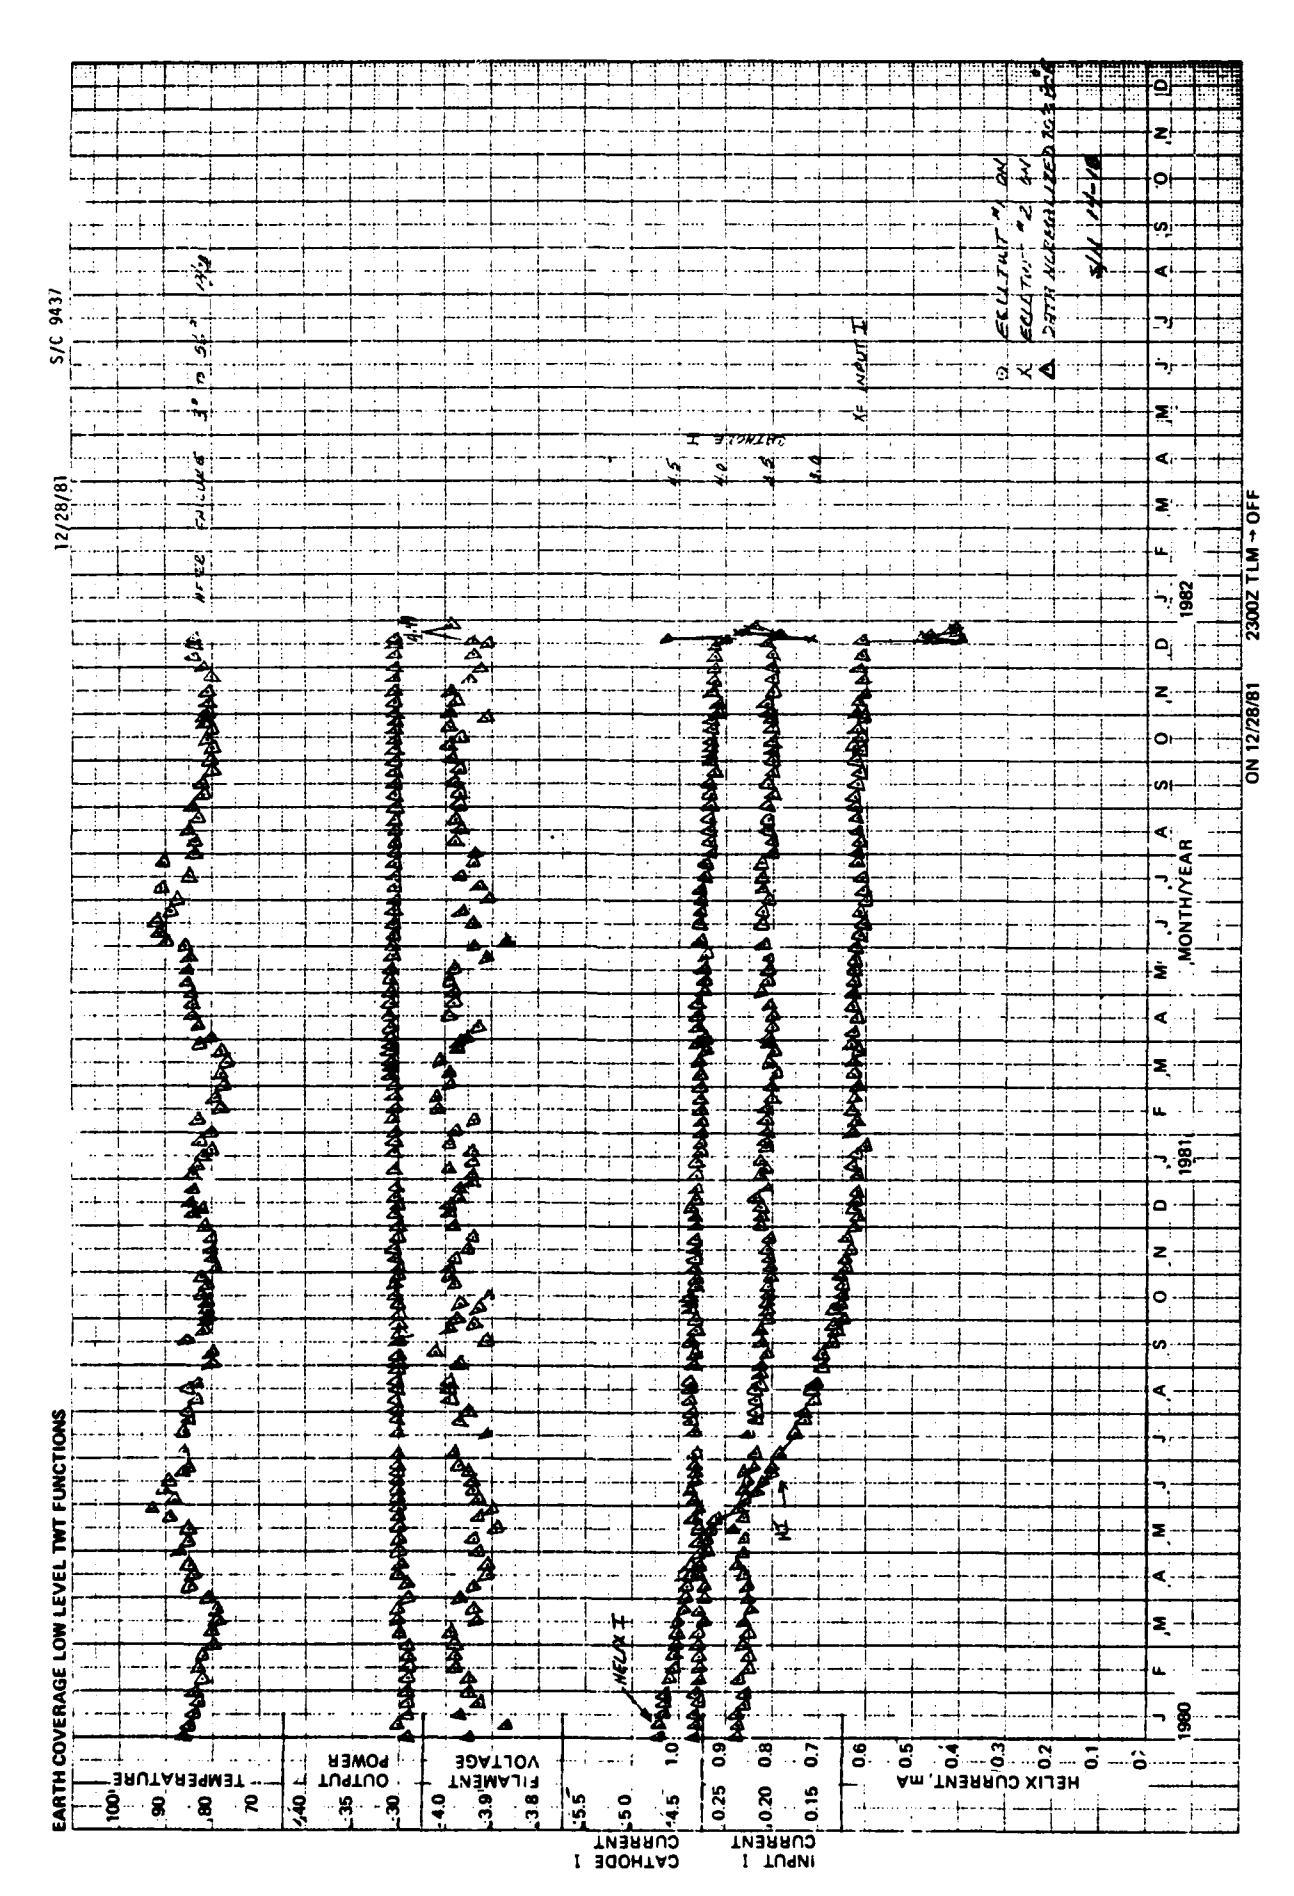
Figure 2

Figures 1 thru 7 show the significant telemetry indications from the amplifiers showing the problem. Note there are many other units in orbit whose performance has been stable for periods in excess of nine years. Experience with both the driver and power output tube in this and other programs shows that the problem is not intrinsic to the cathode type - lives well in excess of ten years appear to be routinely obtainable.

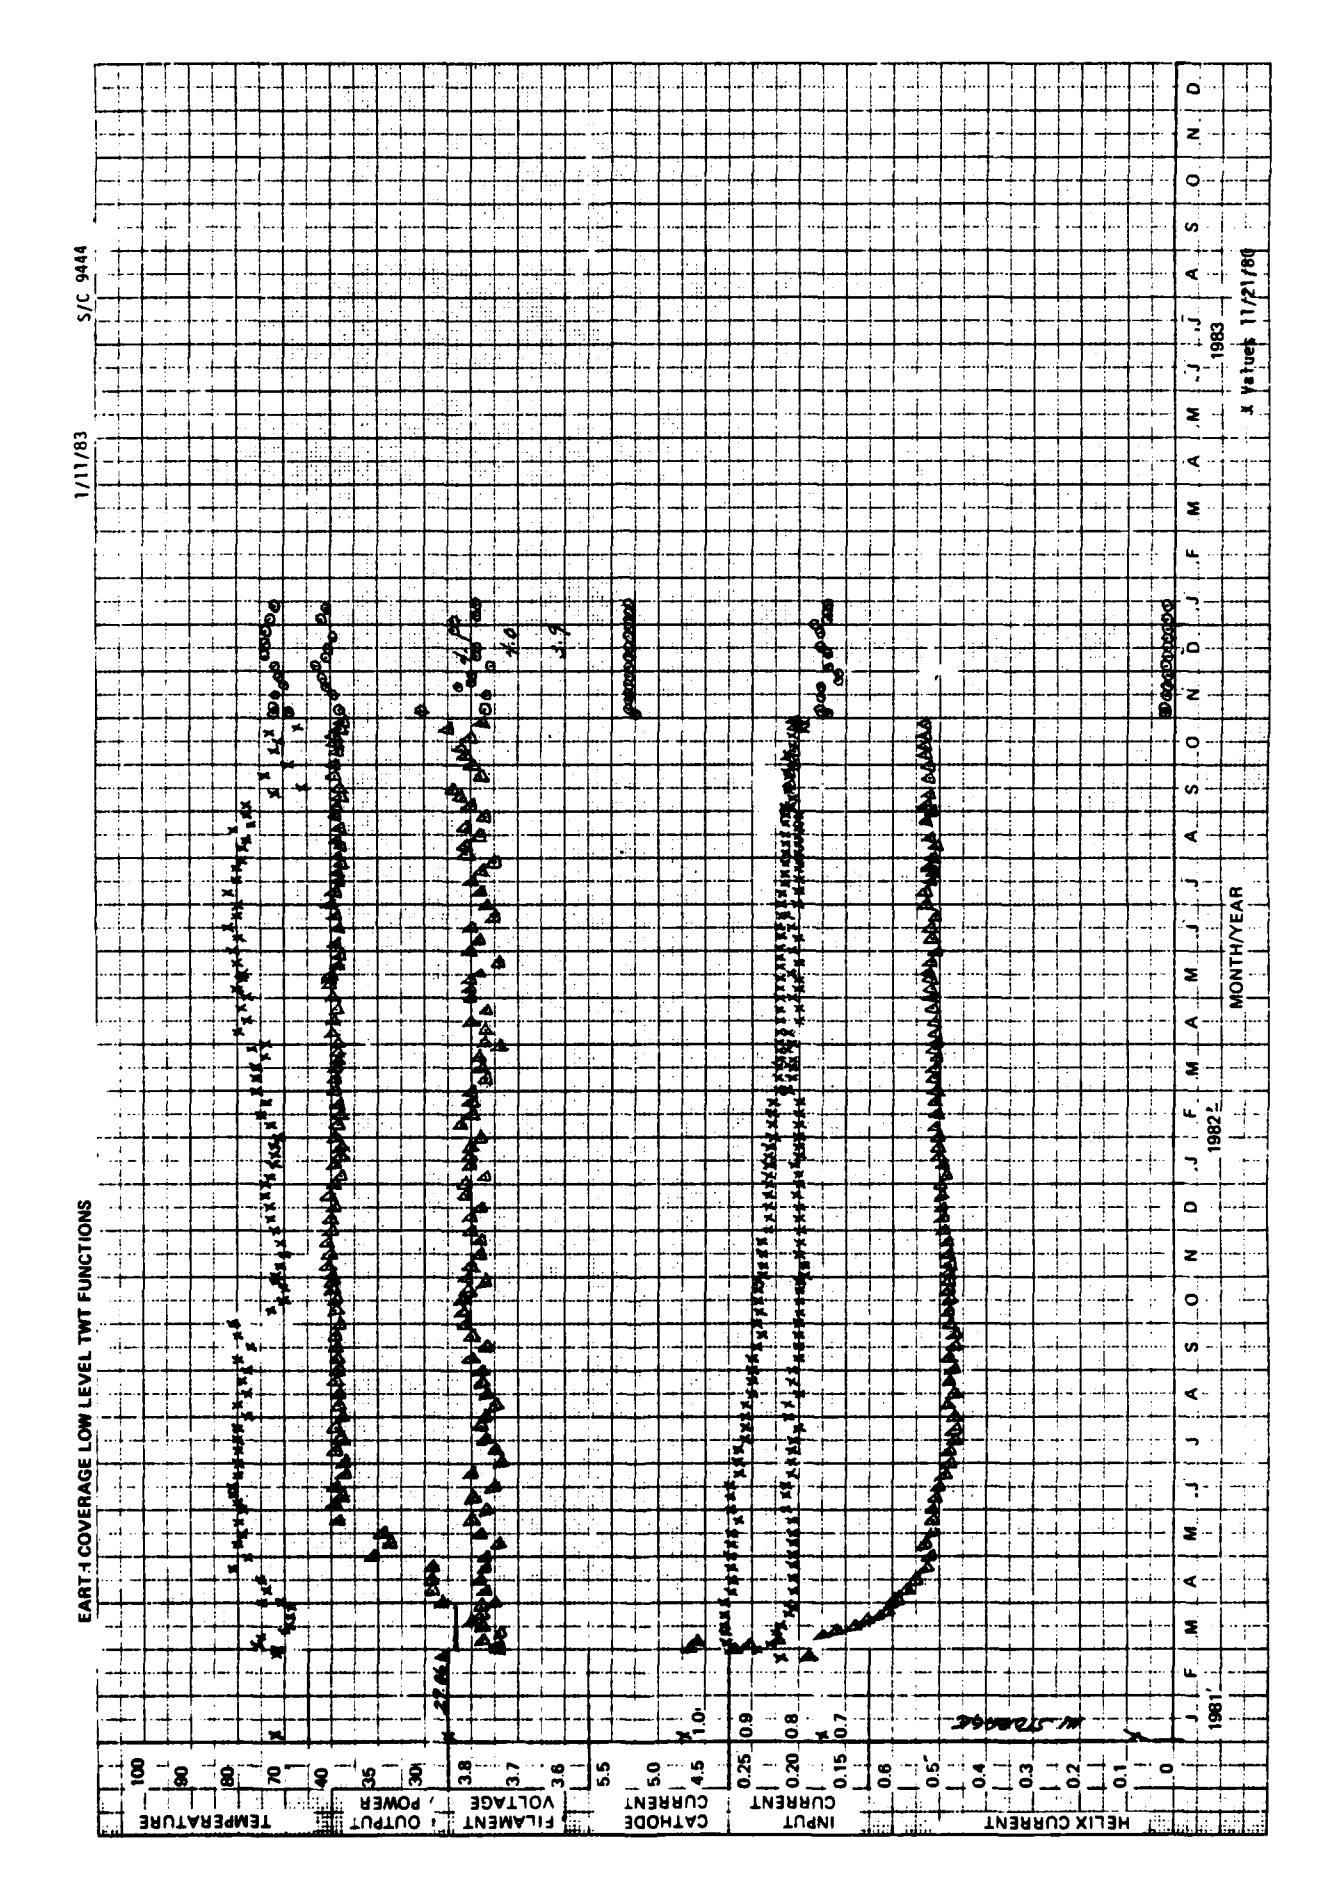
Figure 7

On several occasions transponder gain measurements were made (shutting down communication use of the satellite). Gain losses of 3 to 8 db were found, corresponding to what would be expected given the observed tube currents. From this and other indications it can be taken that the currents telemetered are real within the accuracy of the system, i.e., the problem is not a telemetry aberration. Note that power supply voltages as shown by telemetry are normal for all the amplifiers in question, so that the problem is in the tube. The effect on gain of an increased body current varies with the point in the tube at which the interception occurs. If the current reaches ground in the input section of the helix or in the gun, the effect is identical to a cathode current reduction. The gain loss is less as the ground point moves along the output section and reaches zero if the ground point is beyond the output connection. However, the tube gain also depends on the proximity of the beam current flow to the inside of the helix, and defocusing affects this distance. It was found by experiment that the gain loss is 3-6 db per milliamp of helix current increase, the exact behavior depending on the location of the magnet used to produce the defocus.
