RESURVEY AND INTENSIVE TESTING OF ARCHAEOLOGICAL SITES
AT SAYLORVILLE LAK. (U) IMPACT SERVICES INC MANKATO MN
P M EMERSON ET AL. JUL 83 DACW25-82-C-0068

REPORT DOCUMENTATION PAGE		READ INSTRUCTIONS BEFORE COMPLETING FORM
1. REPORT NUMBER	2. GOVT ACCESSION NO. AD-A135 056	3. RECIPIENT'S CATALOG NUMBER
4. TITLE (and Subtitle) Resurvey and Intensive Testing of Archaeological Sites at Saylorville Lake, Polk and Dallas Counties, Iowa	5. TYPE OF REPORT & PERIOD COVERED Final 9-82 to 7-83

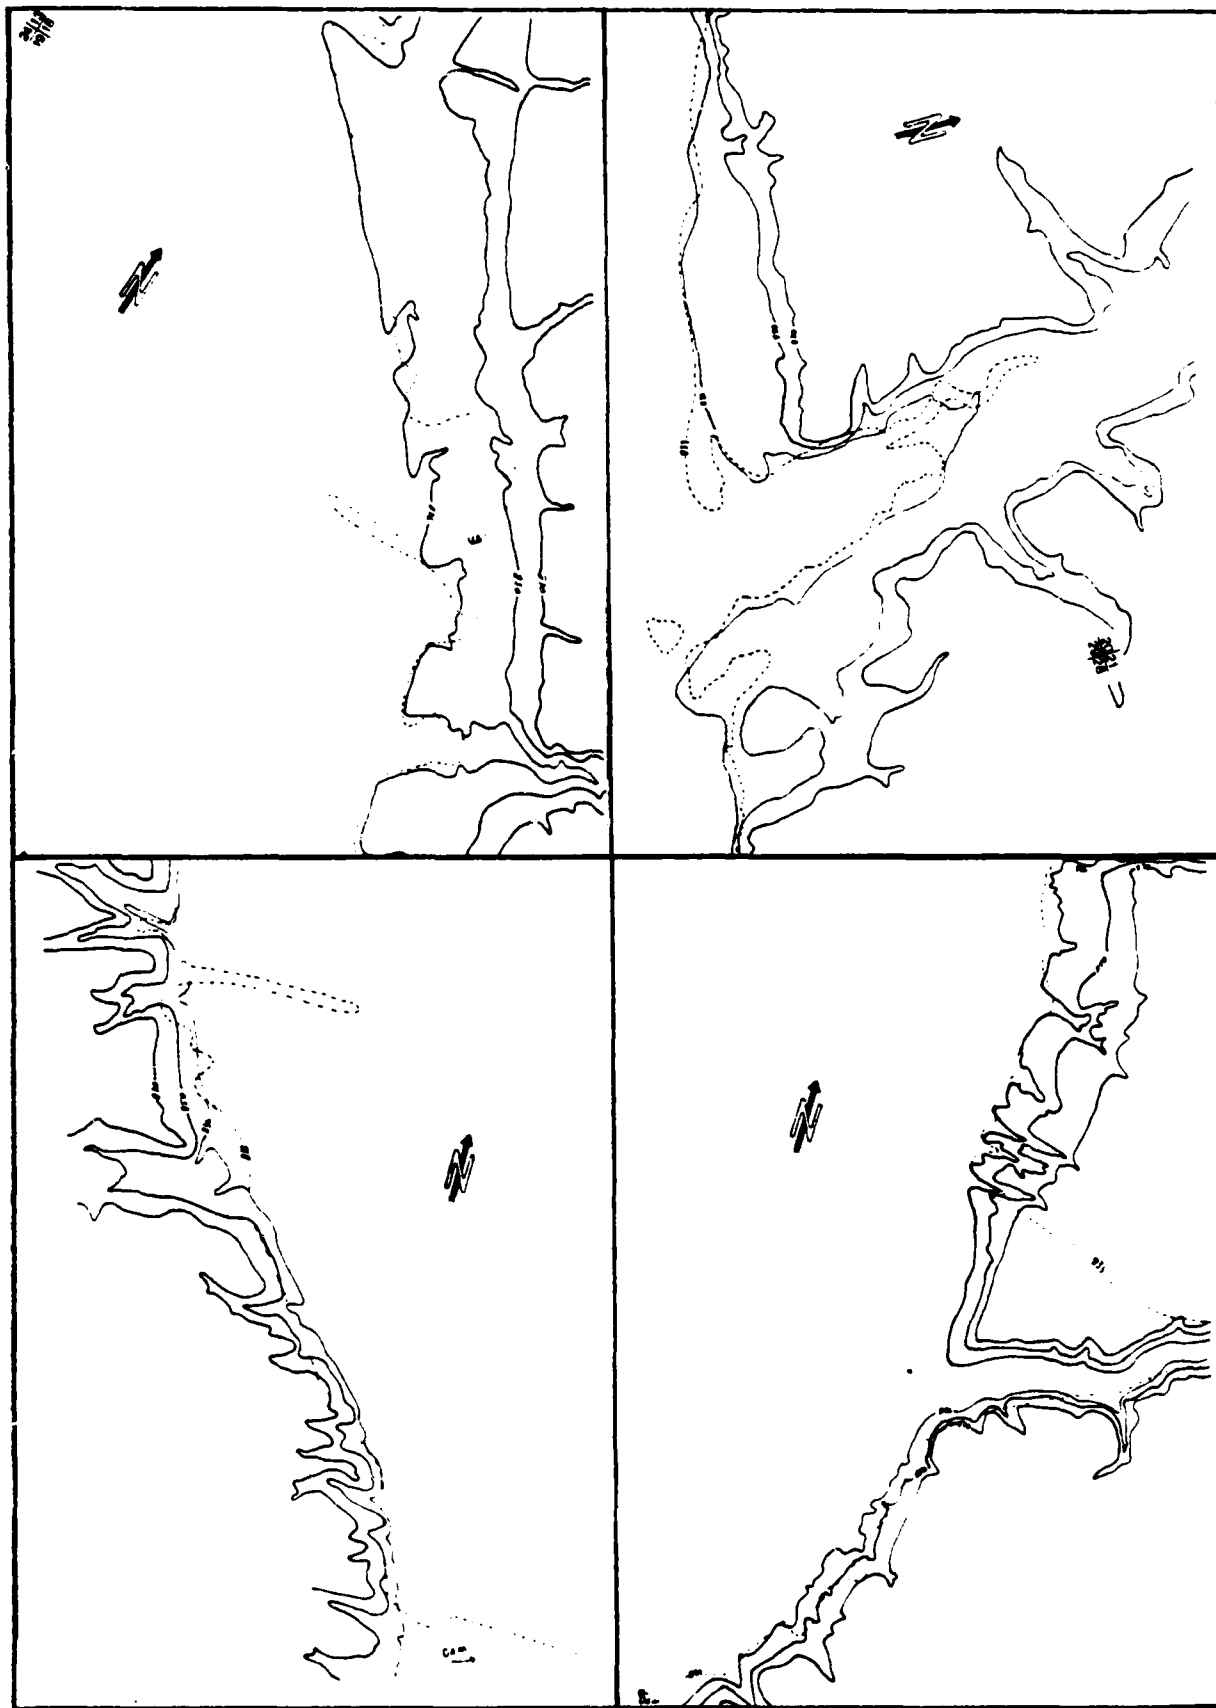
Figure 7. Recent Landscape Alteration at Saylorville Lake

The changes in regional topography reflected in this figure have occurred since 1977, during which time there have been three major high-water episodes and a number of minor fluctuations in lake level. Because the lake is intended to serve as a flood-control reservoir as well as a recreational area, the processes which created the current shoreline will undoubtedly continue to operate in the future. Thus, the probability of attaining a plateau of stability is minimal. Changes in other regional environmental characteristics can also be observed. These changes have occurred - and are occurring - on a macrolevel (long-term changes in biome composition) as well as a microlevel (short-term changes in vegetation resulting from periodic inundation.)
