SA-ALC/MM - 8149

FUEL SYSTEM O-RING LEAKS ON POST P.D.M. C-5A AIRCRAFT

C. J. FORZONO SA-ALC/MMSH Kelly AFB TX 78241

SEPTEMBER 1983

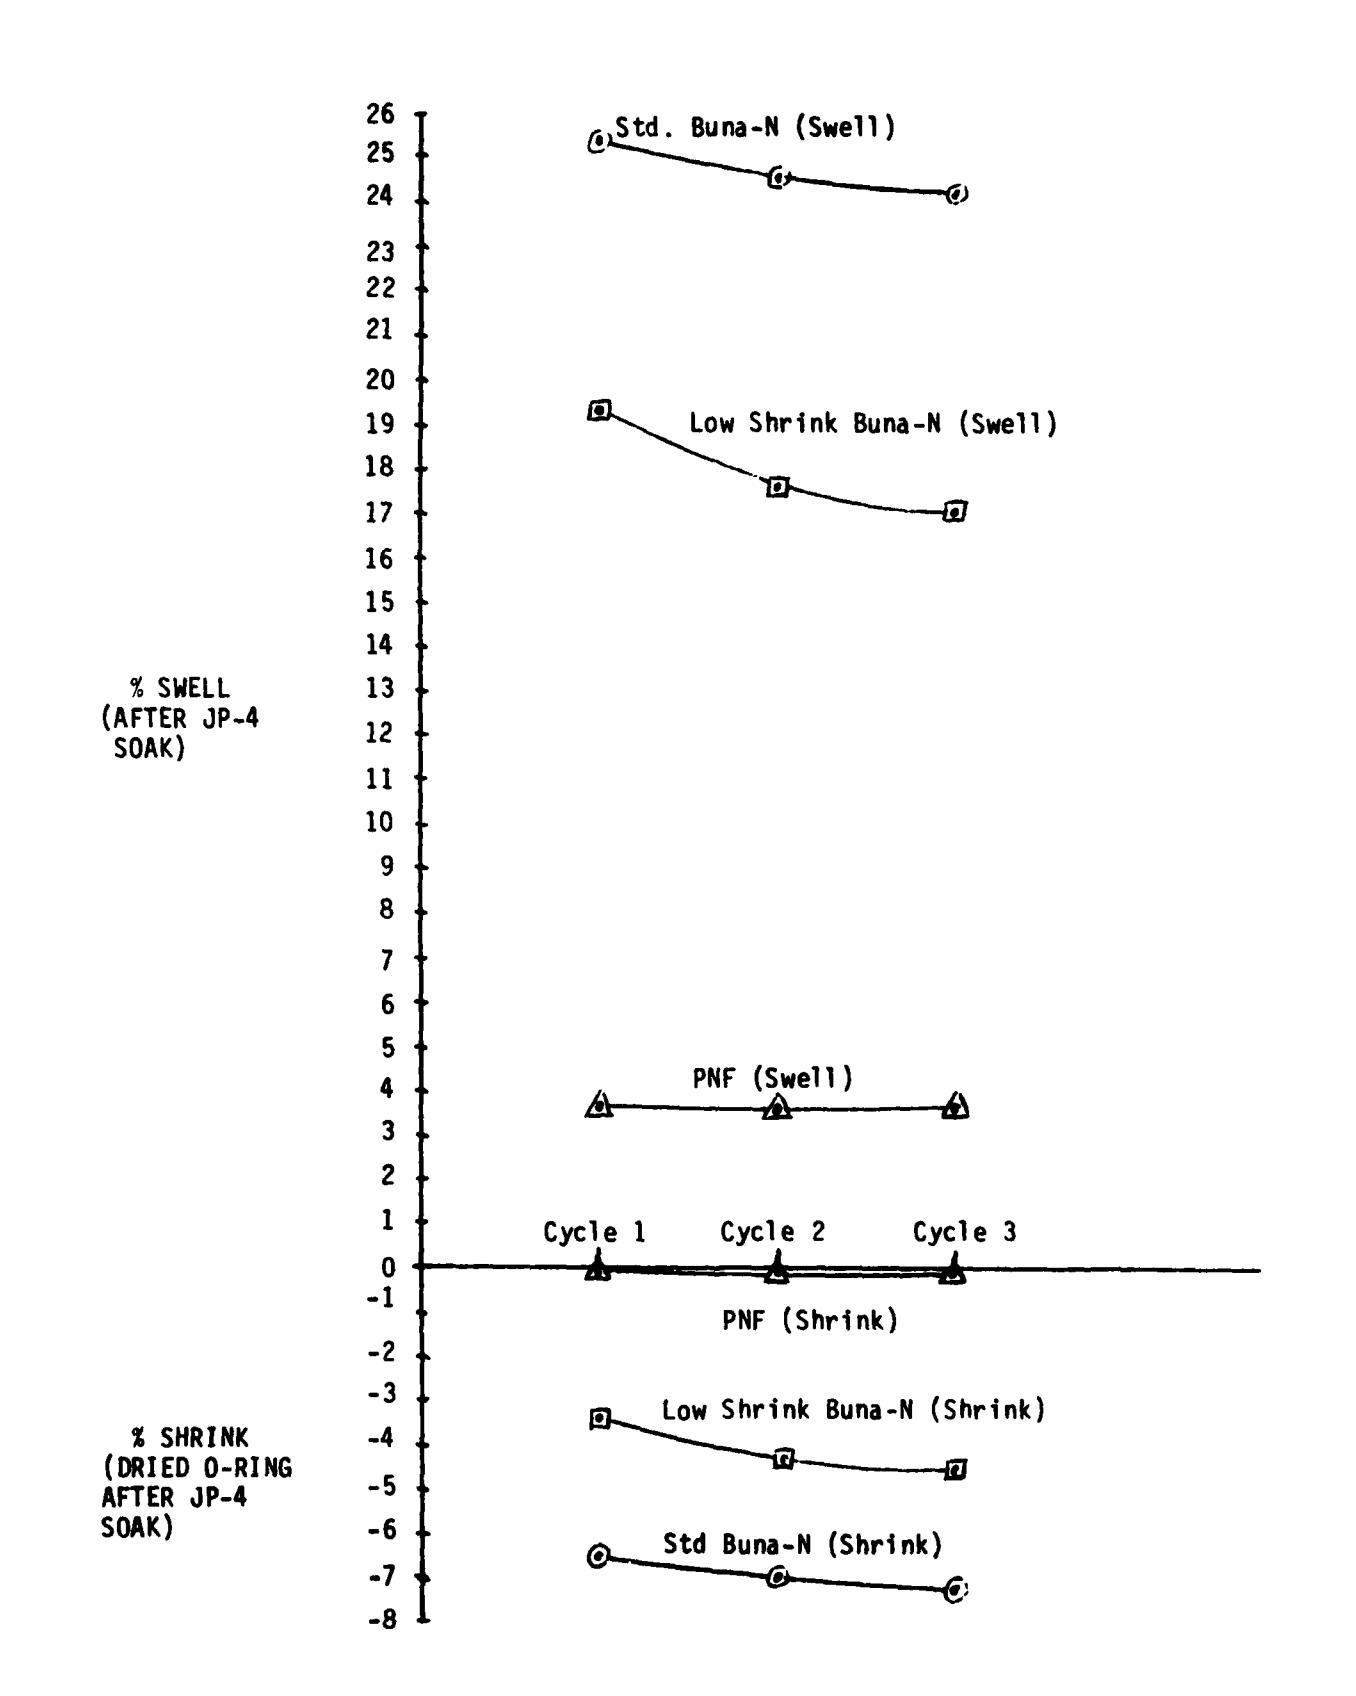
FIGURE 1. SWELL, SHRINK DATA

The low shrink Buna-N O-ring test data shows that they swell about 27% less and shrink about 40% less than the standard Buna-N O-rings. (See Fig 1). Here also, the shrinking occurs because of the loss of plasticizers extracted by the JP-4. However, since the low shrink Buna-N O-ring has a lesser amount of plasticizers than the standard Buna-N, less plasticizer is removed and less shrinkage occurs. Hence the name, low shrink Buna-N.

The PNF O-rings swelled very little compared to the Buna-N O-rings (See Fig 1). Their swell was only 3.6% on the average, and it did not decrease or increase with the successive cycles. As for shrinking, for all practical purposes, there wasn't any. After each cycle, the average shrinkage was about a -0.15%. The PNF O-rings are not affected very much by the JP-4 fuel, they contain no plasticizers, and their -65°F temperature characteristics are acceptible.
