Special Report 84-3

March 1984

U.S. Air Force roof condition index survey Ft. Greely, Alaska

Barry A. Coutermarsh

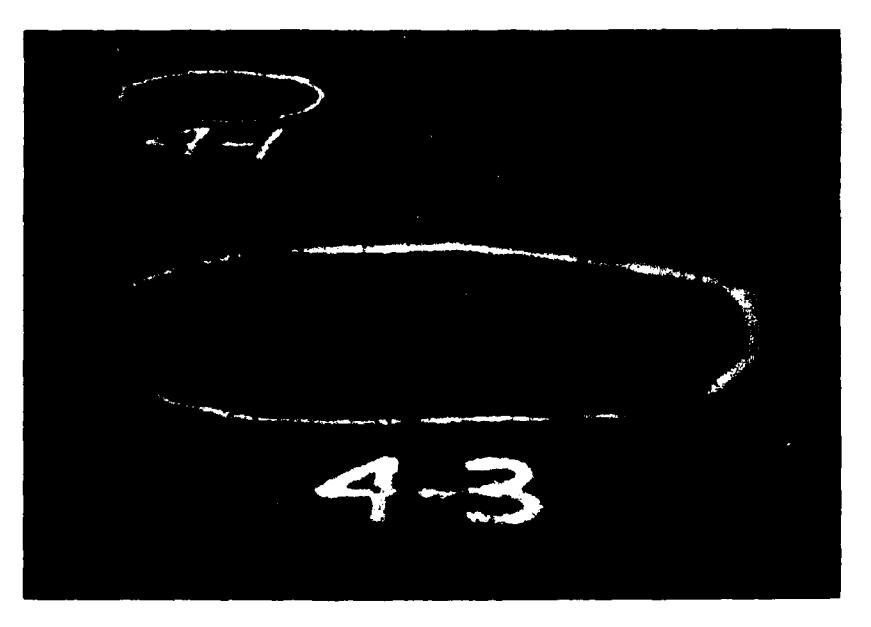
Figure 2. Problem number and quantity painted on a roof next to the outlined defect. Problem 4 (membrane repairs) has no severity level associated with it.

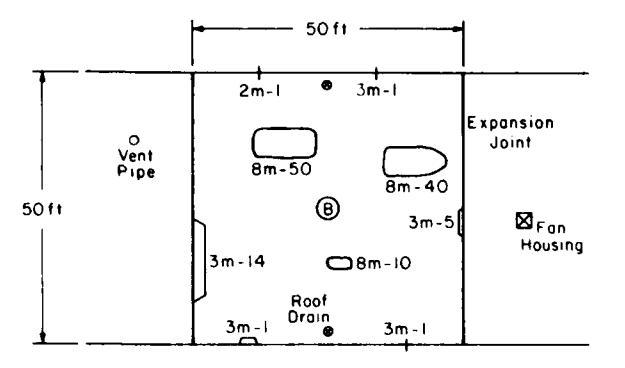
Figure 3. Roof sketch of section B of example roof shown in Figure 1, with defect locations and codes listed. A membrane code such as 8m-50 means problem 8, medium severity with a quantity of 50.

While recognizing that the abole equation is dimensionally inconsistent, we make use of it in the form detailed in AFM 81-36. For the roof shown in Figure 3, there is a total of 25 ft of medium severity defect (problem 3). The problem density calculation for that defect is as follows:

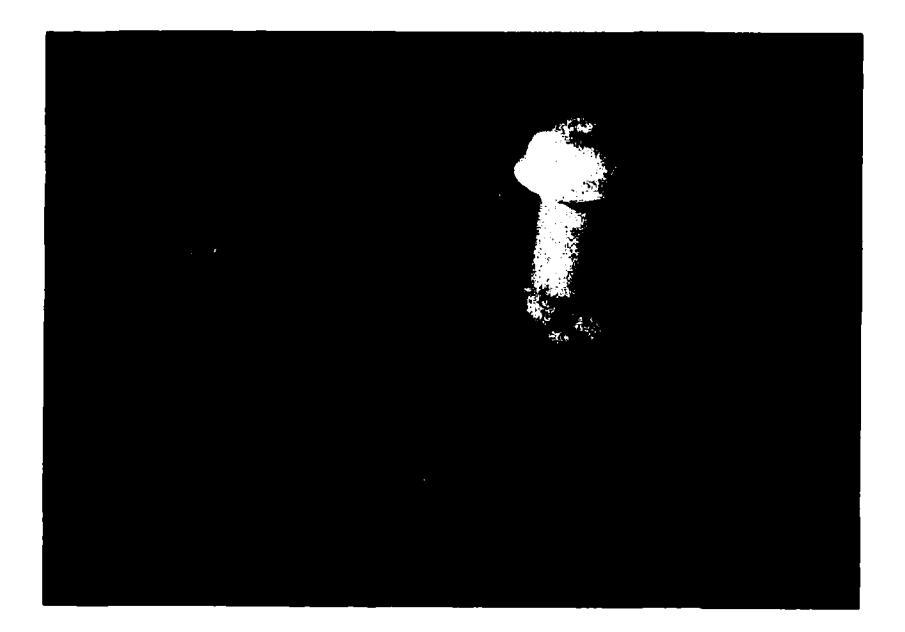
Figure 14. Metal flashing defect, problem 3. This split expansion joint is a high severity defect.
