WILLETT POND DAM MA 00169

NEPONSET RIVER BASIN NORWOOD/WALPOLE, MASSACHUSETTS

PHASE I INSPECTION REPORT NATIONAL DAM INSPECTION PROGRAM

Identification No.: MA00169 Name of Dam: Willett Pond Town: Norwood and Walpole County and State: Norfolk County, Massachusetts Stream: Hawes Brook - Tributary of the Neponset River Date of Inspection: December 5 and 12, 1978

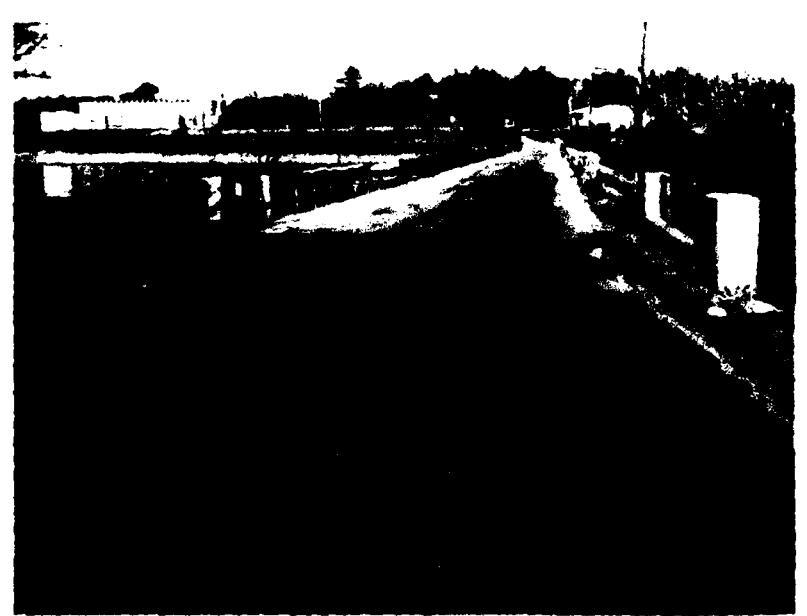
The most obvious deficiency at the main dam is the severe erosion of the upper portion of the upstream face near the crest. This erosion has undermined portions of the roadway, caused

NO. 1 CREST OF DAM FROM SOUTH ABUTMENT

- (2) repair erosion on the upstream slopes of the dam and dike, replacing any missing riprap,
 - (3) construct a curb or drainage ditch along both sides of the roadway on the crest of the main dam to control surface drainage,

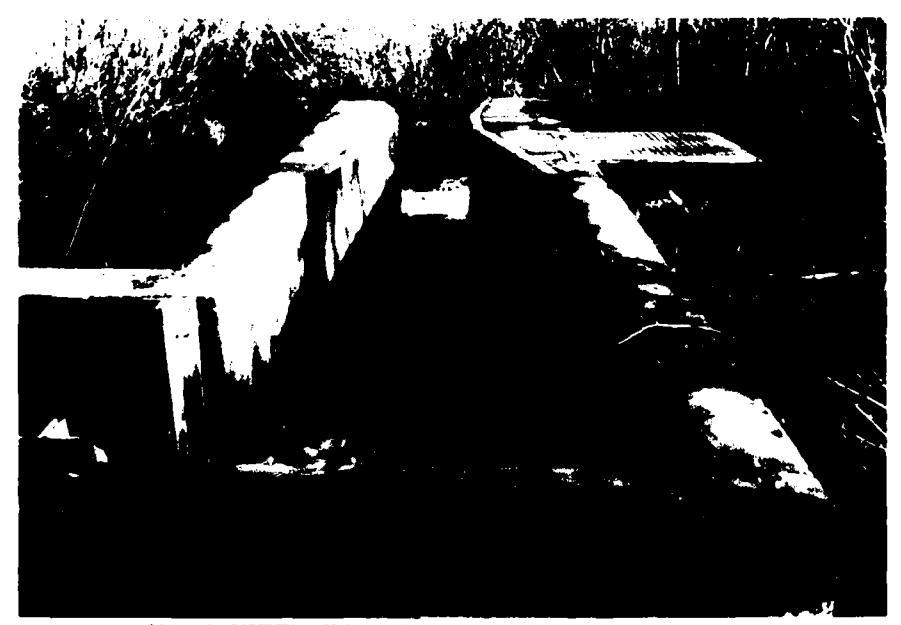
outlets were discharging at the time of inspection and could not be examined closely. The flume is in good condition, although some erosion and spalling has occurred on the inside of the concrete walls. Water is seeping out of the flume through a construction joint on the upstream wall, forming a pool of water outside the wall.

NO. 6 VIEW OF PARSHALL DISCHARGE FLUME

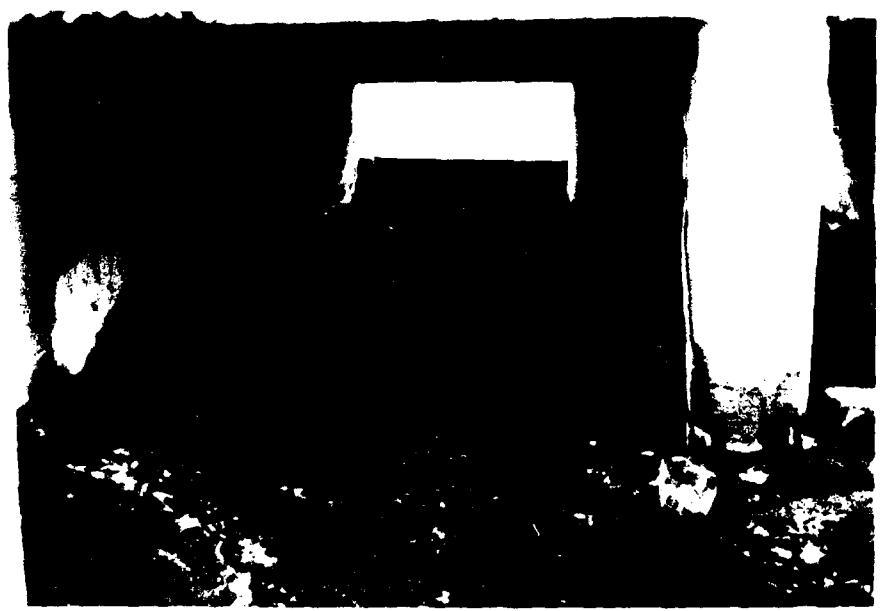
b. Weir and Training Walls	Triple box culvert			
General Condition of Concrete	spalling&erosion below water line, numerous cracks			
Rust or Staining	Some staining			
Spalling	severe below water line, especially on invert			
Any Visible Reinforcing	None			
Any Seepage or Efflorescence	Minor seepage, extensive efflorescence			
Drain Holes	None

NO. 8 INVERT OF BOX CULVERT

- (5) repair damaged gunite and concrete on walls and crest of spillway,
- (6) repair erosion in the floor and in the north side of the spillway discharge channel,
