CONNECTICUT WESTERN COASTAL AREA STAMFORD , CONNECTICUT

MIANUS RESERVOIR DAM CT 00050

PHASE I INSPECTION REPORT NATIONAL DAM INSPECTION PROGRAM

SEPTEMBER 1978

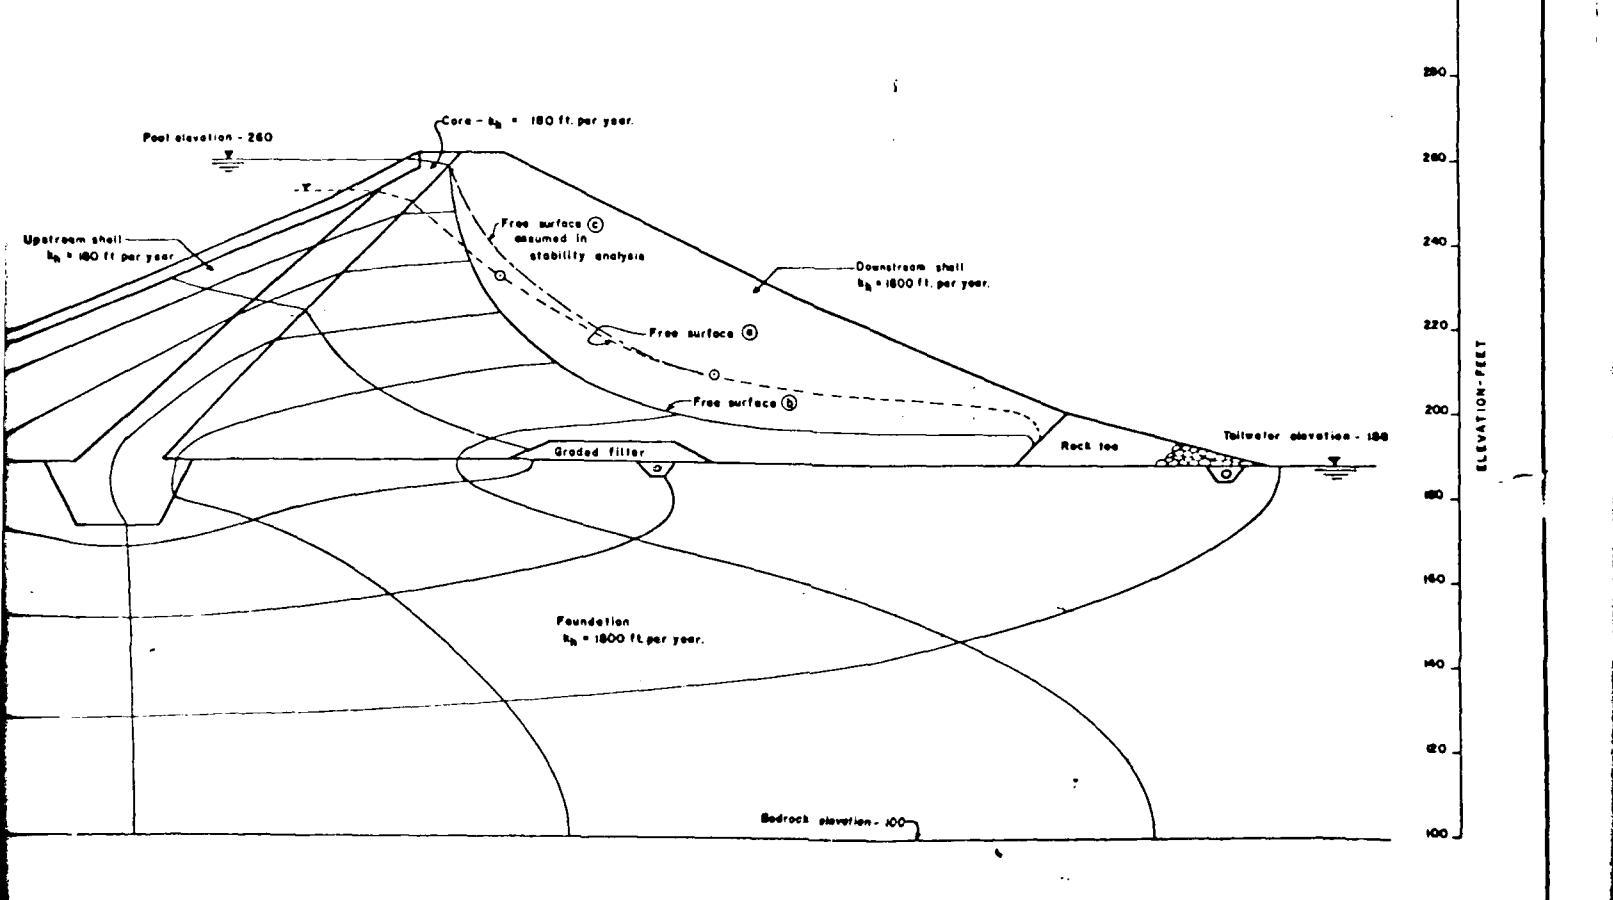
FLOW NET AT CROSS SECTION 5+0

The flow net for a section of the dam at Station 5+0 is shown in Figure 1. In sketching the net, it was assumed, based on field control reports, that the upstream shell and core were of the same permeability and that it was one-tenth that of the downstream shell. For the purpose of drawing the flow net the downstream shell and foundation were assumed to have equal permeabilities and the stratification ratio in all parts of the dam was assumed to be 9. Since the upstream portion of the embankment is relatively impermeable when compared with the foundation, seepage loss estimates may be made by considering the effects of the foundation and embankment individually without substantial error. This was done in all of the following analyses.

As shown in the flow net, not all of the seepage loss is reflected at the weir which measures flow out of the manhole in the rock toe. Thus approximately 1.1 flow paths in the foundation must be discounted when comparing estimated and measured flows. Also, flow measured at the manhole reflects surface runoff after a rainfall. This fact is vividly demonstrated in the lower curves

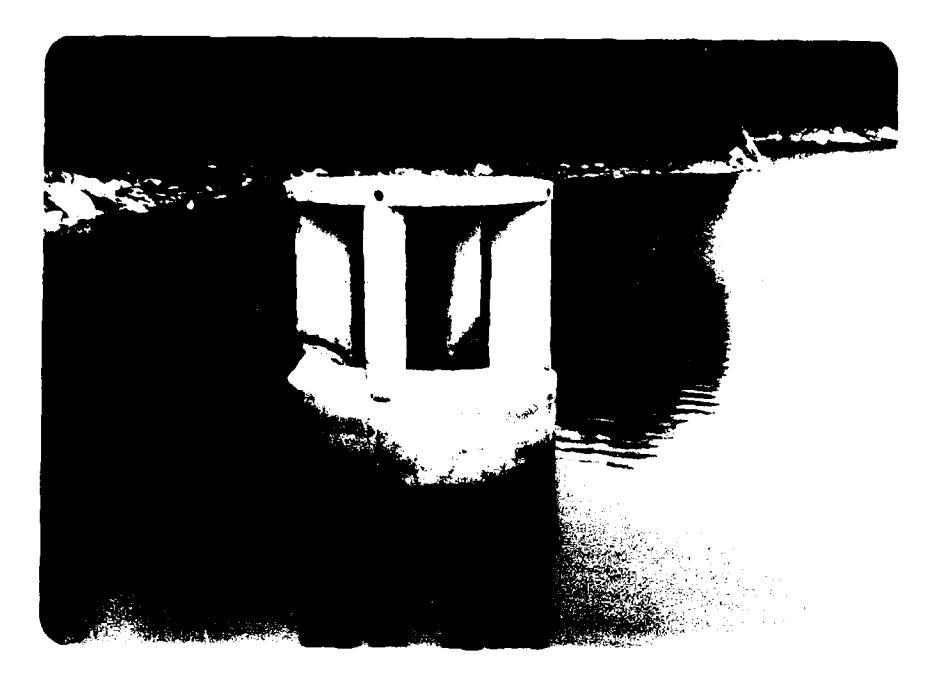
1) <u>Inlet Spillway</u> - The exterior was in excellent condition. The interior was in generally good condition with some spalling noted near the bottom. The base of the drop structure according to the plans is founded directly on bedrock. The inspection of this feature indicated that an irregular scour hole approximately 5 feet deep has developed. Water is apparently flowing from this area into the outlet pipe at a steady rate.

PHOTO #9: Service spillway - Top of the drop inlet shaft.

3) Subsequent to studying feasible methods, the scour hole at the spillway should be repaired.

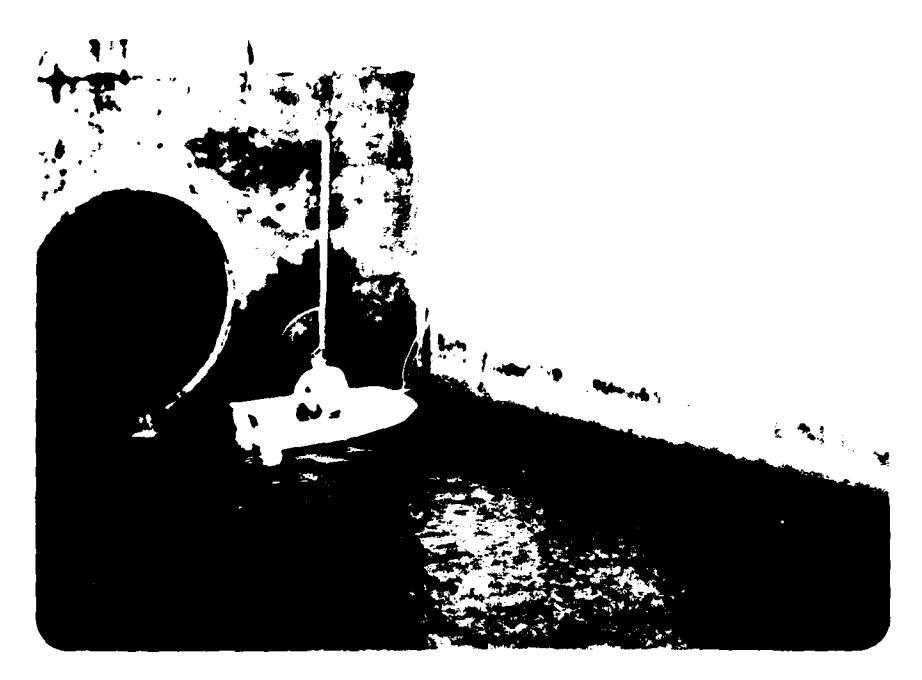
3) <u>Stilling Basin</u> - The concrete endwall and wingwalls are in excellent condition. The bottom of the apron was not clearly visible due to the depth of water. The contacts between the embankment and the outlet structures were in good condition.

4) <u>Blow-Off</u> - The valve for the 30-inch blow-off pipe was easily opened by one man. The flow from the blow-off was clear and free of debris. Upon closing the valve, there was no leakage observed. The end of the blow-off pipe was in good condition.

PHOTO #11: Outlet of the service spillway discharge conduit, and adjacent blow off.
