SHELTON, CONNECTICUT

NATIONAL DAM INSPECTION PROGRAM

PHASE I - INSPECTION REPORT

Identification No.:	CT 00092
Name of Dam:	Means Brook Reservoir Dam
Town:	Shelton
County and State:	Fairfield County, Connecticut
Stream:	Means Brook
Date of Inspection:	November 16, 1979

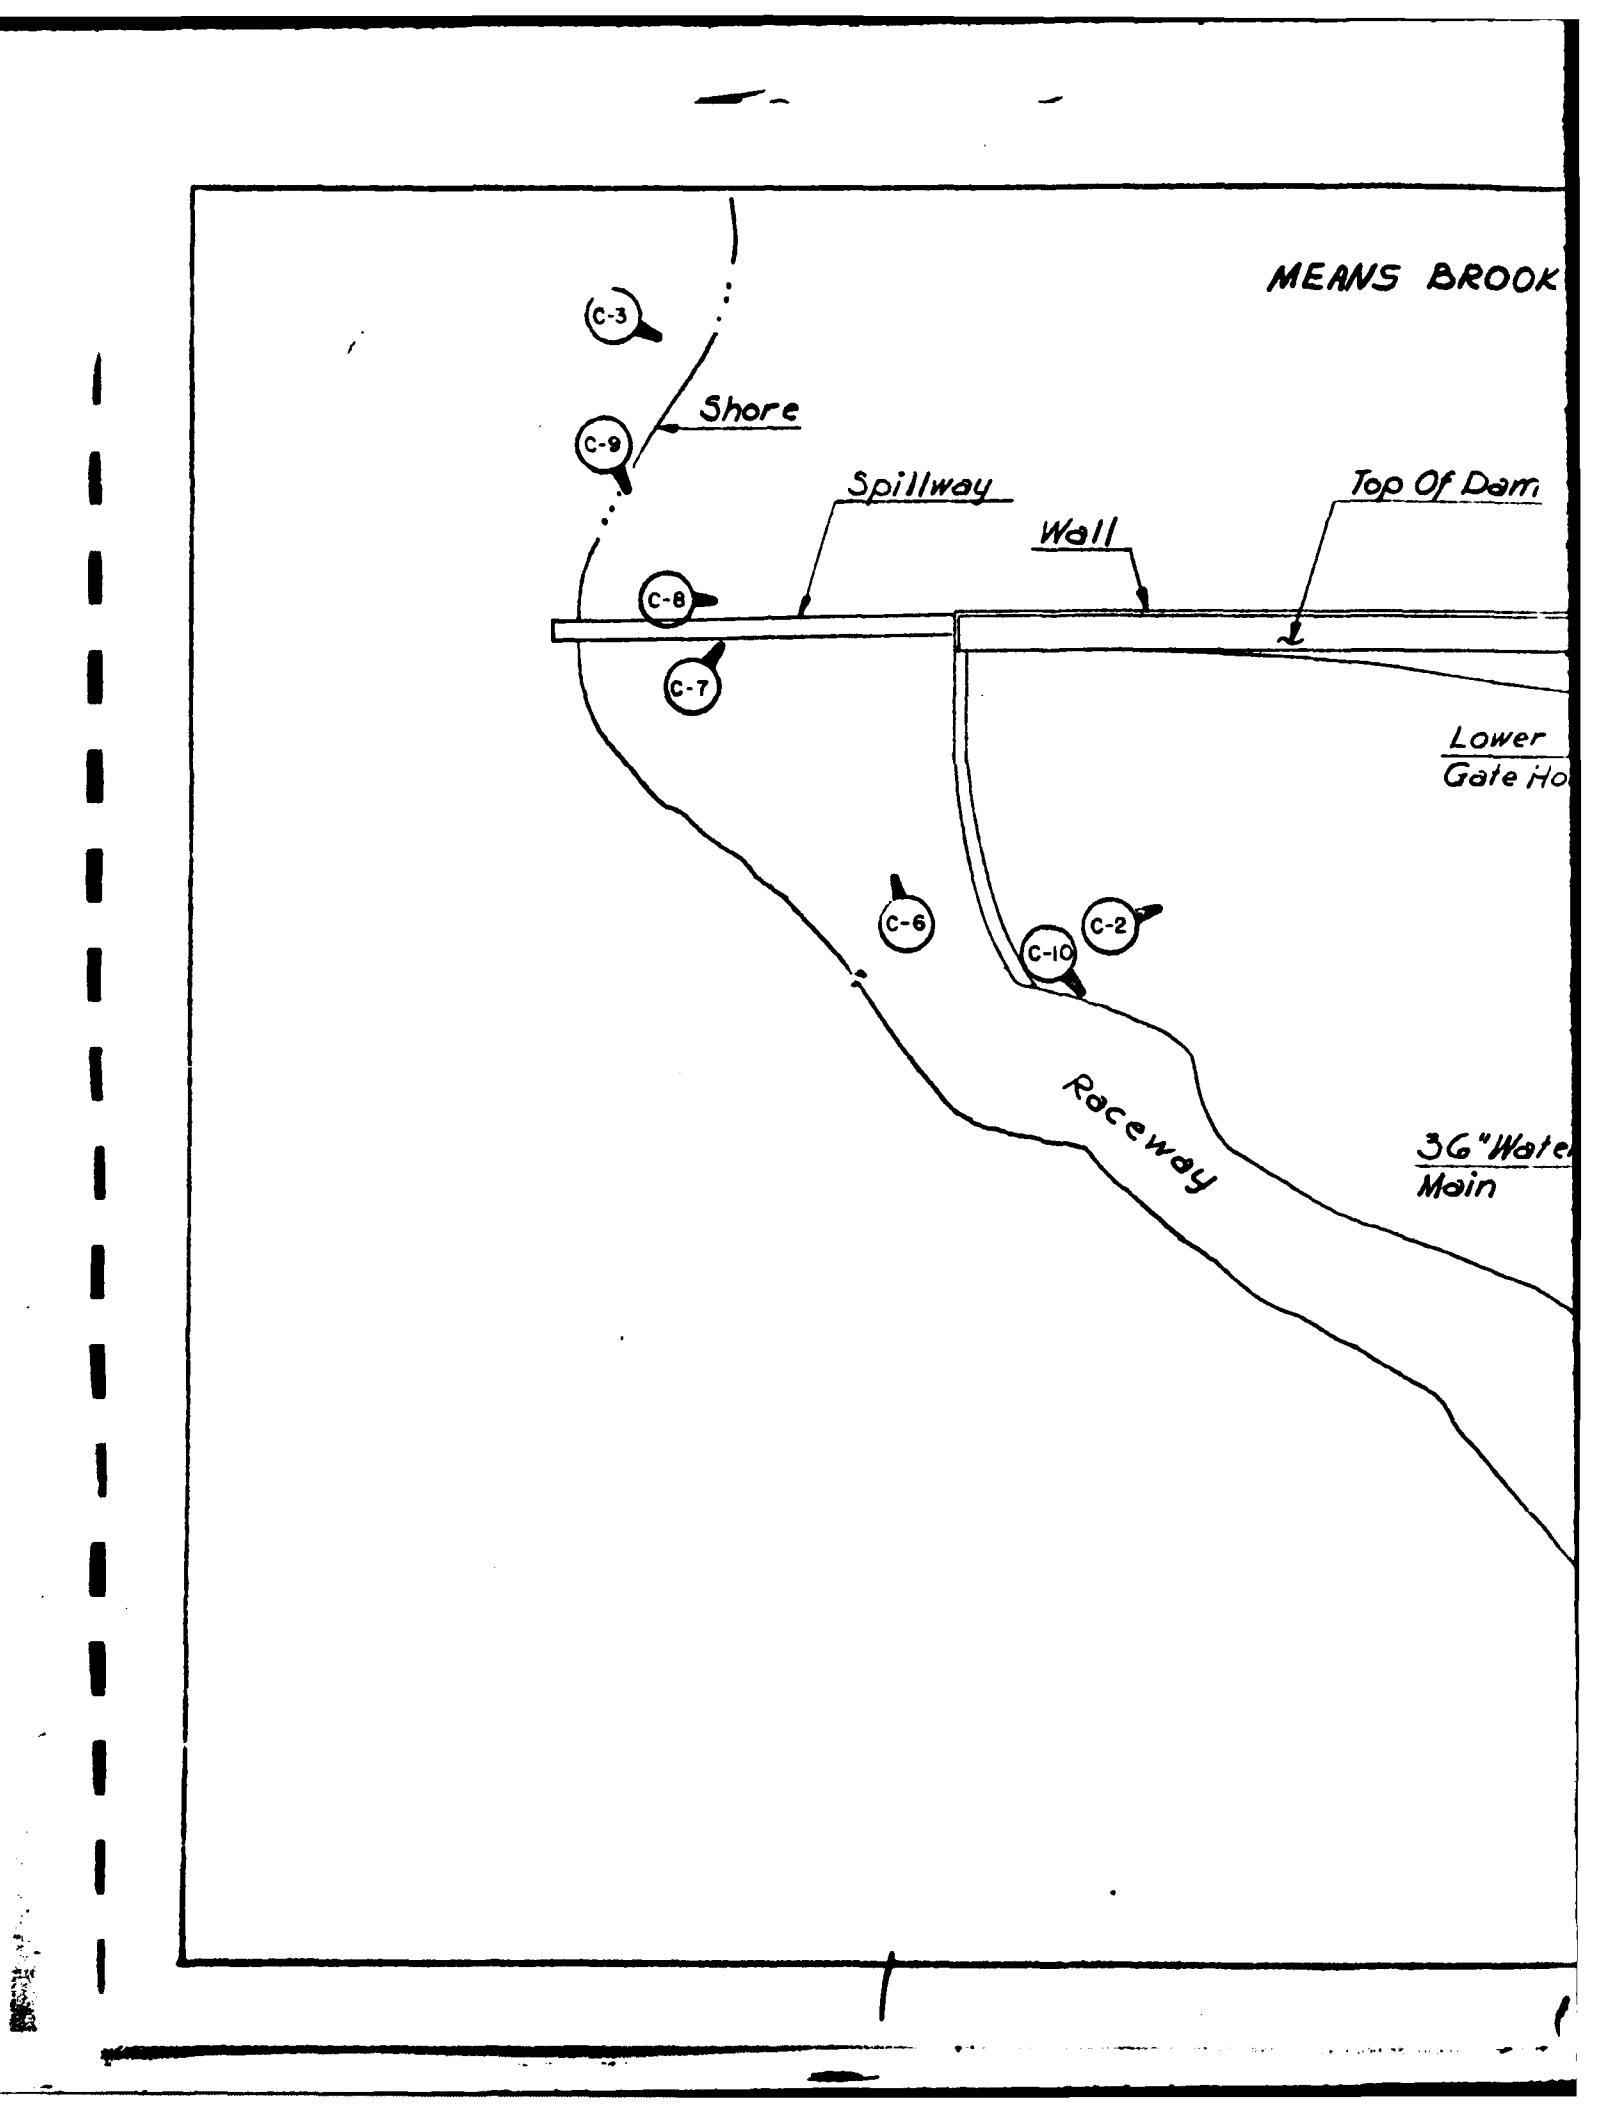
Crest: The top of the dam is concrete with no evidence of settlement or misalignment. The top is spalled (Photo C-4) and there is visible reinforcing in a few locations along the edge of the top (Photo C-5). A 2.1 foot high concrete wall was added to the upstream edge of the dam's crest in 1977 (Photo C-5).

The top of the dam has a width of 10 feet and support pipe railing (good condition) on both the upstream and downstream edges (Photo C-4).

- a. An investigation as to the source and cause of the subsurface flow beneath the spillway.
- b. The upstream face of the dam be visually inspected.
- c. The spalling on the downstream face and the top of the dam be rehabilitated to their original condition.
- d. A further analysis be conducted as to the structural stability of the dam.

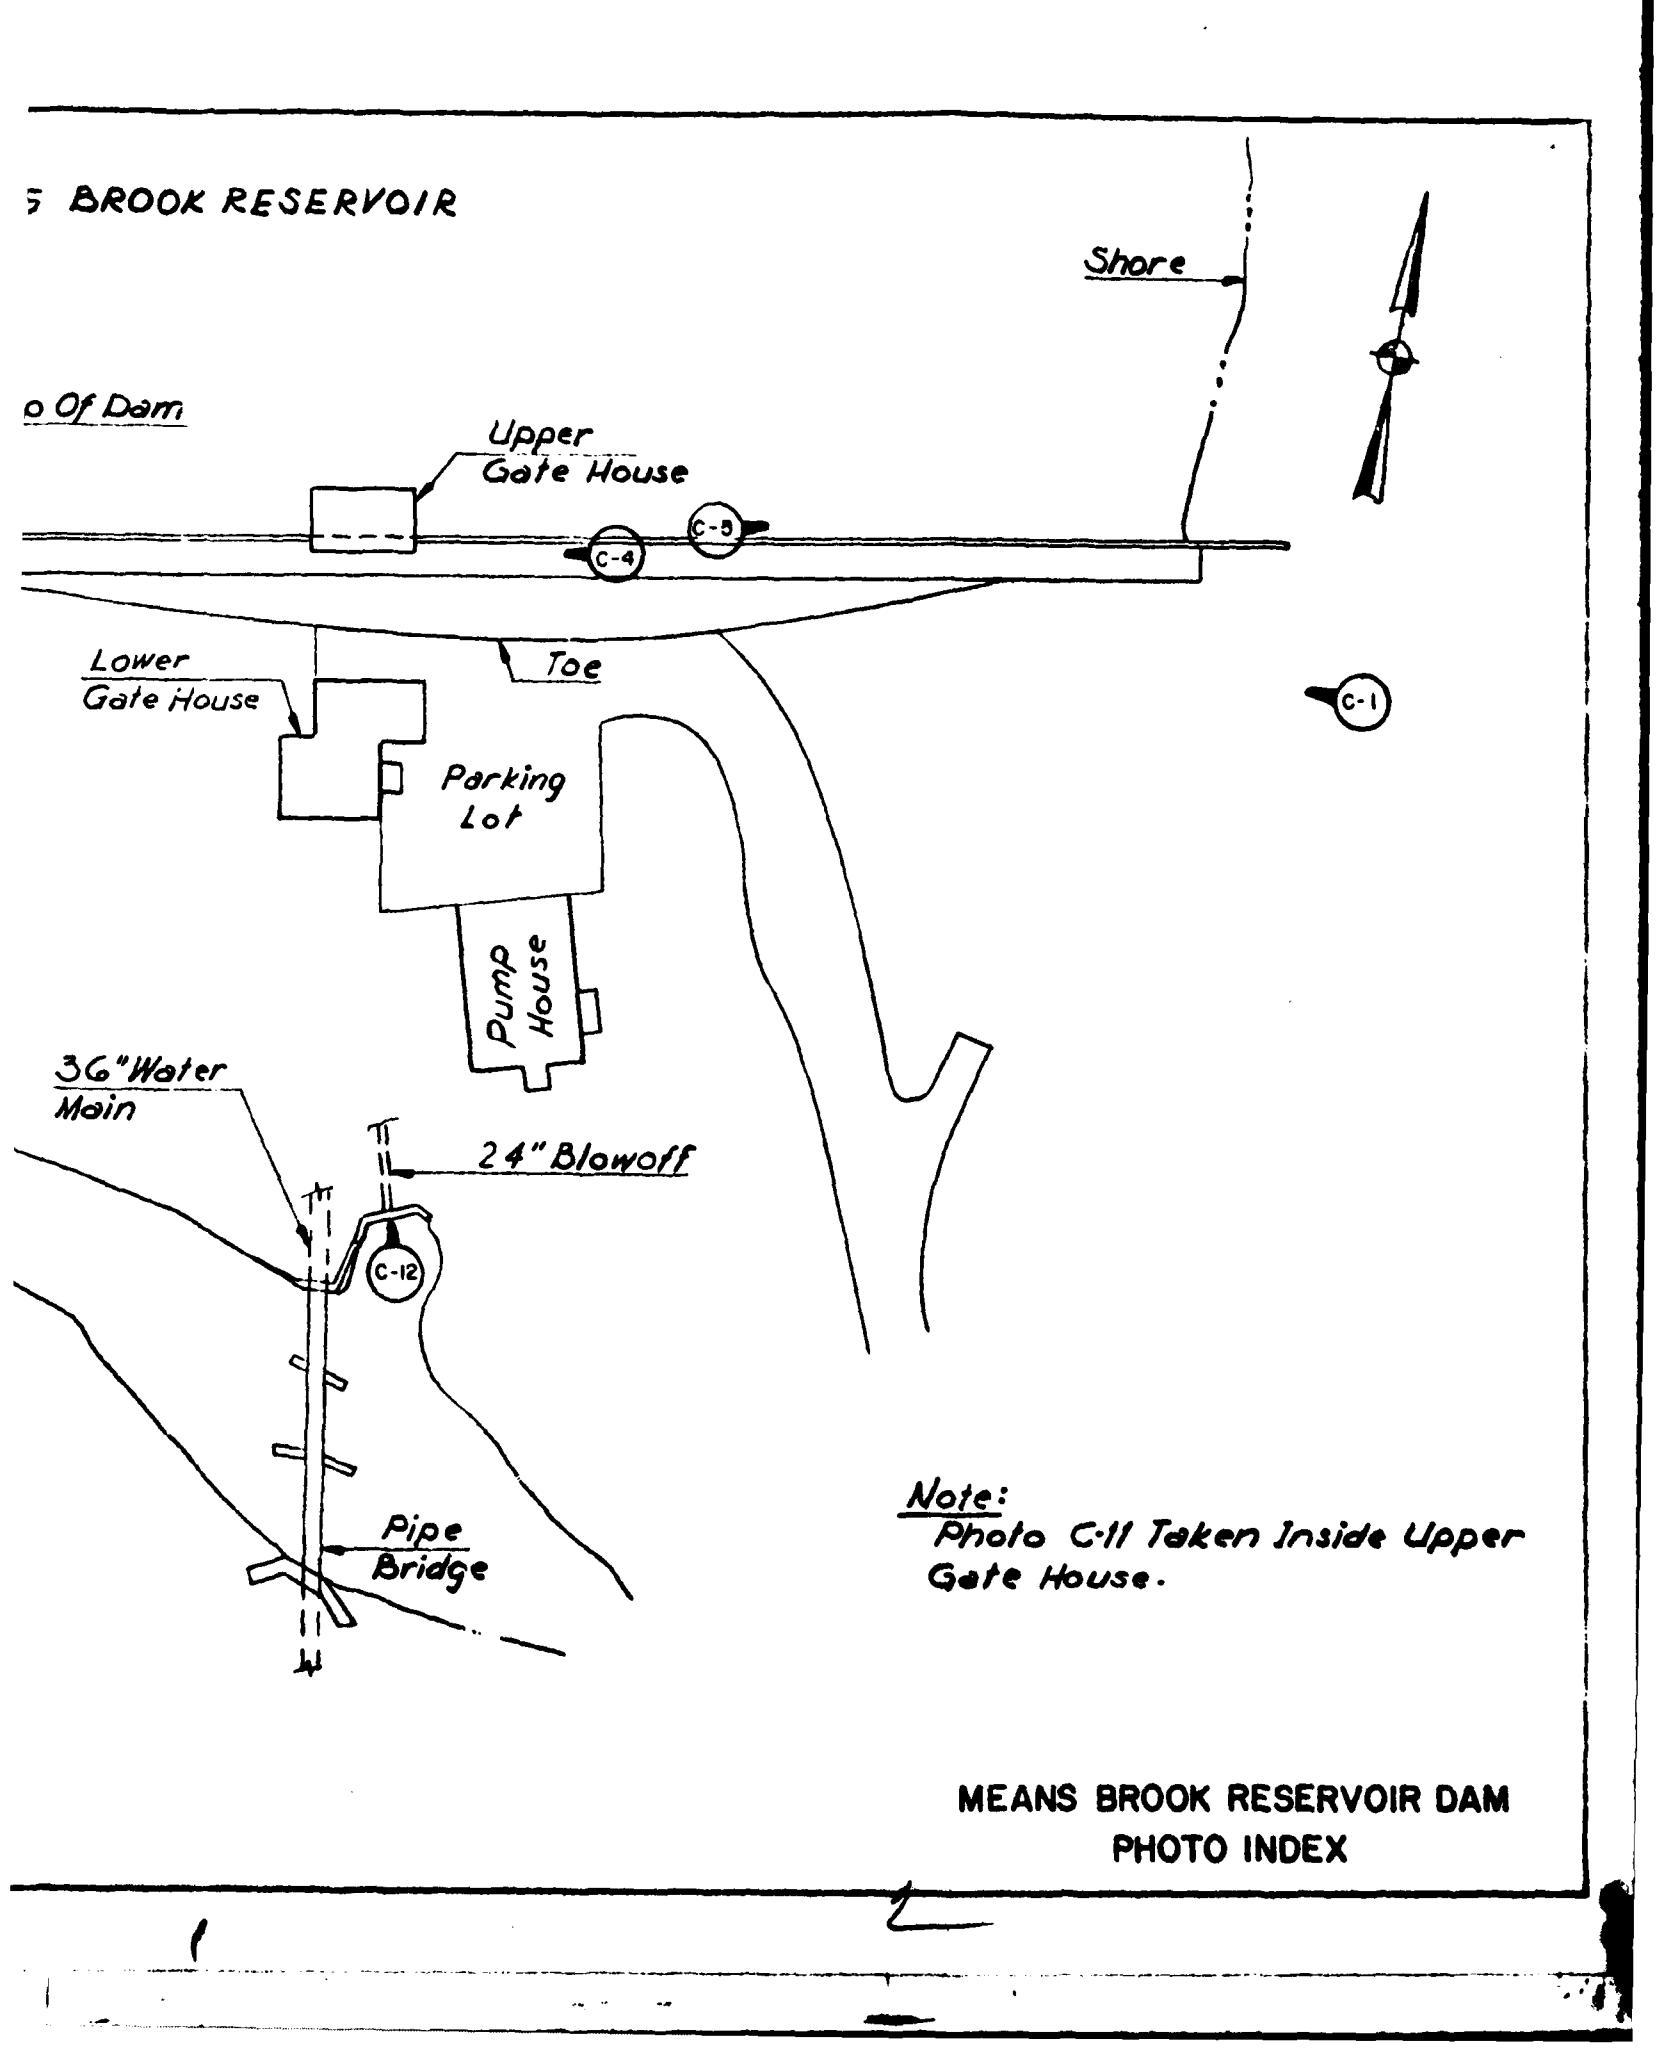
Since no major physical distress or movement has been noted since the construction of this dam in 1917, stability does not appear to be a problem. On the downstream face, the concrete shows signs of spalling and efflorescence. A 2.1 foot concrete wall was added to this structure and the spillway was widened in 1977. Reinforcement is visible in a few places along the edges of the crest.
