PHASE I INSPECTION REPORT NATIONAL DAM INSPECTION PROGRAM

Identification Number: Name: Town: County and State: Stream: Date of Inspection: CT 00061 Lee's Pond Dam Westport Fairfield County, Connecticut Saugatuck May 30, 1980

PHASE I INSPECTION REPORT LEE'S POND DAM CT 00061

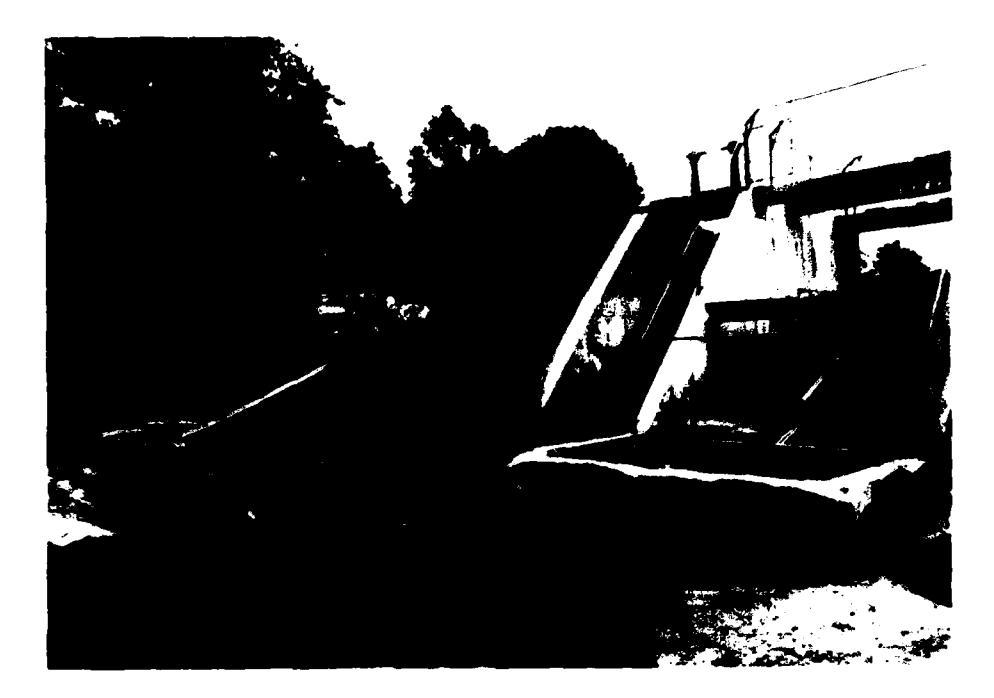
PHOTO 5 SPILLWAY APRON SCOUR POOL

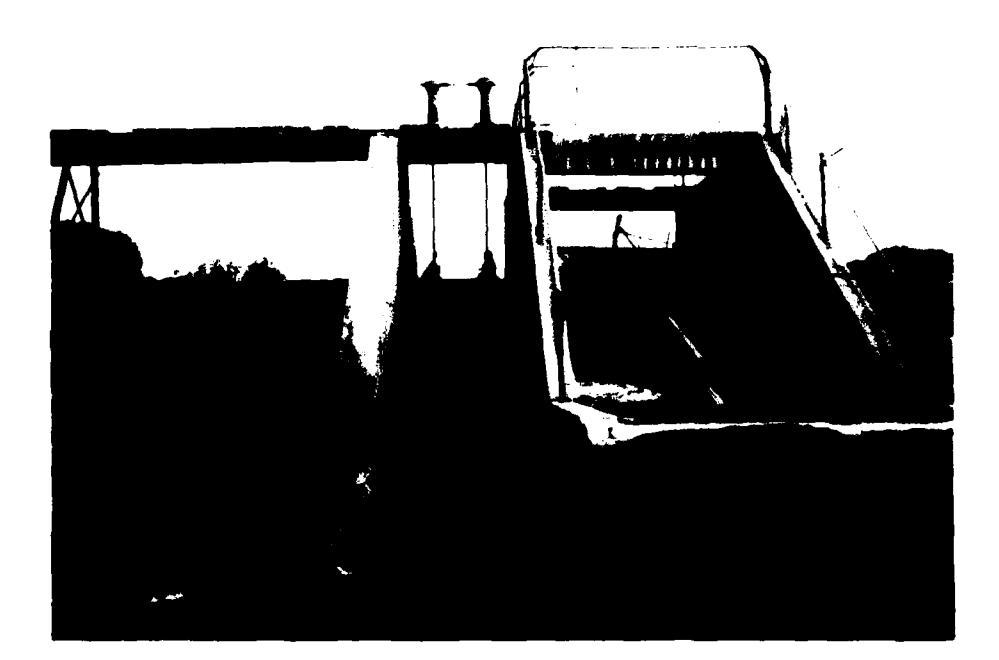
The sluice gate is a wooden gate that has several leaks in it. According to the owner, the gate is operable, however, its actual integrity is questionable (Photo 6). The concrete making up the sluiceway has several areas that are in poor condition with spalled and eroded concrete and exposed reinforcements (Photos 5 and 6). The operating mechanism for the sluice gate is in fair condition, but the location of the handle is unknown.

PHOTO 6 SLUICE GATE - FISHLADDER
