PHASE I INVESTIGATION REPORT NATIONAL DAM INSPECTION PROGRAM

Babson Reservoir Dam is currently classified as having a "high" hazard potential in the Corps of Engineers National Inventory of dams.

PHASE I INVESTIGATION REPORT NATIONAL DAM INSPECTION PROGRAM BABSON RESERVOIR DAM MA 00187

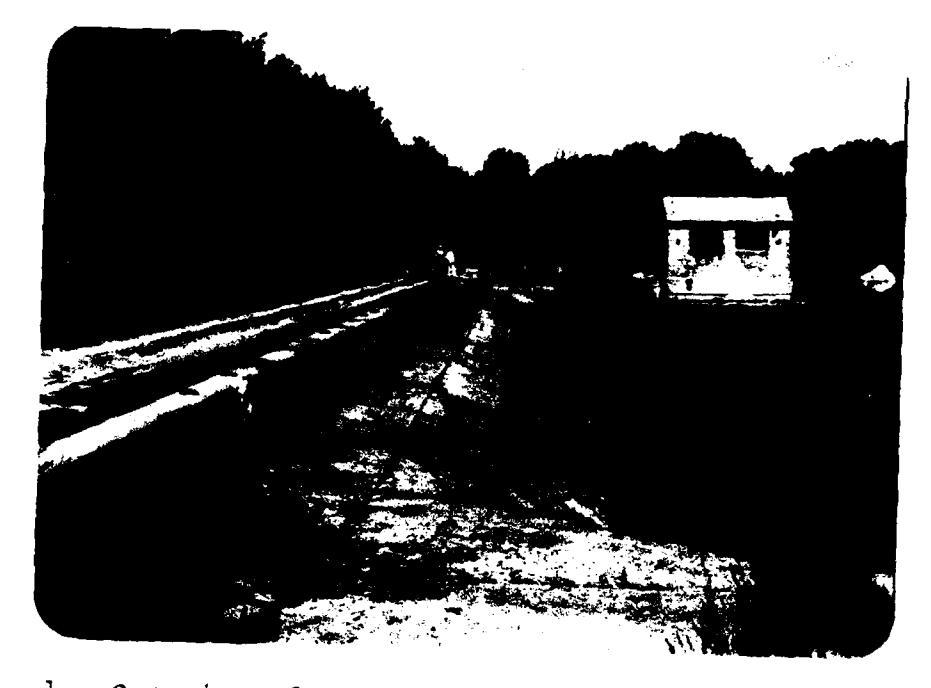
1. Overview of crest and upstream slope from left abutement.

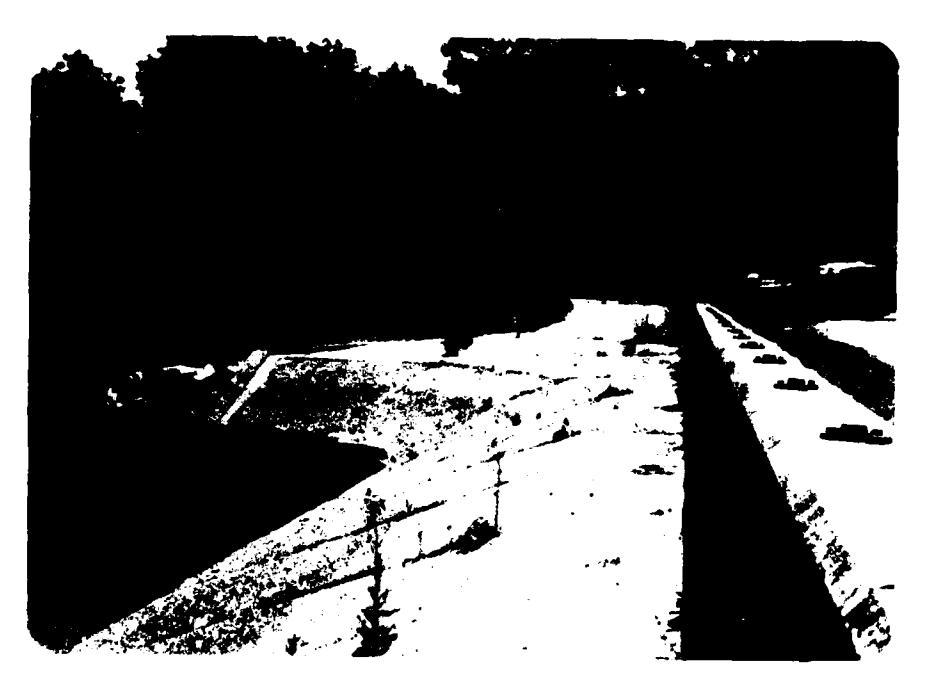
- Concrete pavement slabs on the upstream slope have deteriorated in several localized areas, the most severe of which is shown in Photo No. 6. Isolated cracking and minor differential settlement of the slabs relative to the core wall has occurred. The sealant used at the slab joints has broken down and needs replacement. A number of joints now have vegetation. The upstream slope is shown in Photos No. 4 and 5.

4. Upstream paved slope at left end

- 7. Reseal all joints in the concrete pavement on the upstream slope, exposed core wall and spillway. Remove all loose concrete patches, fill all resultant voids, spalls, and missing pieces of pavement with concrete.

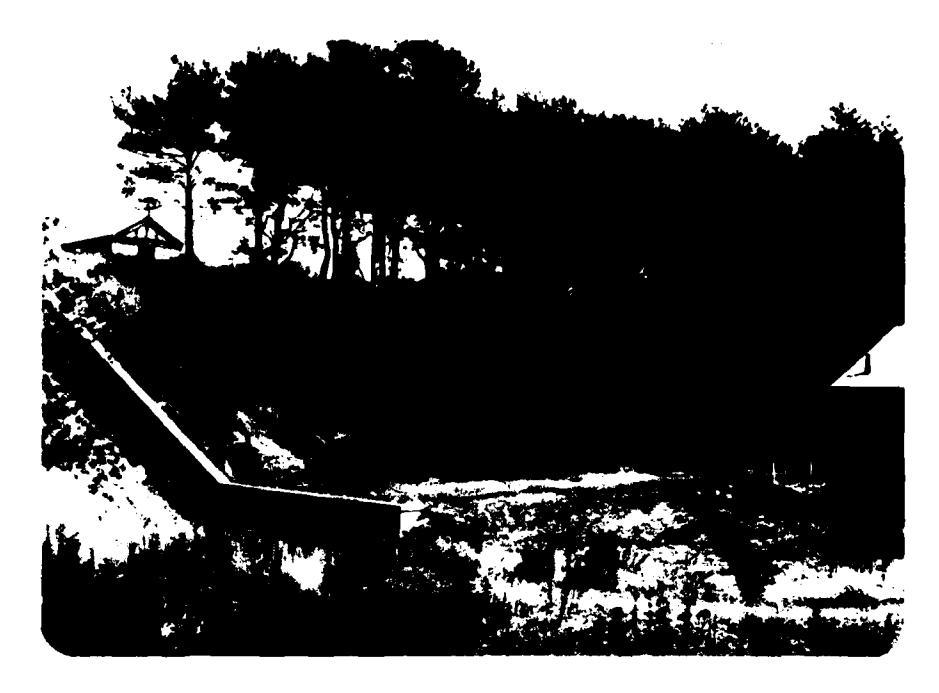
7. Downstream slope left of spillway

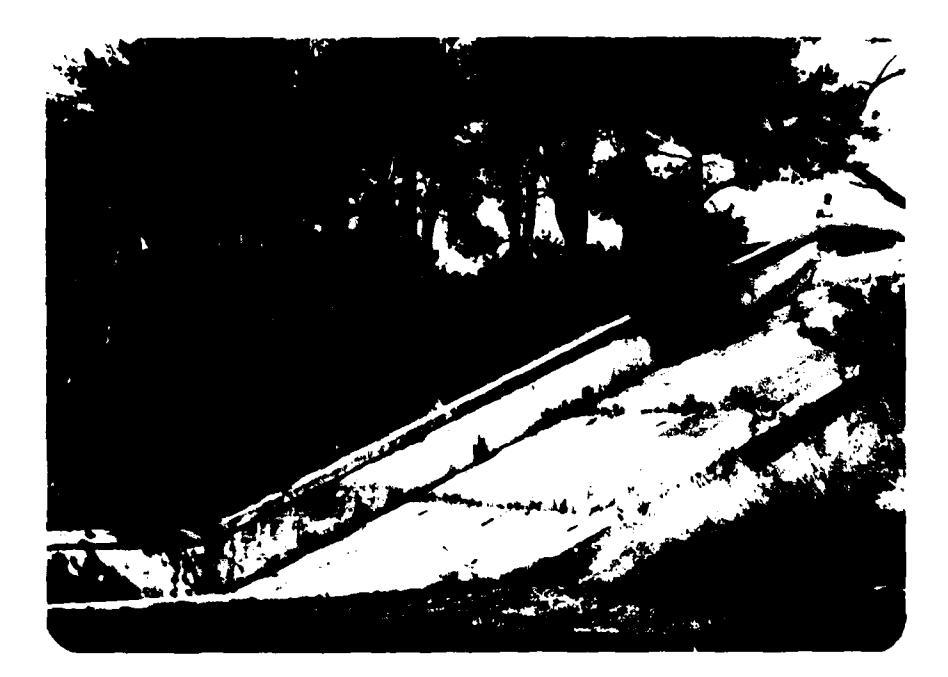
8. Downstream slope right of spillway

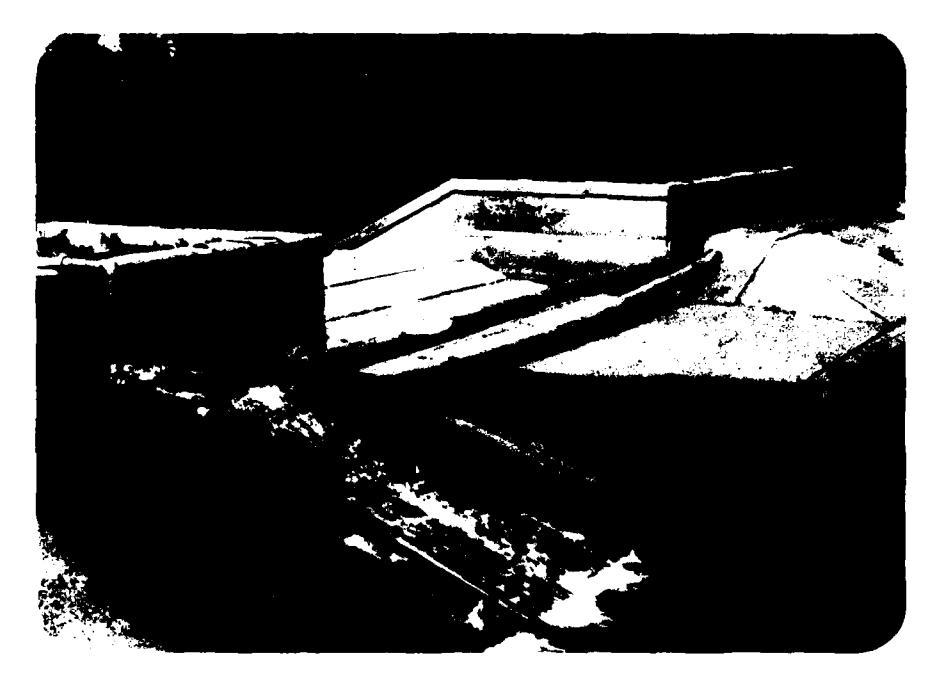
C. Appurtenant Structures. The spillway was found to be in good condition. The approach to the spillway is formed by pavement slabs on the upstream face of the dam, Photo No. 9. The surface of the slabs has eroded and the aggregate is exposed. The sealant at slab joints has broken down. Two logs are present at the entrance to the spillway, Photo No. 9. The impact of these logs against the core wall has caused spalling of the wall. Flashboards on top of the weir are in good condition. The flashboards have been securely bolted to each other and fastened to the training walls. It is questionable whether these flashboards would release under flood conditions.

9. Spillway approach and log boom

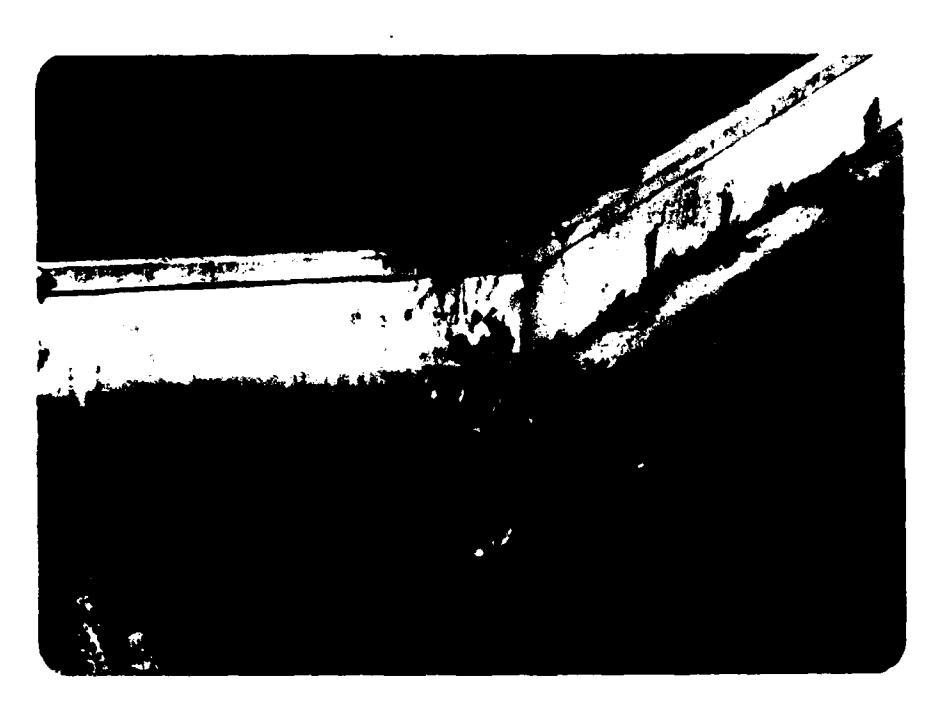
12. Training wall right of stilling basin
