AMMRC TR 84-39

MOBILE ACCELERATOR NEUTRON RADIOGRAPHY SYSTEM

W. E. DANCE, S. F. CAROLLO, AND H. M. BUMGARDNER
LTV AEROSPACE AND DEFENSE COMPANY
VOUGHT MISSILES AND ADVANCED PROGRAMS DIVISION
P. O. BOX 650003
DALLAS, TEXAS 75265-0003

FINAL REPORT

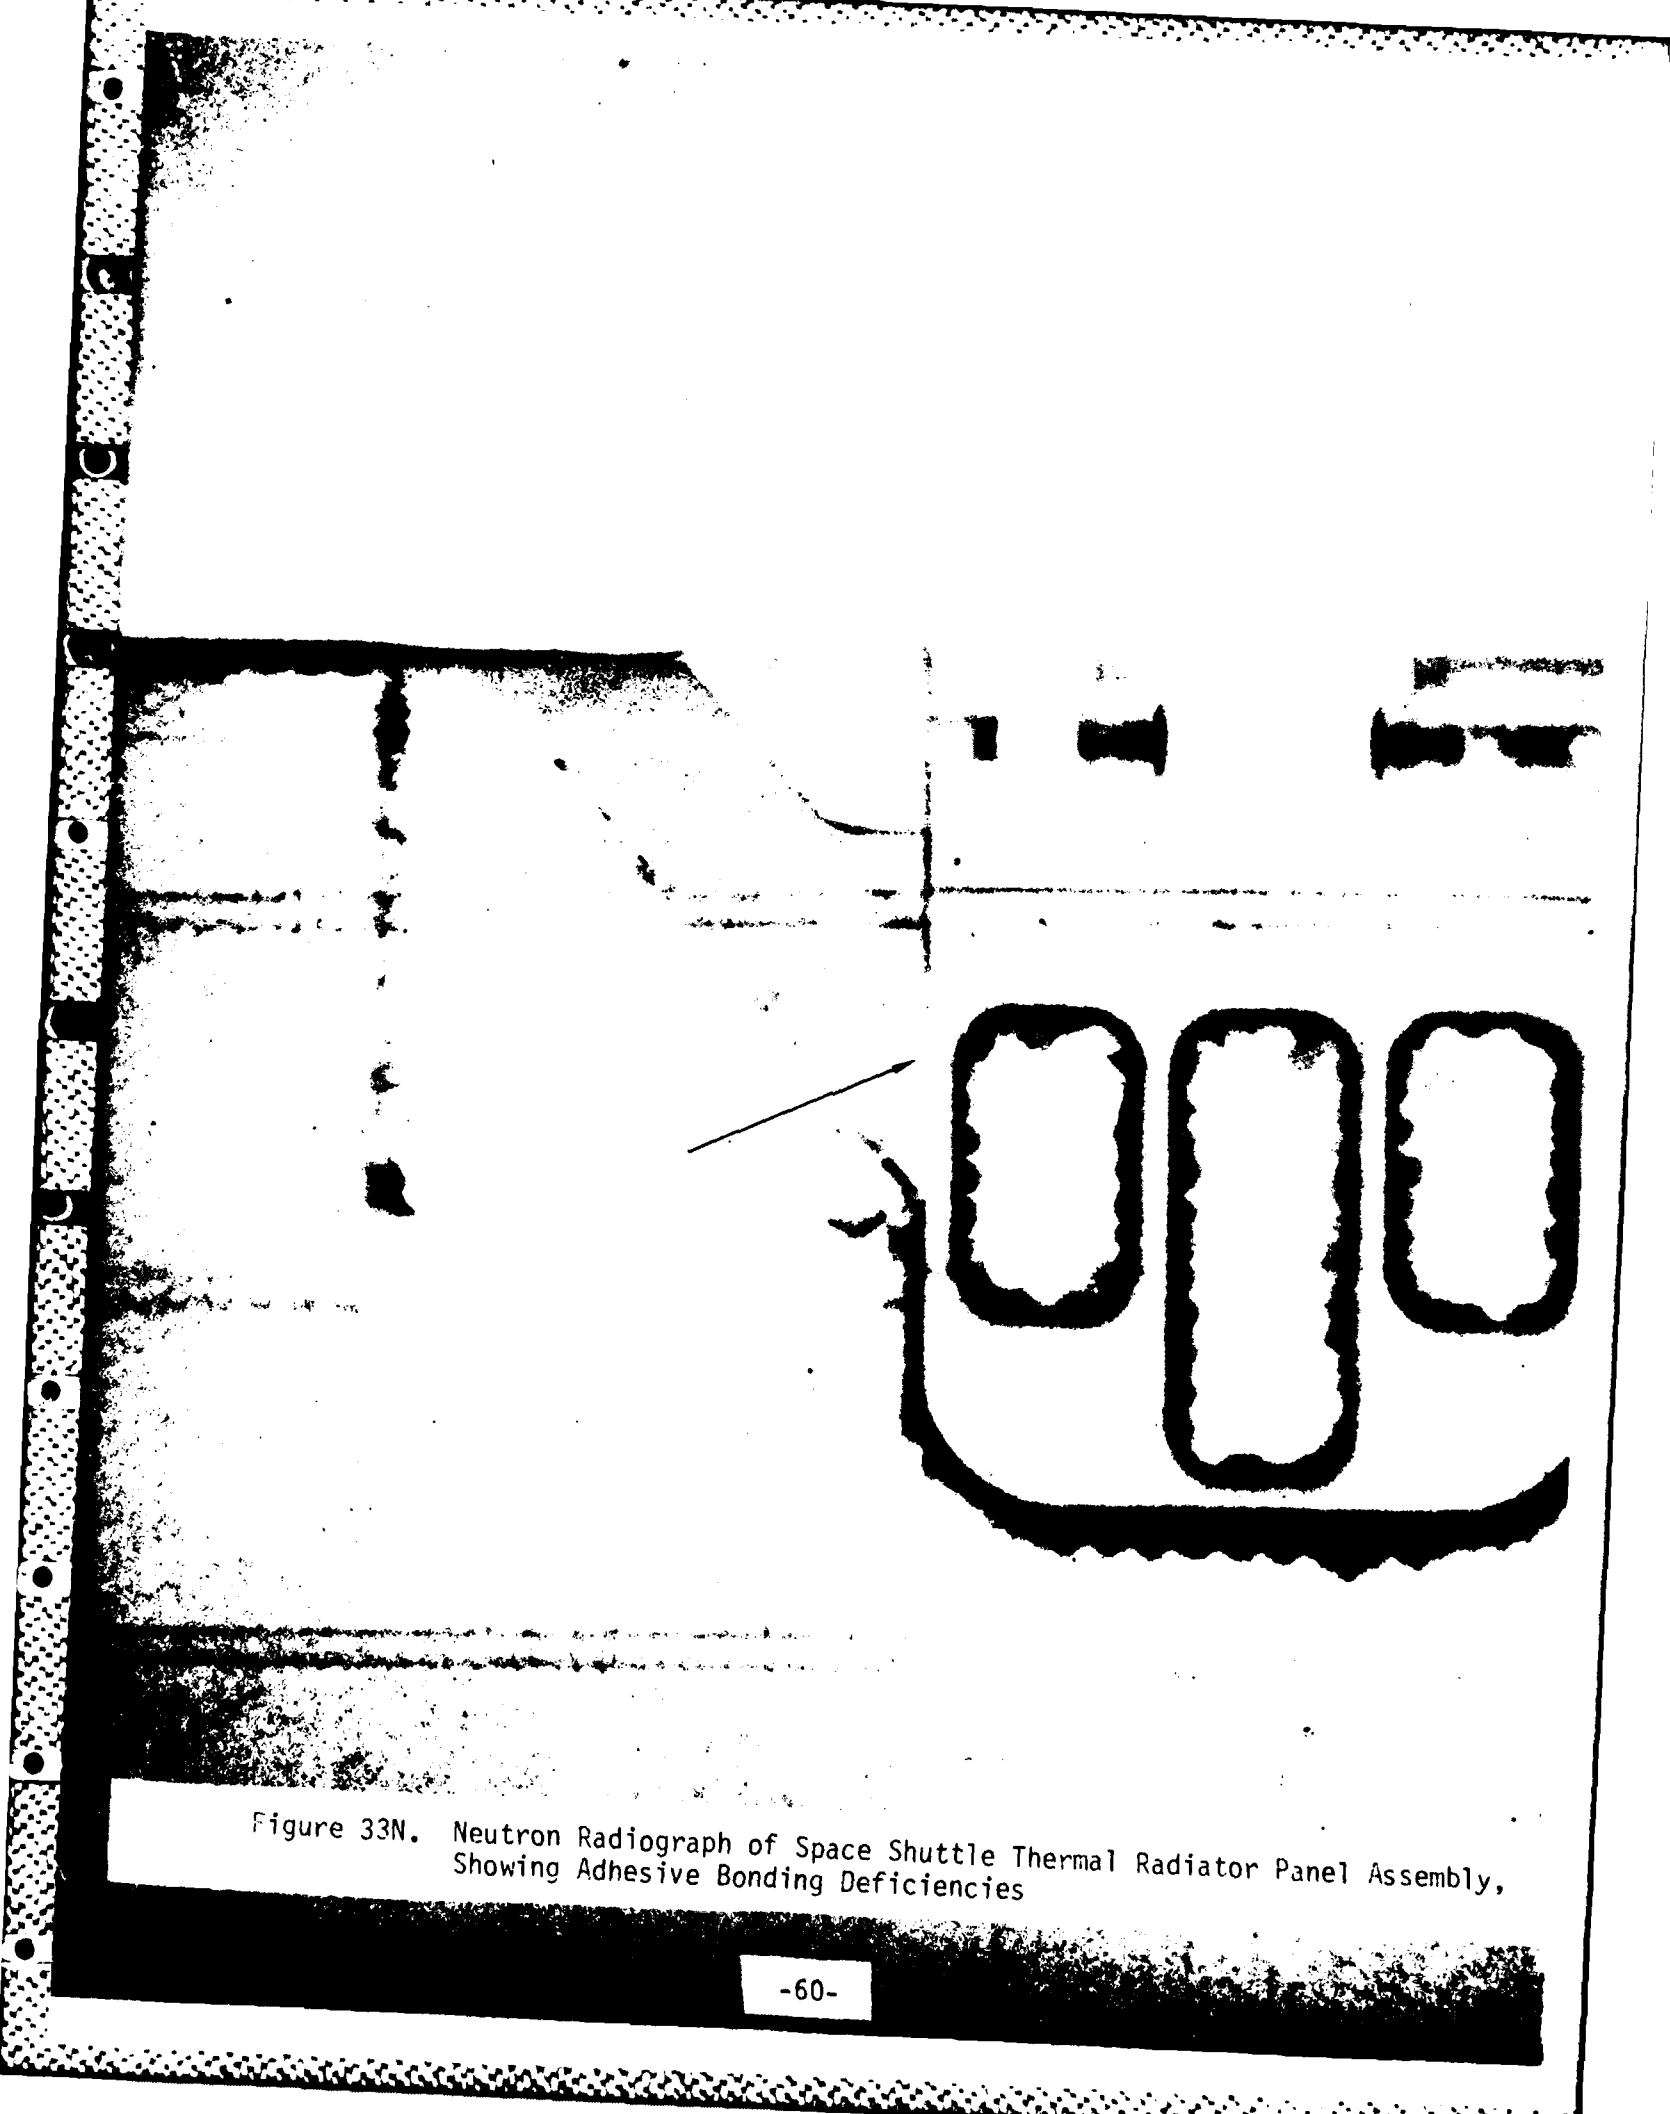
A series of radiographs was made to evaluate application of this type mobile system to inspection of large structures such as the space shuttle thermal radiator panels manufactured by Vought. Figures 33X and 33N are x and neutron radiographs of one of these panels in the area of an aluminum fixture bonded into the panel. In this case, the specific area in question was the edge bond between two components comprising the fixture. As seen, the x-ray does not image this bondline, and the neutron radiograph images all the bonding material in the structure, indicating an inadequate bond in the area denoted. Figure 34N is a neutron exposure made at an oblique angle of approximately 40 degrees from perpendicular to the beam, in order to determine the depth of the questionable edge bond. As seen, the depth profile of this bondline is faithfully imaged. Based on these images, a repair of this area by simple adhesive injection at the appropriate points was effected, which obviated the need for skin removal.

Figure 33N. Neutron Radiograph of Space Shuttle Thermal Radiator Panel Assembly, Showing Adhesive Bonding Deficiencies

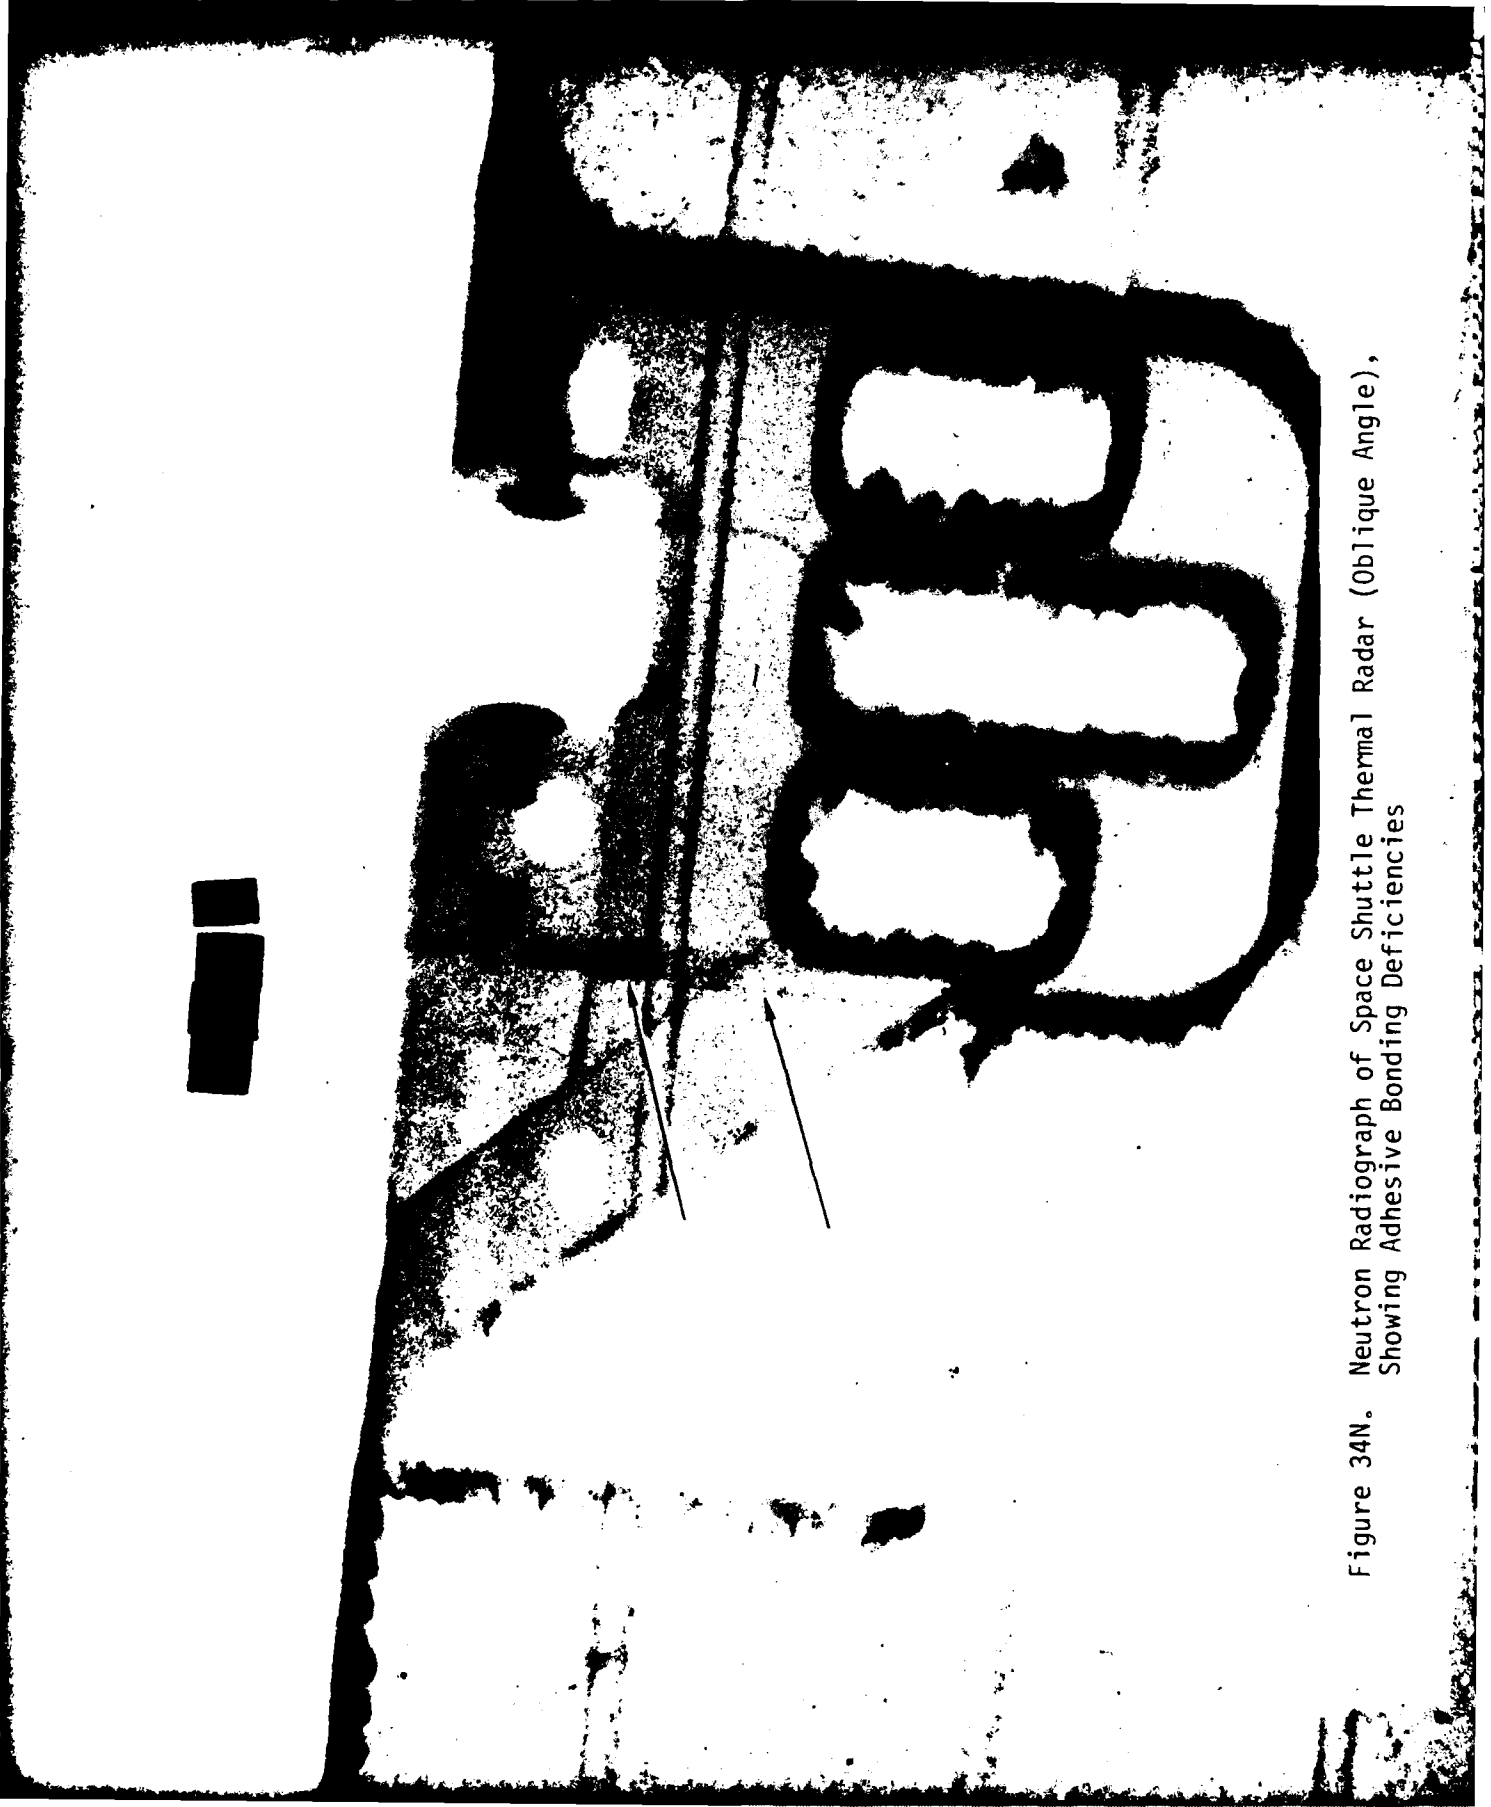
Figure 34N. Neutron Radiograph of Space Shuttle Thermal Radar (Oblique Angle),
Showing Adhesive Bonding Deficiencies

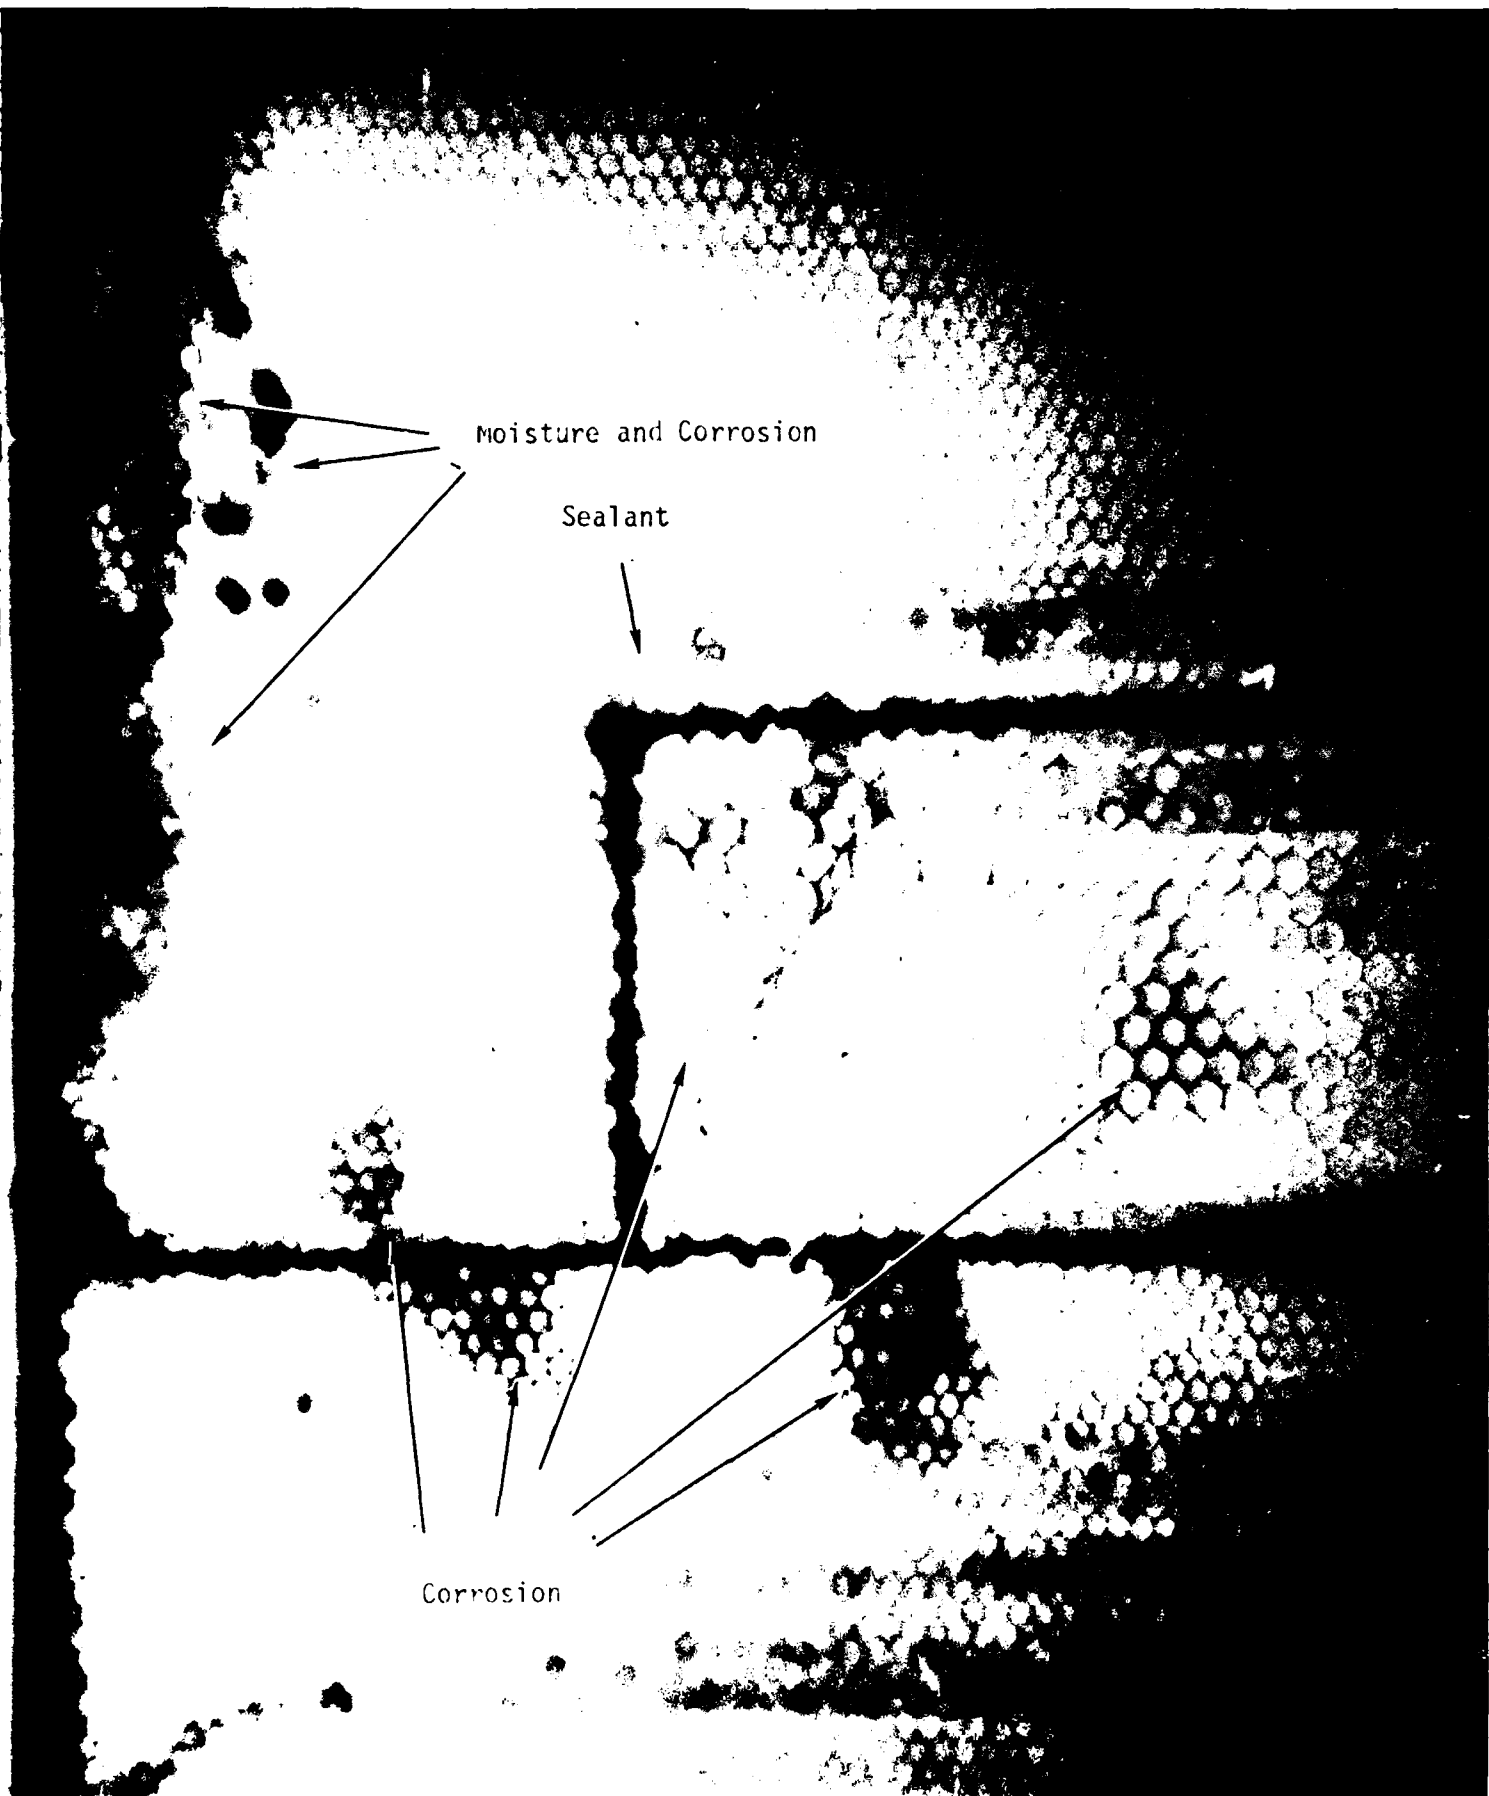
The next neutron radiograph in this series, Figure 46N, resulted from inspection of an F-111 forward engine access panel. Moisture and corrosion are clearly imaged, in addition to adhesive fillets and sealants. A very fast (3 minute) exposure of a similar panel, Figure 47N, is compared with a 90 minute exposure of the same area, Figure 48N. This comparison is made here to assess the extent to which one can trade high resolution for speed in a mobile operation and still adequately detect the defect(s) in question. As noted, the 3 minute radiograph shows sufficient detail to interpret most of the features of the 90-minute image.

Figure 46N. Neutron Radiograph of F-111 Forward Engine Access Panel Showing Corrosion, Moisture, Adhesive and Sealants

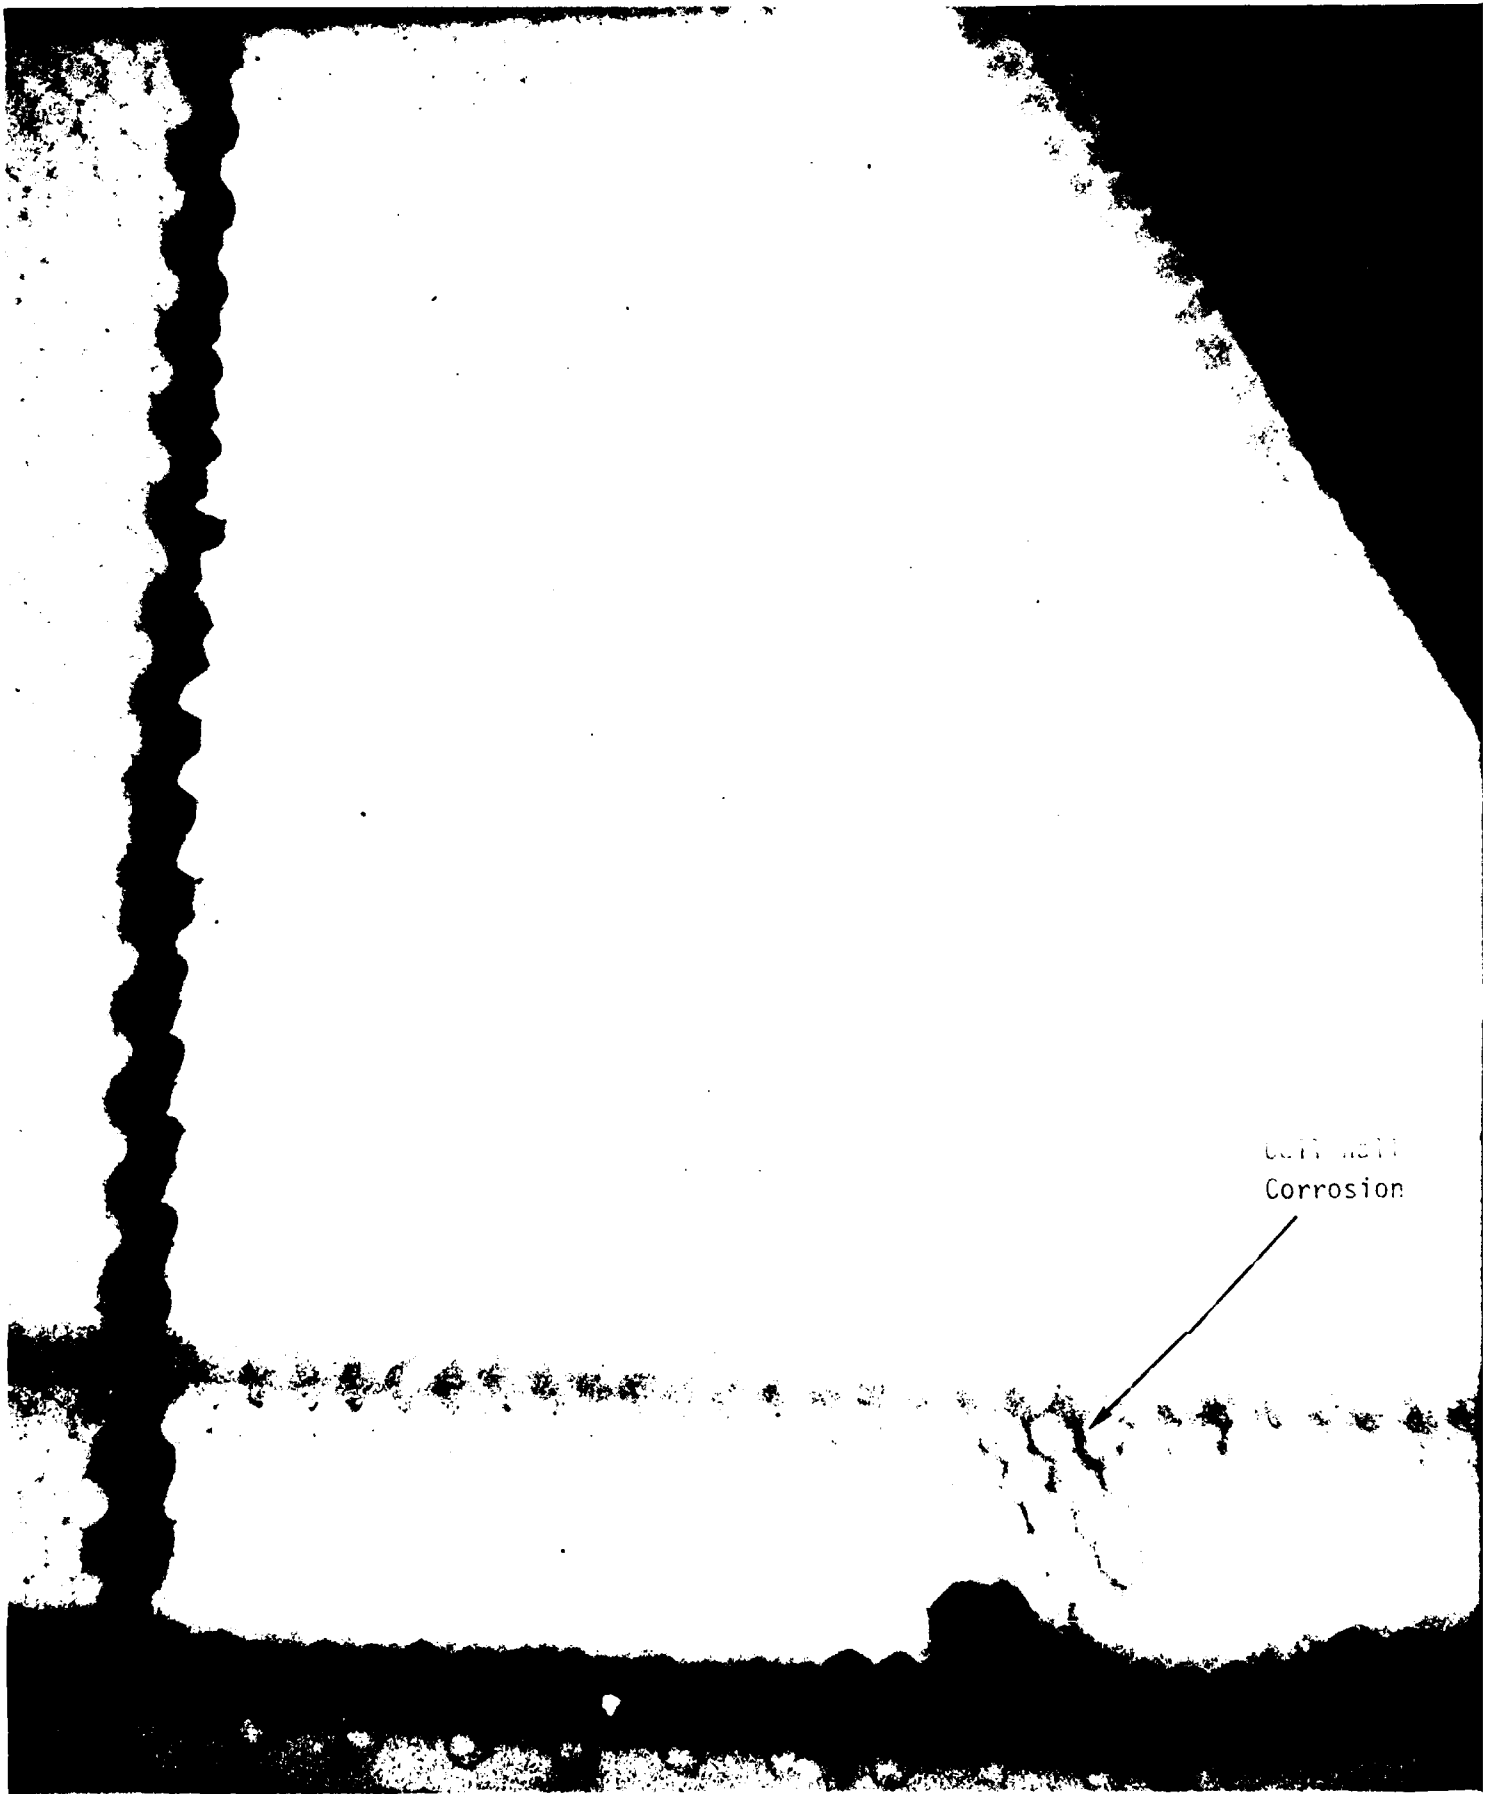
The next radiograph, Figure 49N, is the result of inspecting an F-111 horizontal stabilizer tip cap, which is shown in the photograph of Figure 50, after post-radiography removal of the skin. Prior to neutron inspection, the part was inspected by x-ray and acoustic emission, and areas of suspected moisture and corrosion as indicated by these techniques were marked on the surface of the part, as seen in the above photograph. Cell-wall corrosion is

Cell Wall
Corrosion

Figure 49N. Neutron Radiograph of F-111 Horizontal Stabilizer Tip Cap Indicating Cell Wall Corrosion

indicated in the neutron radiograph as noted by the arrow. This was verified by visual inspection after removal of the skin, as shown in the close-up photograph, Figure 51. Although acoustic emission indicated defects, x-ray inspection indicated no cell-wall corrosion.

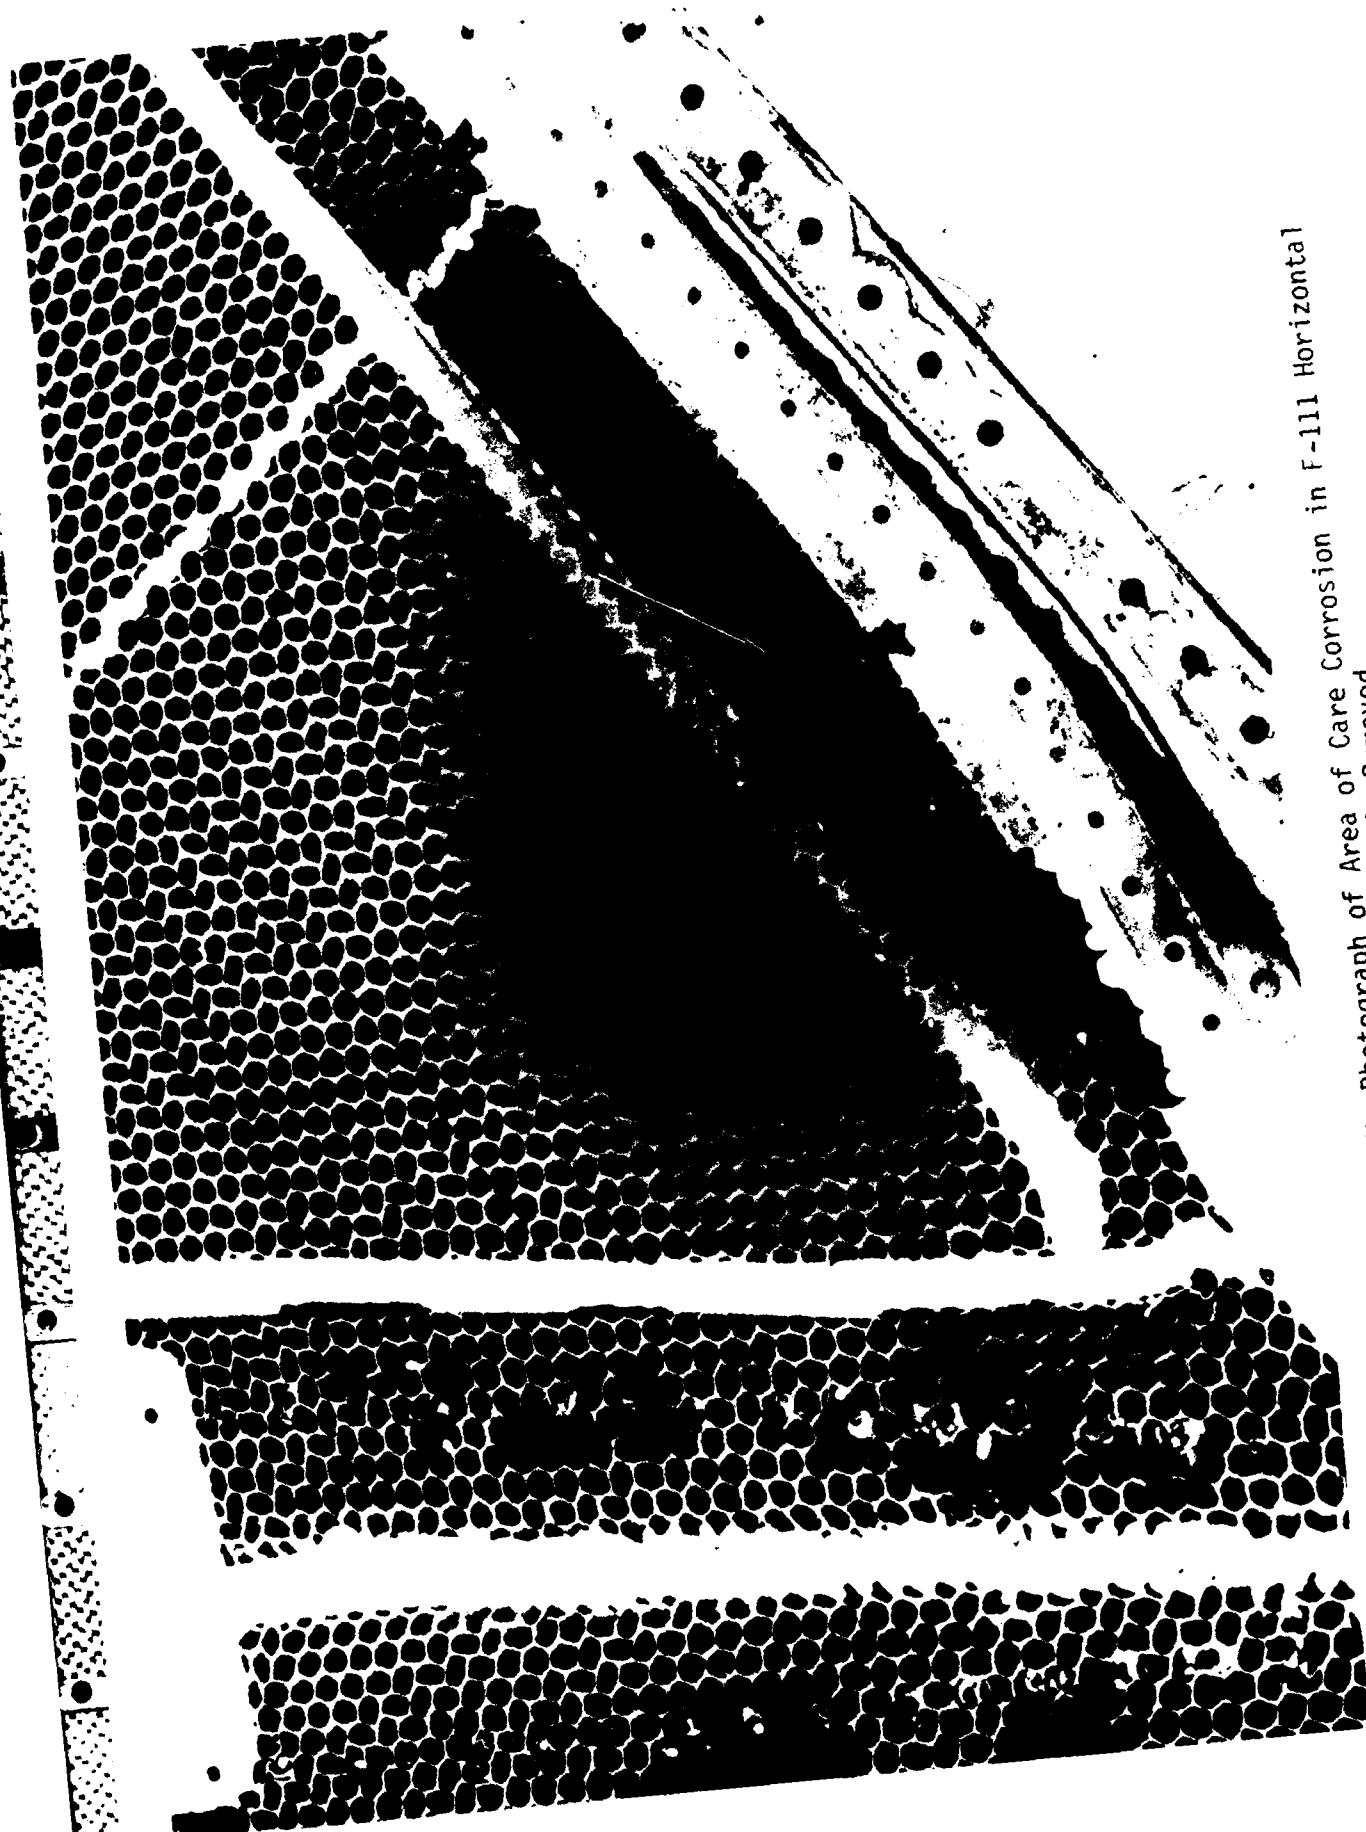
Figure 51. Close-Up Photograph of Area of Care Corrosion in F-111 Horizontal Stabilizer Tip Cap with Skin Removed

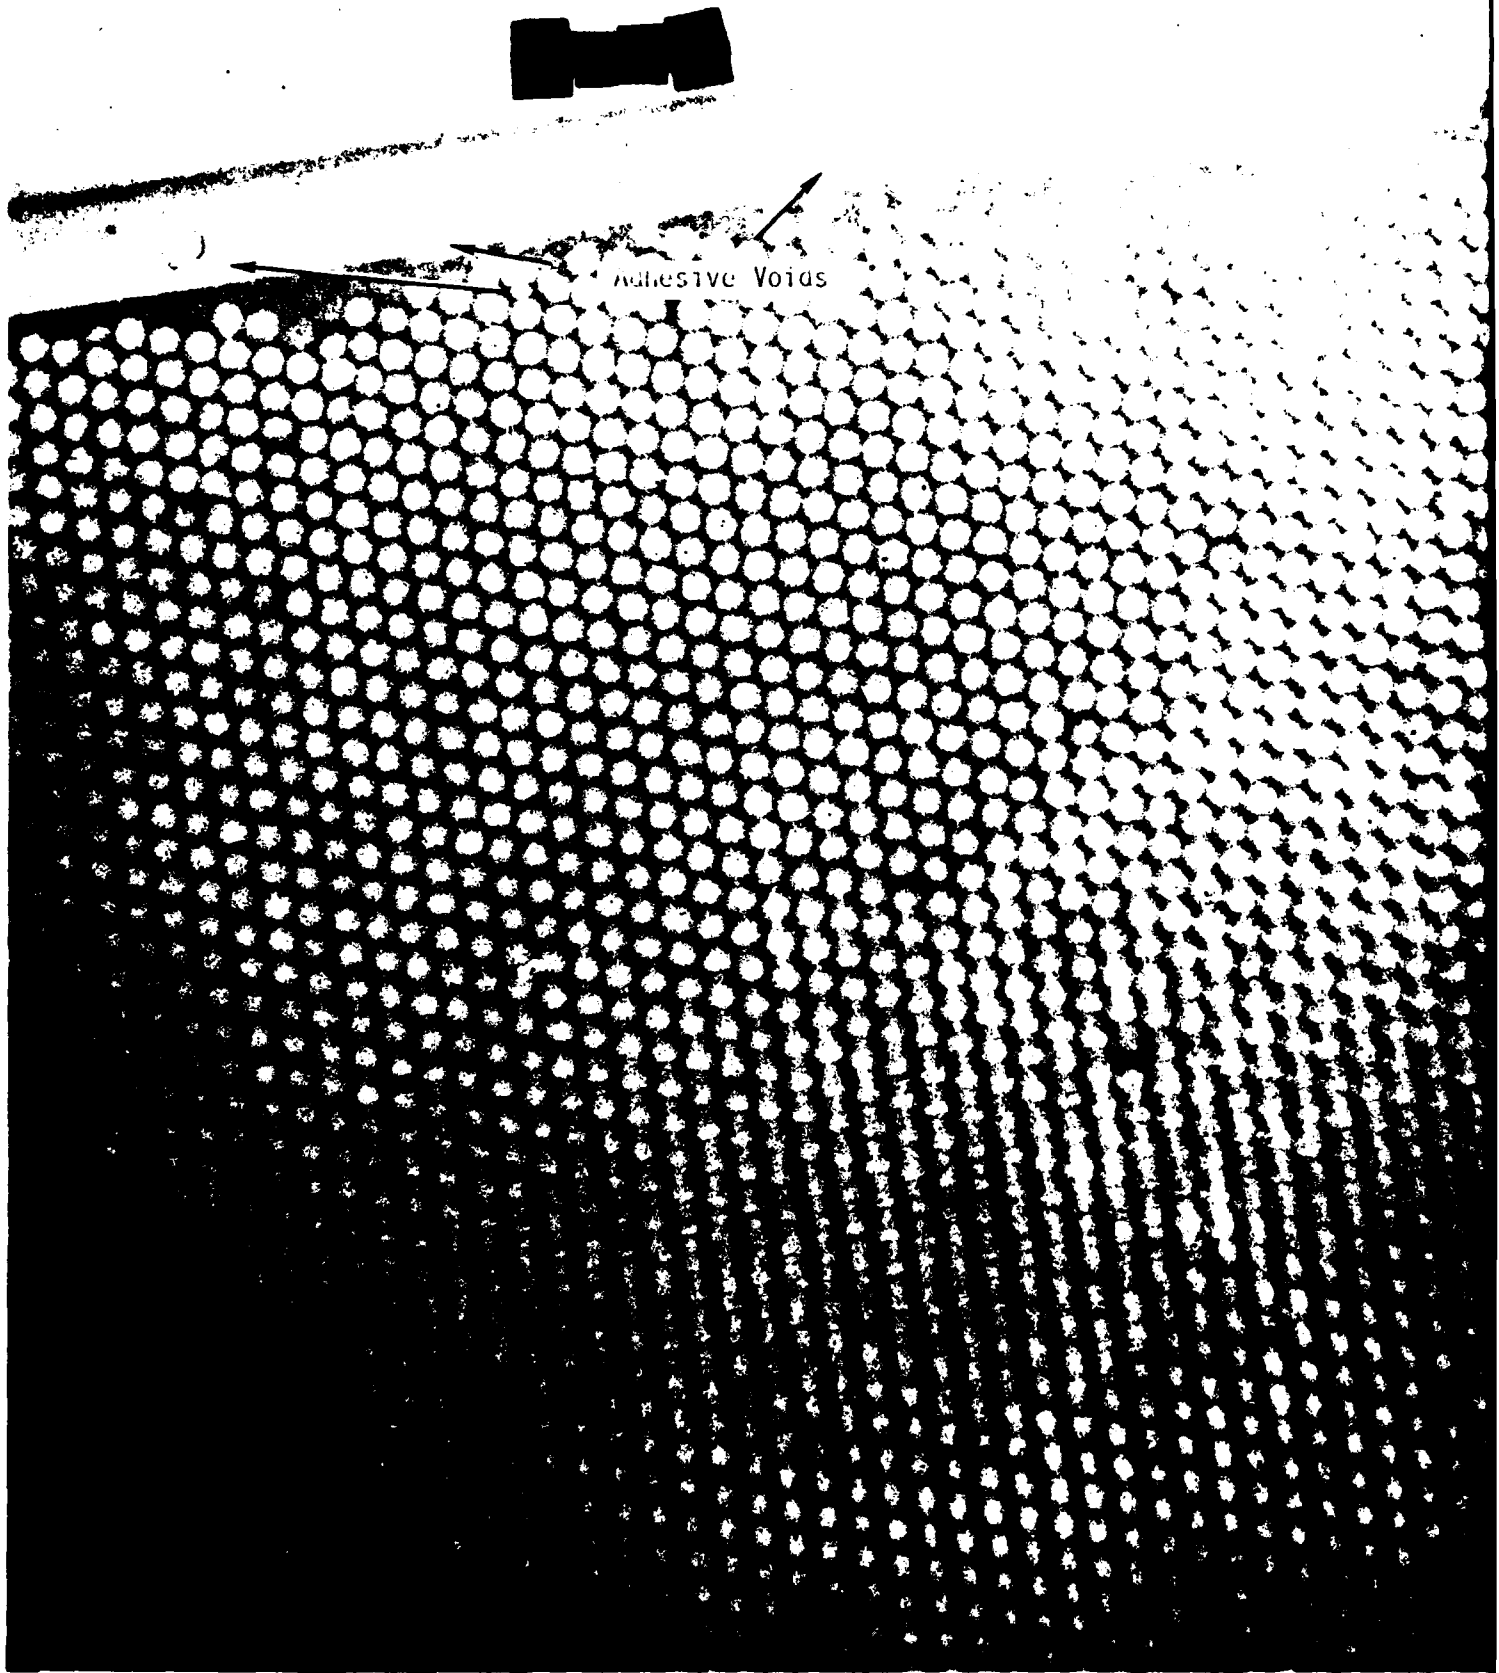
A vertical stabilizer leading edge (removed from F-111 aircraft) was also inspected. The neutron radiograph revealed "worm-hole" type voids in the adhesive at the leading edge close-out bond. This type void in the critical leading edge location is a likely area for moisture to enter the honeycomb structure. This radiograph is shown in Figure 52N.

Figure 52N. 15-Minute Neutron Radiograph of Leading Edge of F-111 Vertical Stabilizer Showing "Wormhole" Voids in Adhesive

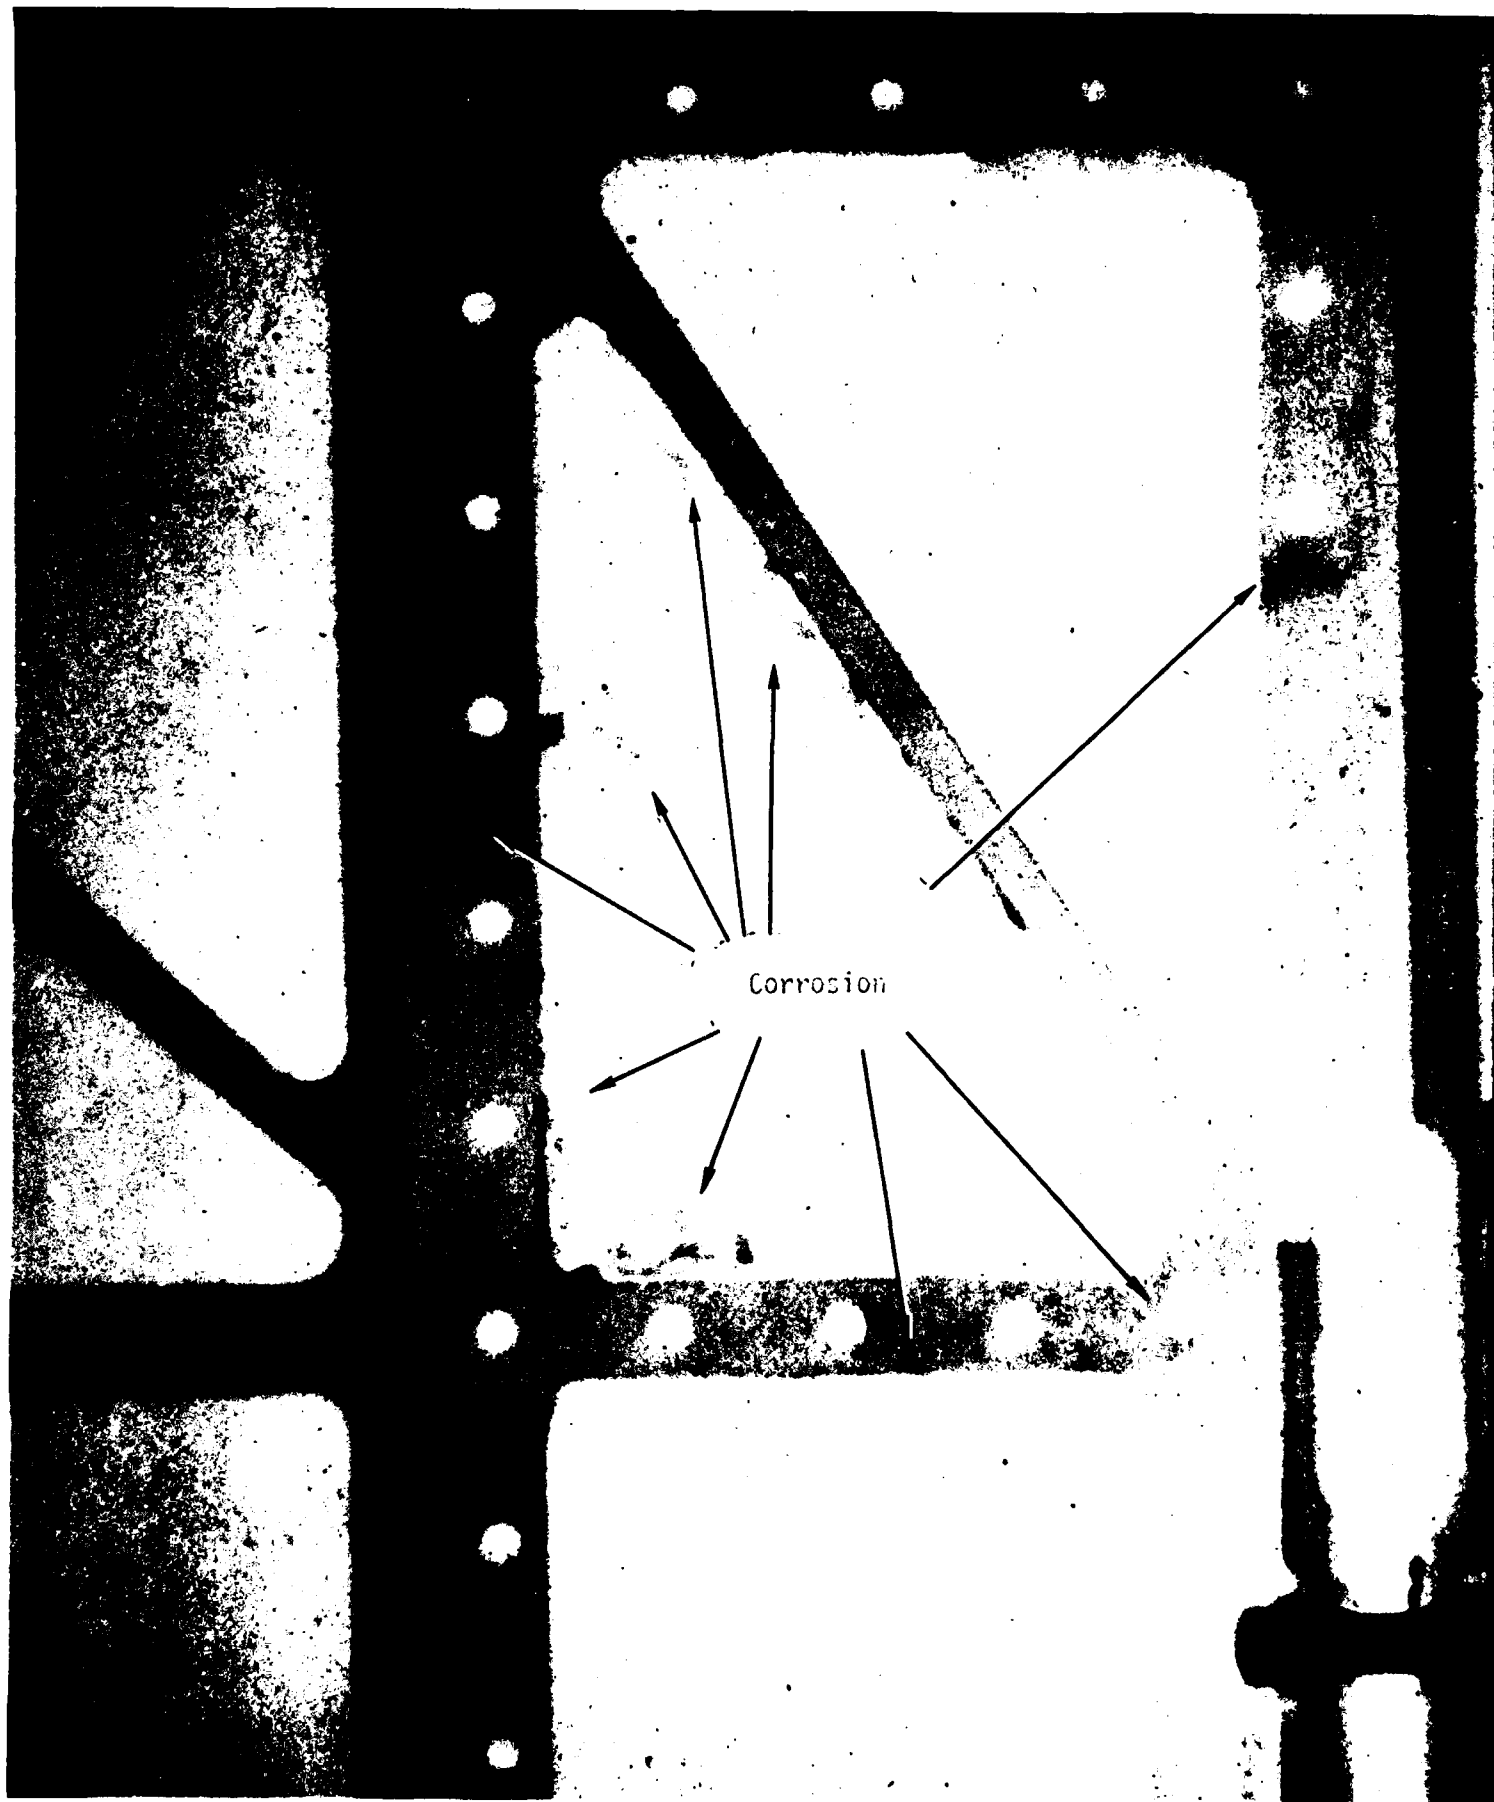
Figure 56N is the neutron image of a T-39 main landing gear door, exhibiting corrosion in the thin aluminum panel between the stiffeners, and in the stiffener itself in some areas. An x-ray of the same specimen is shown in Figure 56X. The x-ray also images the more severe areas of corrosion by indicating loss of metal in those areas and in some cases by imaging moisture.

Figure 56N. Neutron Radiograph of T-39 Main Landing Gear Door Showing Corrosion

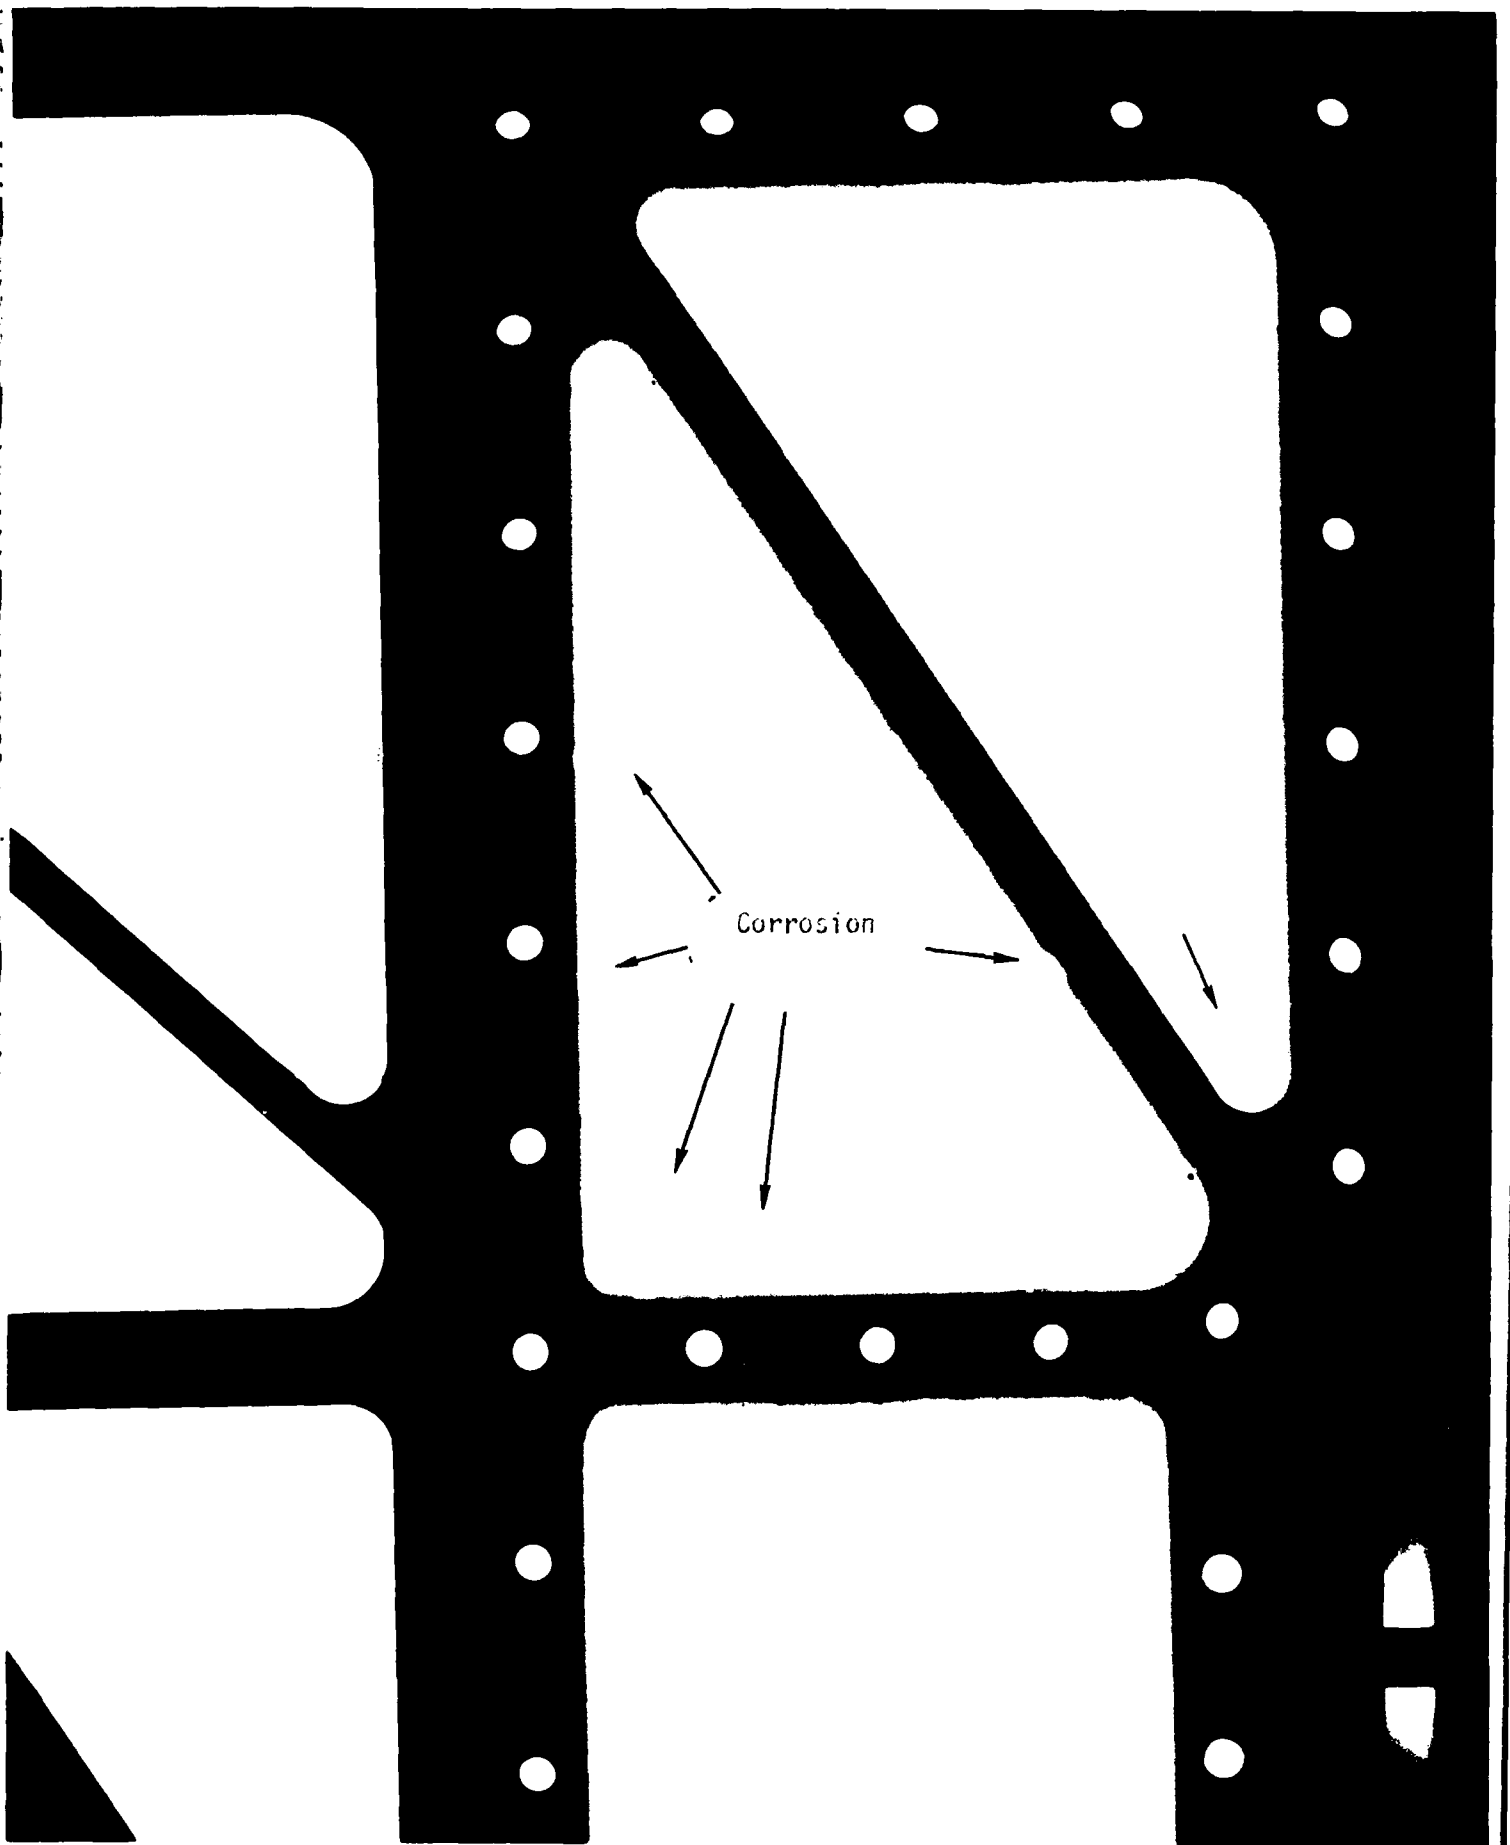
Figure 56X. X-Ray Radiograph of T-39 Main Landing Gear Door Showing Pitted Areas in Thin Webb Area
