AMMRC TR 84-39

MOBILE ACCELERATOR NEUTRON RADIOGRAPHY SYSTEM

W. E. DANCE, S. F. CAROLLO, AND H. M. BUMGARDNER
LTV AEROSPACE AND DEFENSE COMPANY
VOUGHT MISSILES AND ADVANCED PROGRAMS DIVISION
P. O. BOX 650003
DALLAS, TEXAS 75265-0003

FINAL REPORT

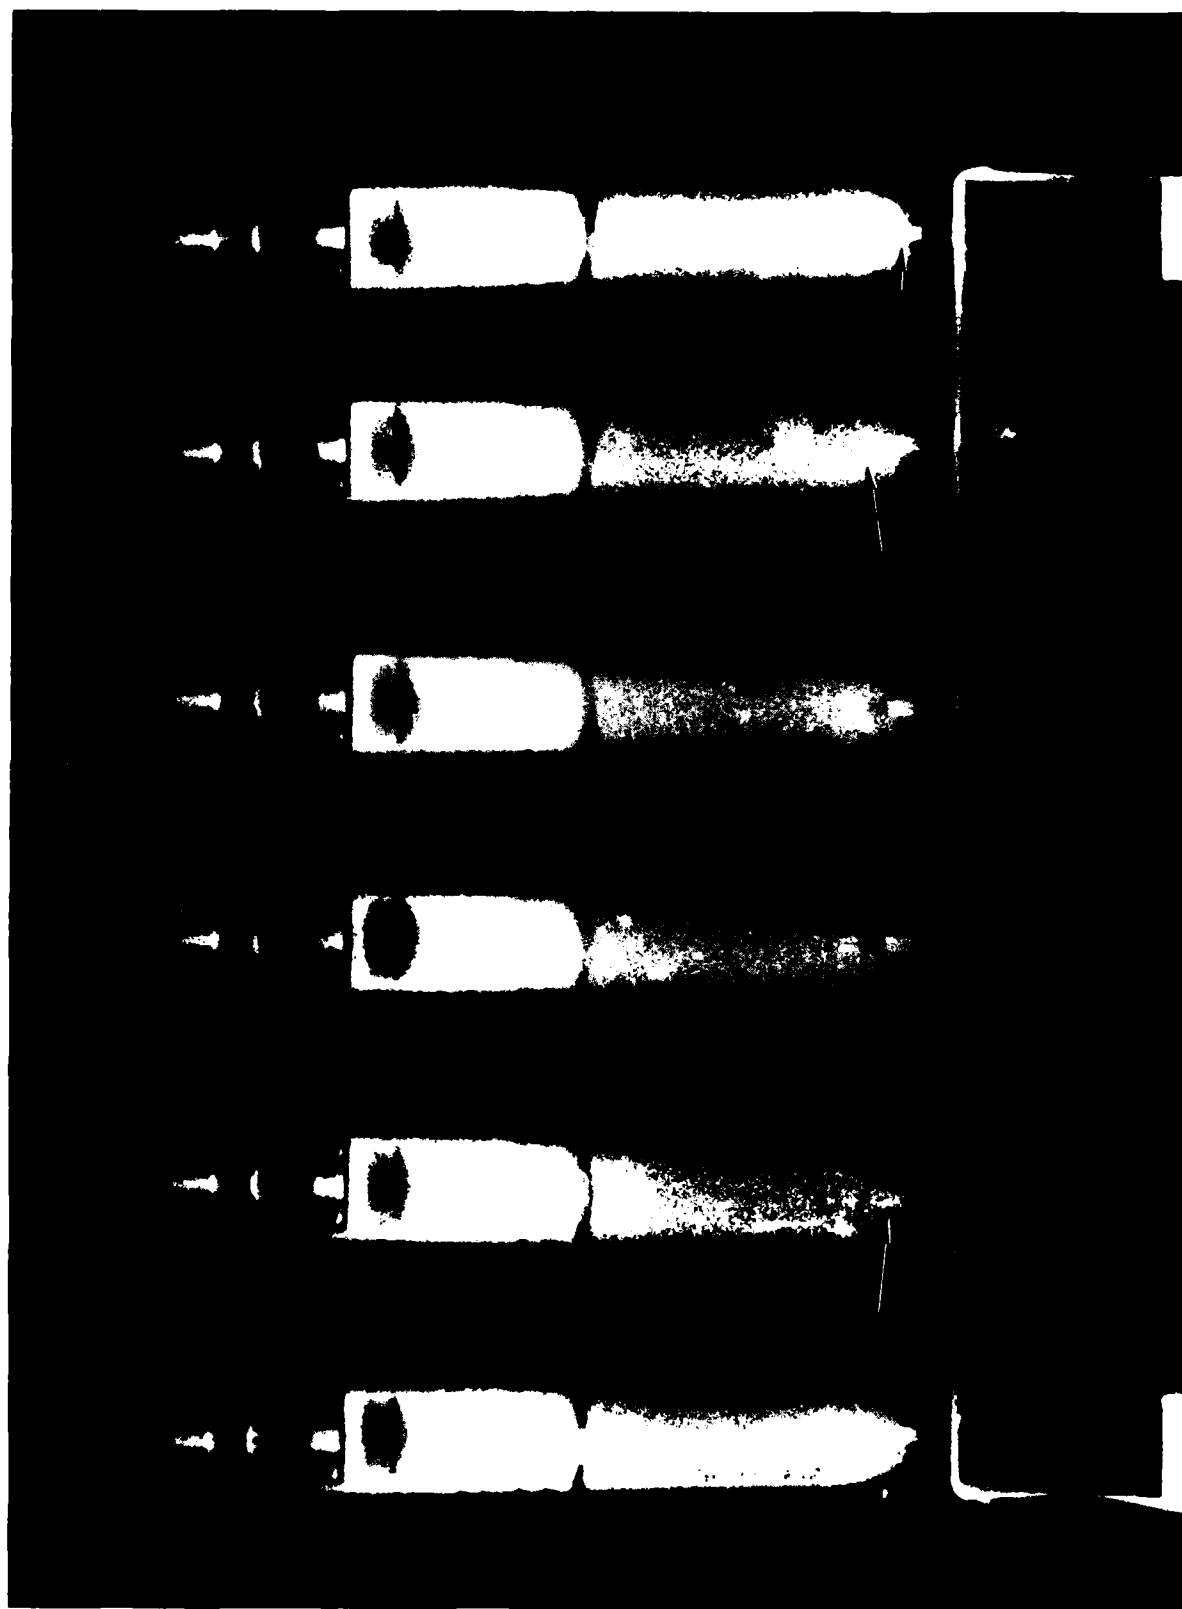
Figure 67N. Neutron Radiograph of 30 mm XM Projectiles Showing Unacceptably Random Positions of Flash Elements Along Projectile Axes (Bottom of Projectiles)
