PHASE I INVESTIGATION REPORT NATIONAL DAM INSPECTION PROGRAM

WARE INDUSTRIES MAIN (UPPER) DAM MA 00594

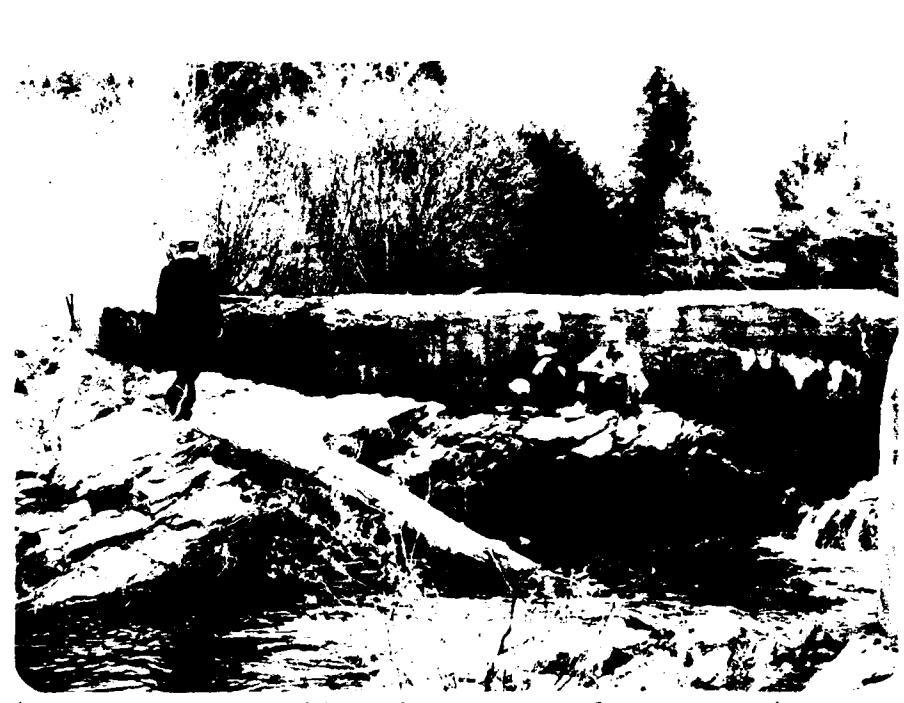
A spillway extension wall extends 50 ft. to the right from the main dam, Photo No. 4. Concrete shows considerable deterioration at the top edge and the vertical downstream face. The wall is undermined at the right end, Photo No. 5, and at the left end adjacent to the main dam, Photo No. 6. The wall exhibits cracks and efflorescence. The wall is 2 ft. wide at the top and has an upstream slope which was measured to be 2 horizontal to 1.3 vertical.

4. Downstream side of concrete dam extension

- 1. Repair the concrete surfaces on the concrete dam extension to prevent continued deterioration of this structure in the future. Loose weak concrete should be removed and the surface restored by the application of concrete mortar, shotcrete or other methods. Areas of contact with bedrock should also be restored.

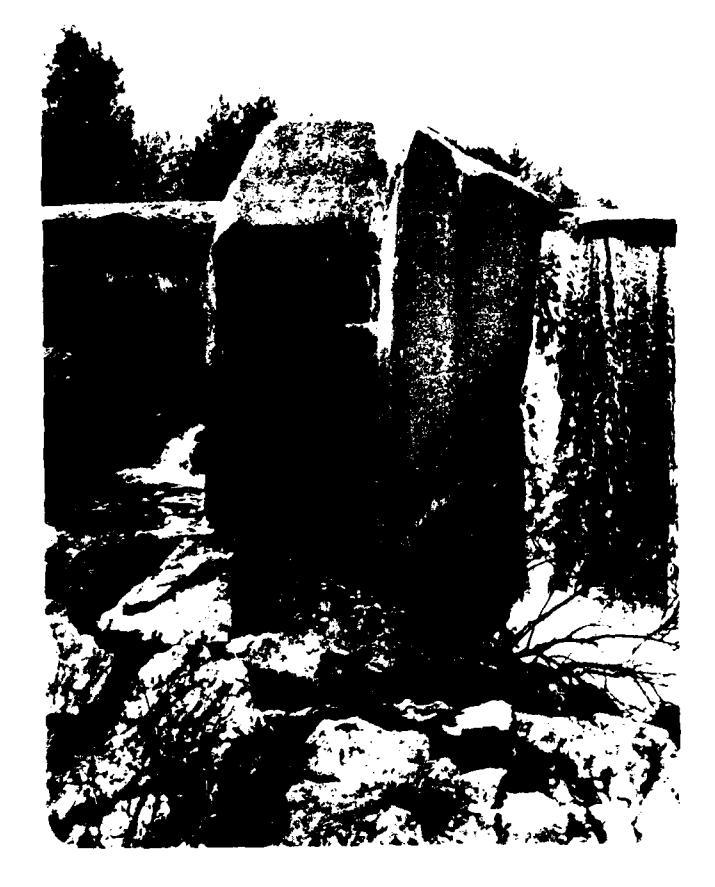
B. Dam. The view of the main dam (spillway weir) was obscured by flowing water during the inspection. The left side wall is constructed of cut granite masonry. A number of the blocks at the downstream end of this wall are loose and have fallen free, barely visible in Photo No. 2. The right wall of the main dam is constructed of concrete, Photo No. 3. The wall is undermined at the downstream end and has small spalls on the edges of the concrete, Photo No. 7.

7. Concrete pier between main dam and concrete dam extension

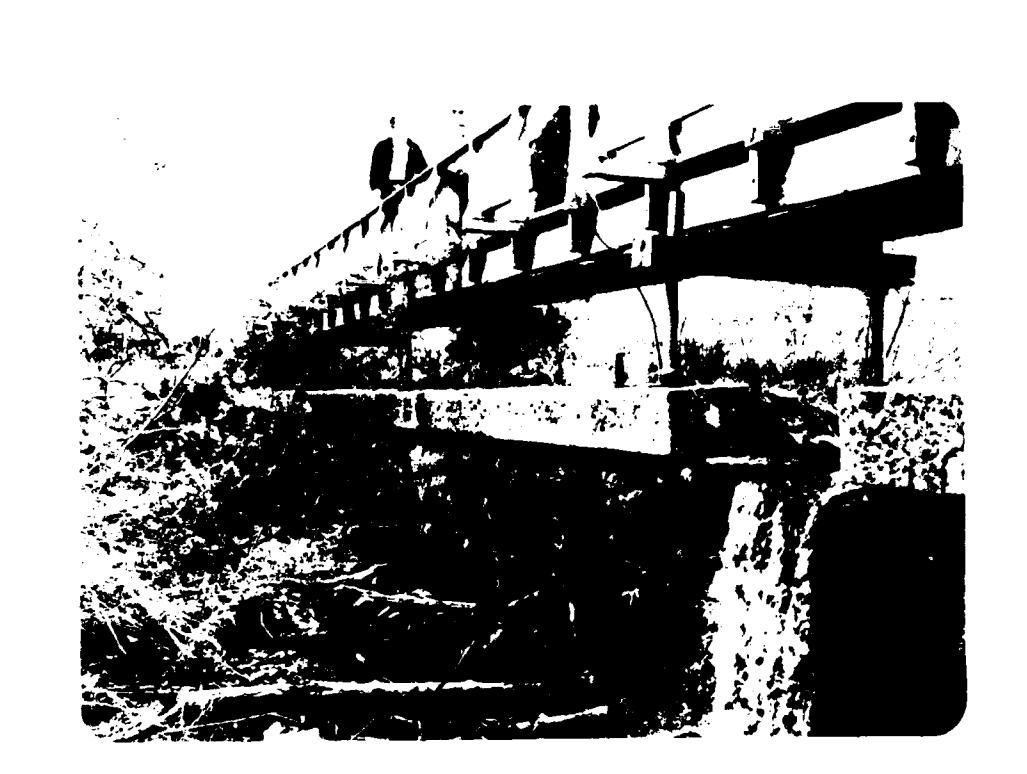
An overflow weir is present on the southeast side of the canal, allowing water to flow back into the main channel. The weir is made up of cut quarry stones for the main portion of the wall and a cut granite cap for the weir crest. One section of the cut granite cap has been removed to provide a pilot channel, Photo No. 8. Trees and brush has been cut recently downstream of the channel. They are presently piled in the channel itself. The access bridge which parallels the overflow weir is in good condition. It is of timber construction. Several of the pier caps for this bridge have cracked timbers. Conditions on the approach to the overflow weir are shown in Photo No. 9.

8. Overflow weir with wood walkway

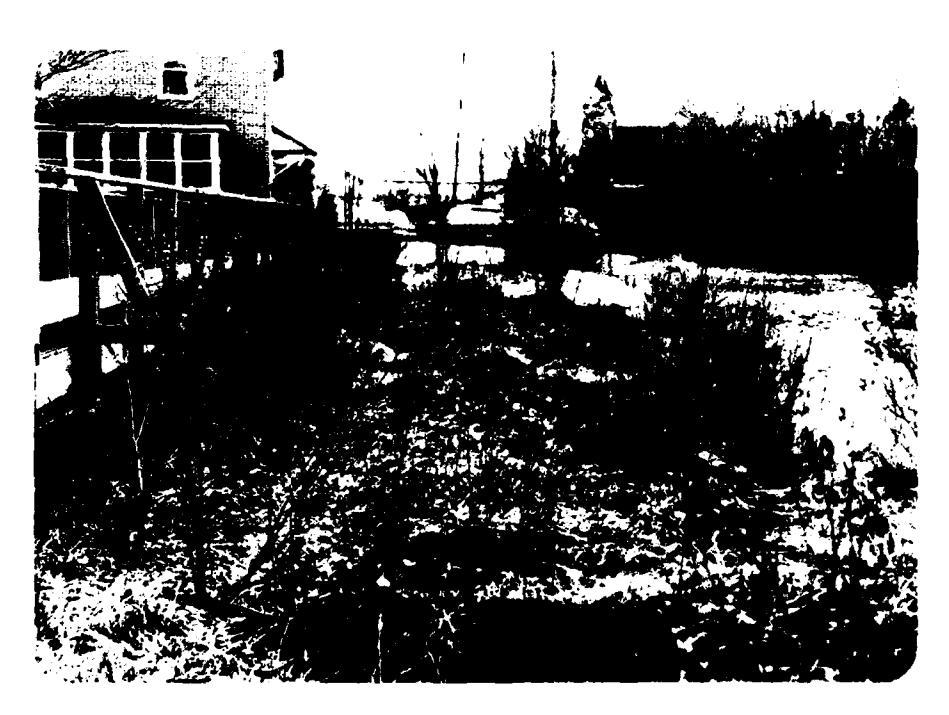
9. Approach to overflow weir from canal

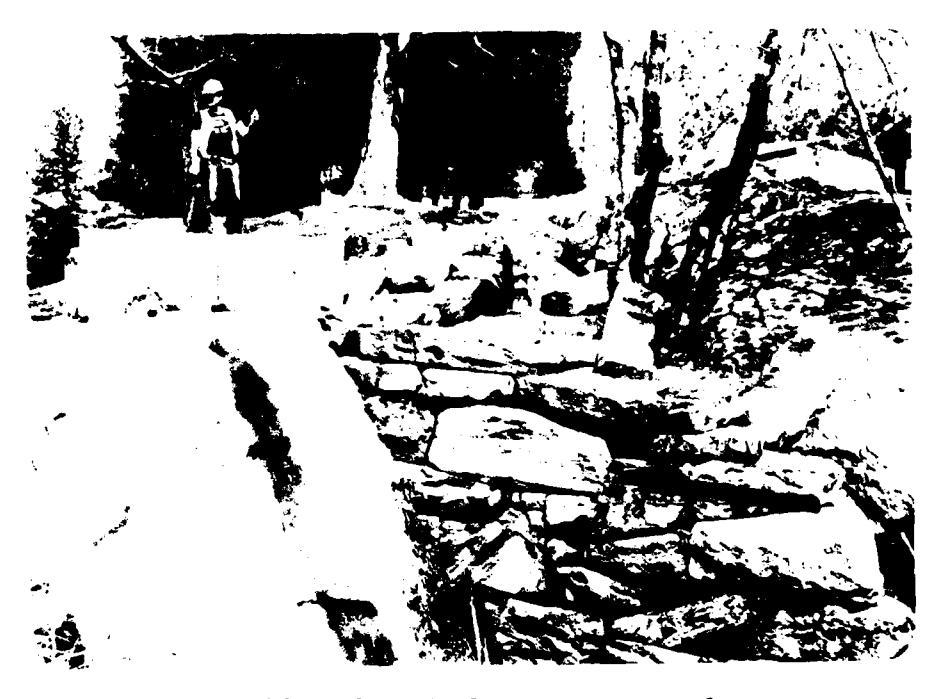
12. Stone wall below left abutment of emergency spillway
