SOMERSET RESERVOIR DAM MA 00792

MASSACHUSETTS-RHODE ISLAND COASTAL BASIN SOMERSET, MASSACHUSETTS

PHASE I INSPECTION REPORT NATIONAL DAM INSPECTION PROGRAM

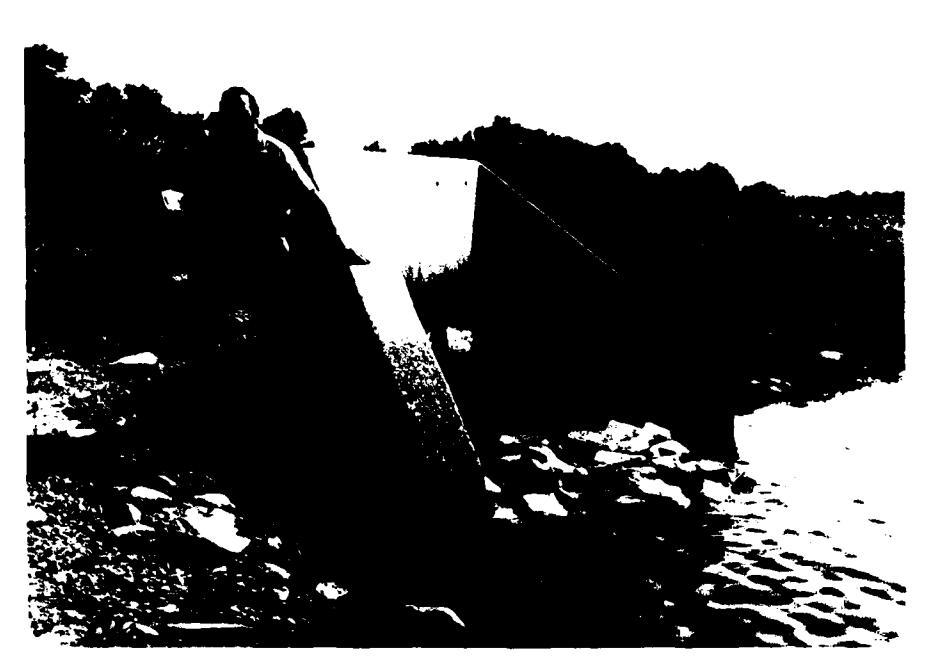
13. Outlet of 30-inch water intake from Segreganset River
