3
	MERRIMACK RIVER BASIN
	HOLDEN, MASSACHUSETTS
	QUINAPOXET RESERVOIR DAM
	MA 00929
	PHASE I INSPECTION REPORT
NAT	IONAL DAM INSPECTION PROGRAM
	JUN 2 7 1985
NEW F	DEPARTMENT OF THE ARMY ENGLAND DIVISION, CORPS OF ENGINEERS WALTHAM, MASS. 02154
	SEPTEMBER 1980
	DISTRIBUTION STATEMENT A Approved for public release; Distribution Unlimited

NATIONAL DAM INSPECTION PROGRAM PHASE I INSPECTION REPORT

QUINAPOXET RESERVOIR DAM MA 00929

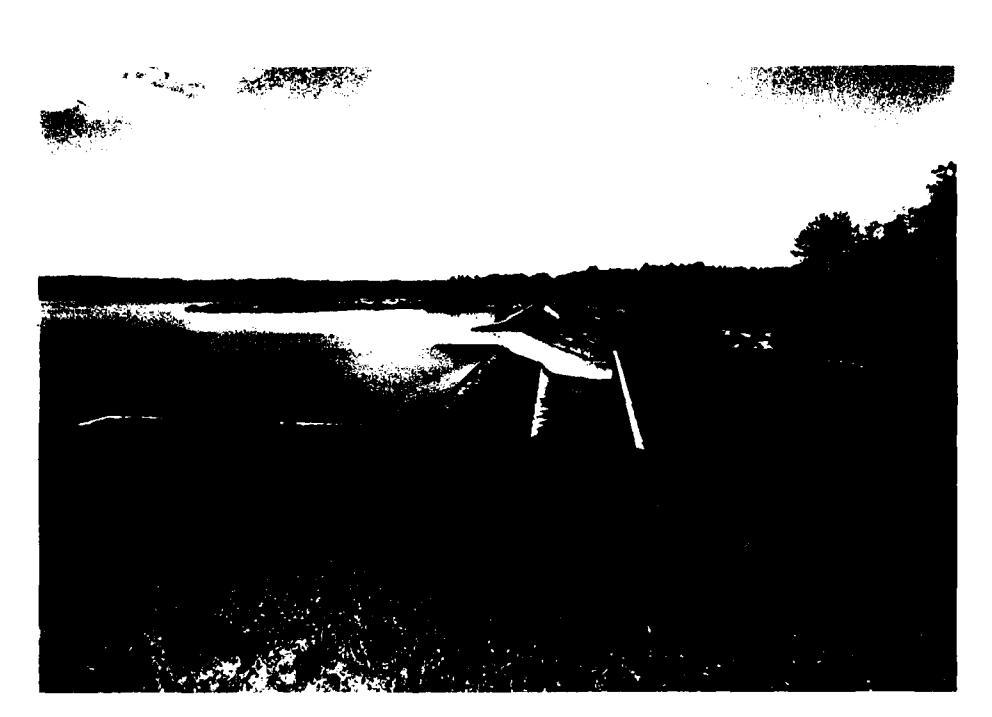
1. OVERVIEW OF DAM FROM RIGHT ABUTMENT.

- b. <u>Dam</u> The dam and spillway, Photos 1, 8 and 9 appear to be in generally good condition, based on the visual site examination. No evidence of embankment settlement, lateral movement or other major deficiencies was observed. The following specific items were noted:

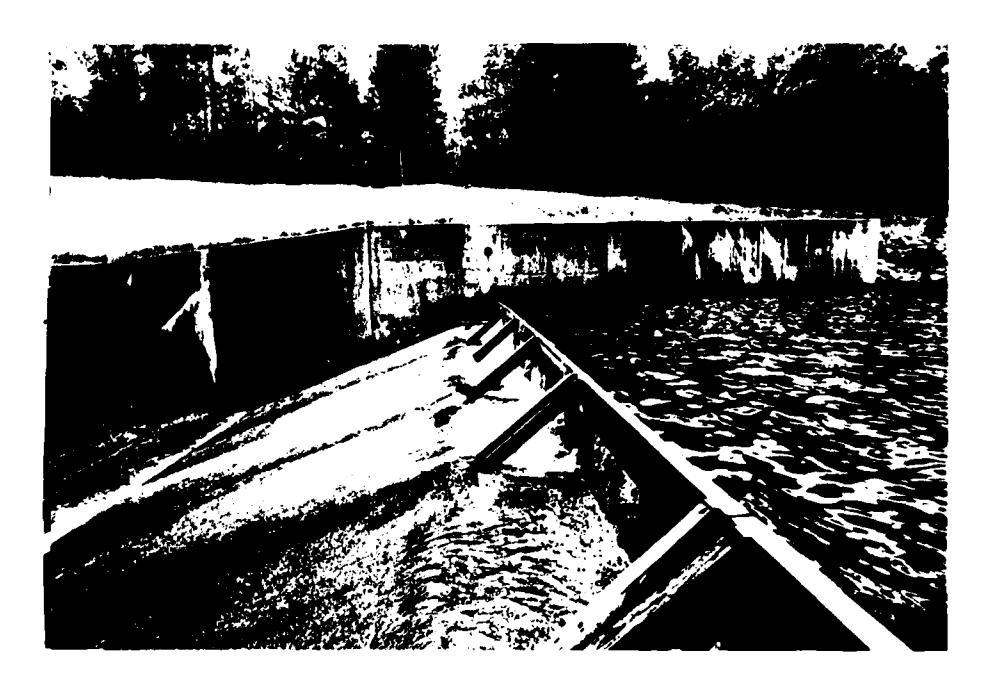
- (6) The side wall joint immediately downstream of the spillway weir at its right end is exhibiting structural distress in the form of cracking, as shown in Photo 6. The sealant at other joints in the spillway side channel, chute and stilling basin is in need of renewal.

6. VIEW OF RIGHT SIDE OF SPILLWAY.

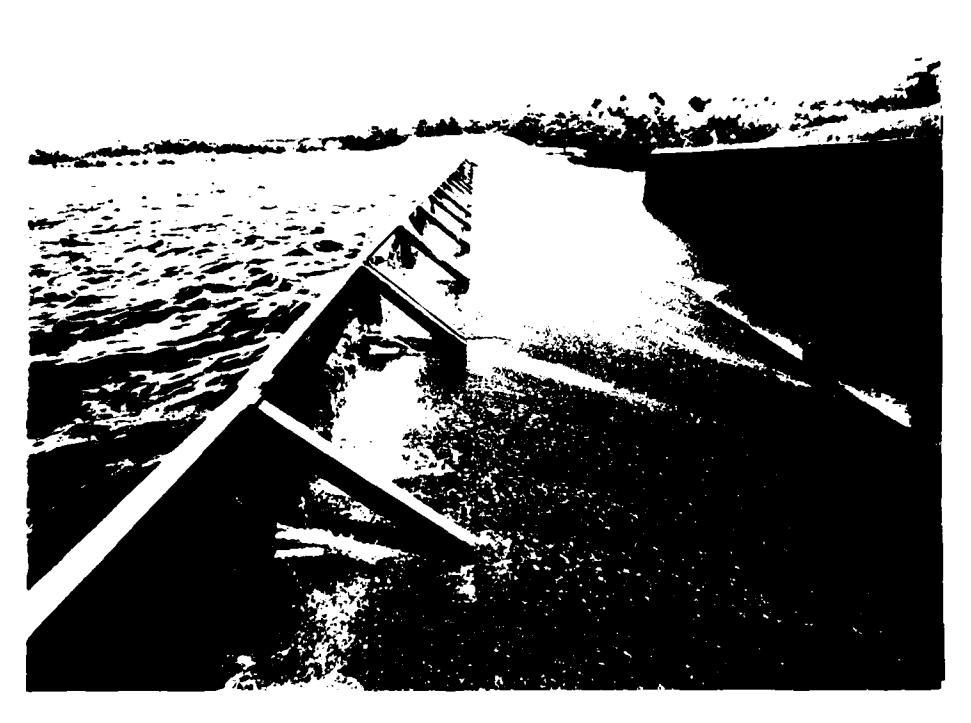
- (4) No piezometers were found on the dam embankment.
 - (5) One of the flashboard braces near the right end of the spillway is missing as shown in the foreground of Photo 7.

7. VIEW OF SPILLWAY AND SPILLWAY LEFT ABUTMENT.

- (2) Periodic readings should be made on any piezometers that can be restored. This data would provide a useful check of embankment and drainage system performance.
- (3) Replace the missing flashboard brace near the right end of the spillway weir.
- (4) Repair the cracked wall joint immediately downstream of the right end of the spillway weir and reseal other joints in the spillway, chute and stilling basin walls.
- (5) Establish a formal maintenance program and operational procedures for the dam.
- (6) Prepare a formal emergency procedures plan and warning system in cooperation with downstream officials and institute a program of biennial technical inspections.
- 7.4 <u>Alternatives</u> There are no practical alternatives recommended.

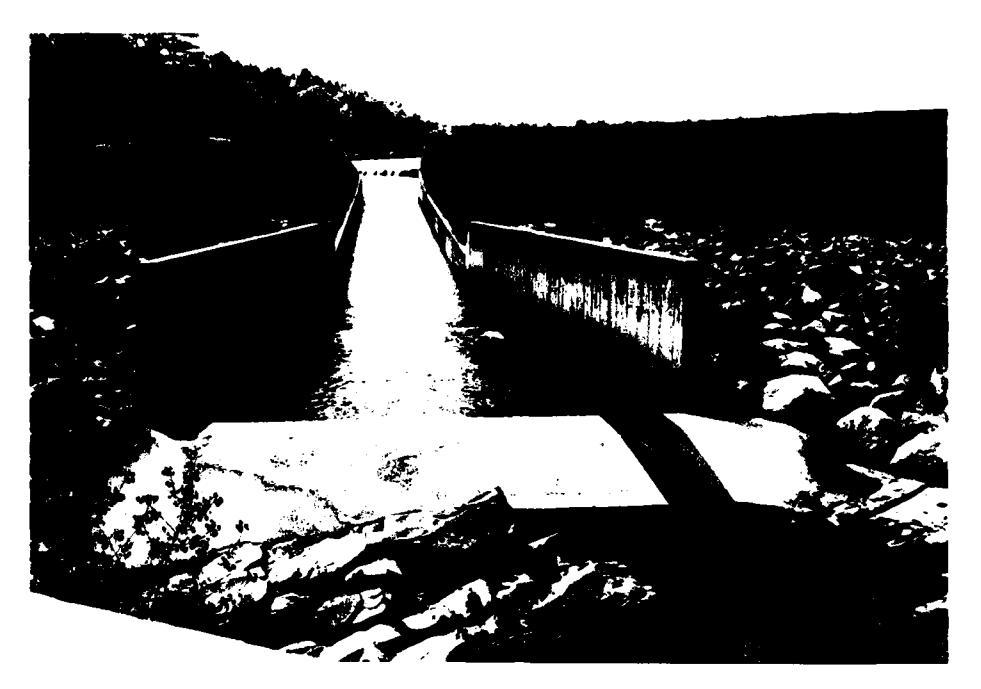
9. VIEW OF SPILLWAY DOWNSTREAM CHANNEL FROM PRINCETON STREET BRIDGE. NOTE SILL AND V-NOTCH DRAIN IN FOREGROUND.

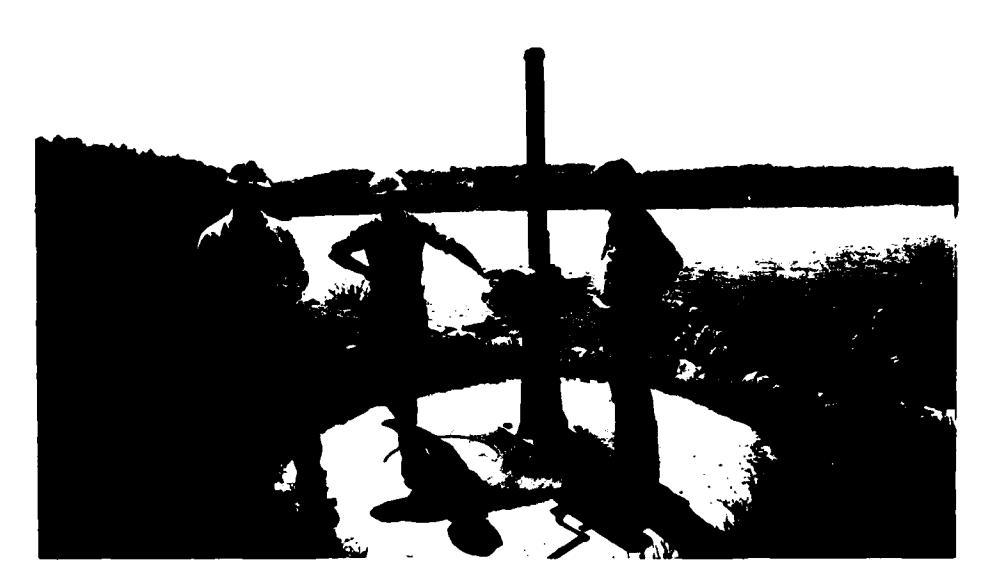
- c. Appurtenant Structures
 - (1) The outlet works is in good condition. The sluice gate was opened slightly during the site examination and then closed as shown in Photos 11 and 12.
 - (2) The dike is also in good condition with no observed evidence of embankment settlement, lateral movement or other major deficiencies. The dike however is covered by tall grass, weeds and a significant amount of brush and small trees as shown in Photos 13 and 14.
- d. <u>Reservoir area</u> The Quinapoxet Reservoir is surrounded by moderately sloped hills which are heavily forested. The shore line of the pond is undeveloped and no structures would be affected by the test flood surcharge.

11. RESERVOIR DRAIN GATE OPERATOR ON DAM CREST. PUMP HOUSE IS VISIBLE ON FAR SIDE OF RESERVOIR.

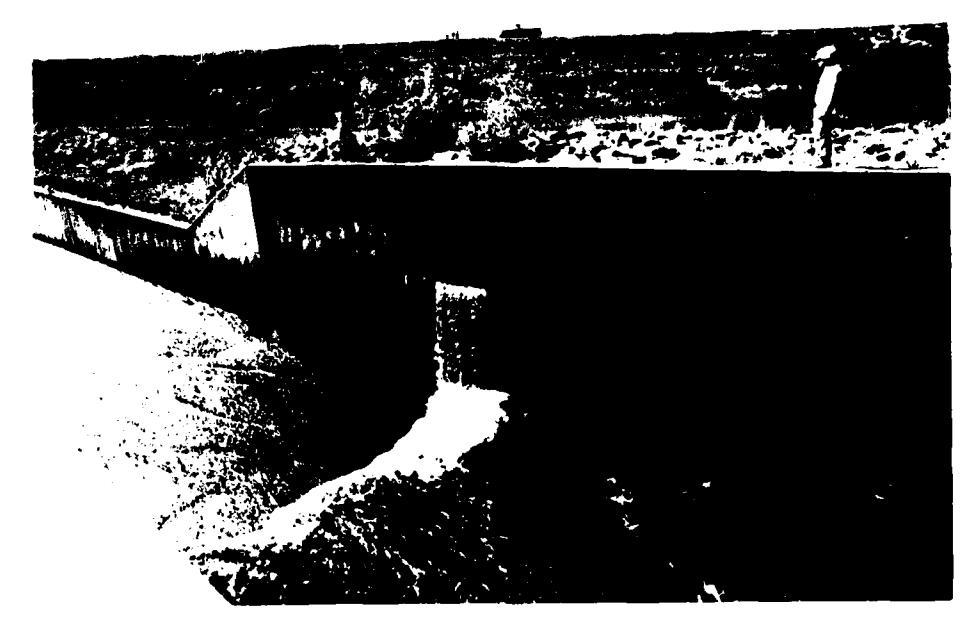
12. PHOTO OF RESERVOIR DRAIN OUTLET AT SPILLWAY CHANNEL. STILLING BASIN TAKEN DURING TEST OPERATION OF DRAIN.
