Inclosed is a copy of the Rochester Reservoir Dam Phase I Inspection Report, which was prepared under the National Program for Inspection of Non-Federal Dams. This report is presented for your use and is based upon a visual inspection, a review of the past performance and a brief hydrological study of the dam. A brief assessment is included at the beginning of the report. I have approved the report and support the findings and recommendations described in Section 7 and ask that you keep me informed of the actions taken to implement them. This follow-up action is a vitally important part of this program.

As a result of the visual inspection of this facility, the dam is considered to be in POOR condition. Major concerns are: major active seepage at the downstream toe of the right section of the dam embankment; wet areas at several locations near the downstream toe of both sections of the dam embankment; water lines under continuous pressure beneath the left section of the dam embankment; stumps of recently cut large trees and their associated root systems on the crest of the dam embankment; extensive brush and small trees growing on the downstream slope of the dam embankment; minor

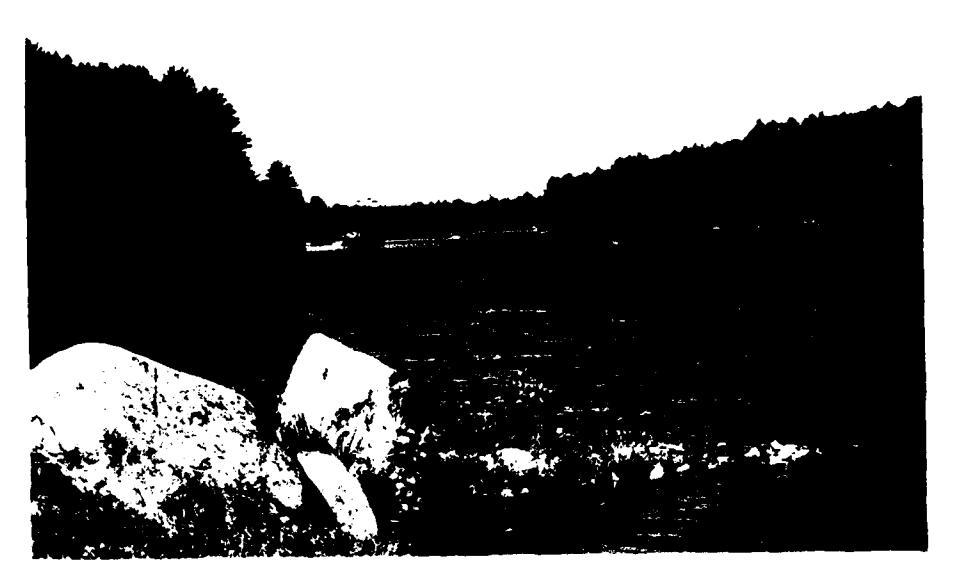
Photo No. 1 - General view of reservoir from center of dam.
