MERRIMACK RIVER BASIN Ashland, New Hampshire

# SQUAM LAKE DAM NH 00059

# PHASE I INSPECTION REPORT NATIONAL DAM INSPECTION PROGRAM

# MERRIMACK RIVER BASIN ASHLAND, NEW HAMPSHIRE

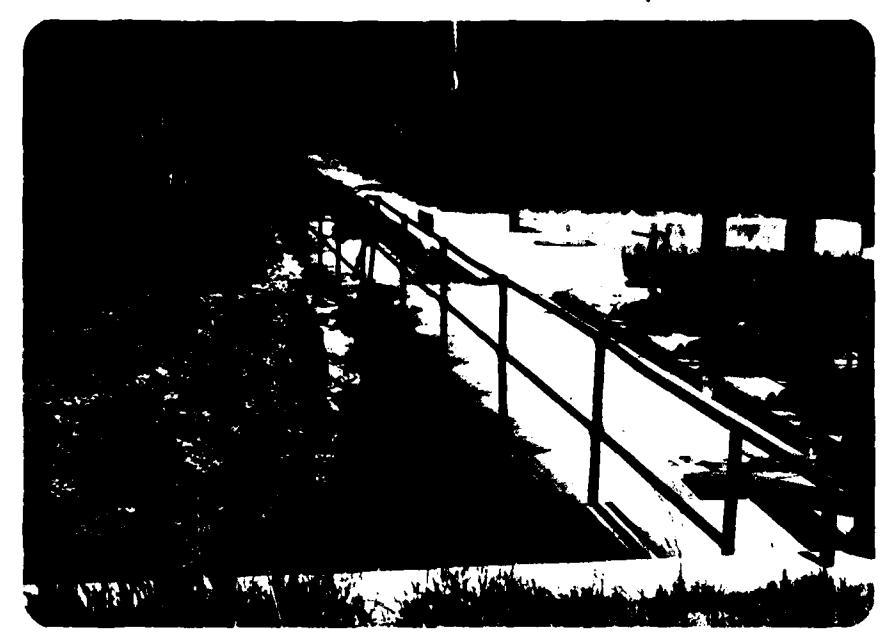
Photo 1 - View of the dam takenfrom the left abutment, looking toward the right abutment. The spillway section is in the foreground, showing the sluice gate hoists and the stems of sluice gates. The right abutment non-overflow section is in the foreground.

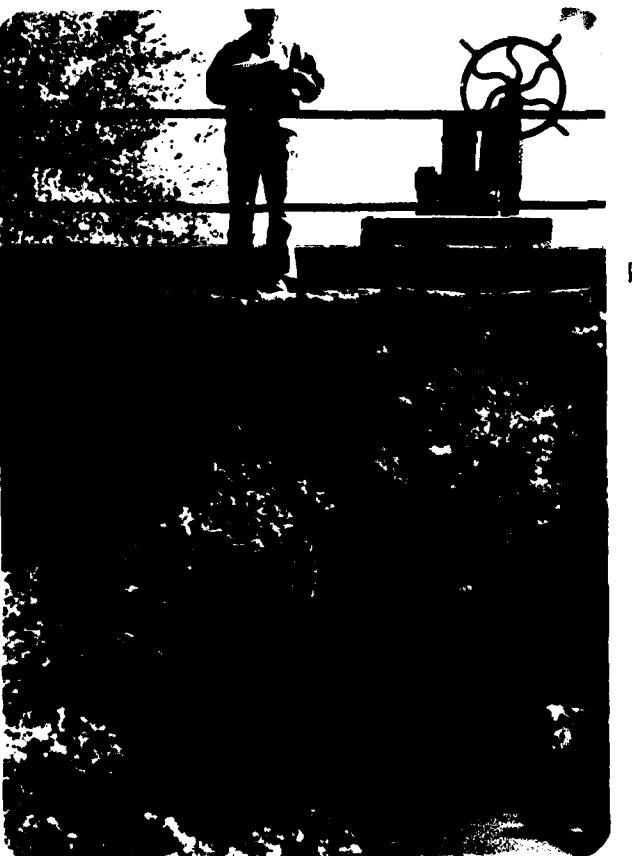
(2) <u>66-inch Diameter Penstock through the Right Non-overflow</u> <u>Section of the Dam</u>. This abandoned and cutoff penstock at one time led to a mill situated immediately downstream of the dam. On the upstream face of the dam, a manually operated sluice gate seals the entrance to the penstock. This gate is no longer used and is simply left in the closed position. There was no discernible leakage coming from the open end of the penstock. This gate should either be repaired as necessary for use as an additional low level outlet or dismantled and the penstock permanently sealed. Plans for permanently sealing this penstock are in the files of the NH-WRB, but as far as could be determined, this modification was not carried out.

Photo 2 - View of the right abutment non-overflow section from downstream. The original masonry wall is visible in front and the new concrete parapet wall is in the background. The 66-in. diameter abandoned penstock and its gate hoist are visible at the picture's right.

VISUAL EXAMINATION OF	OBSERVATIONS	REMARKS AND RECOMMENDATIONS
SEEPAGE OR LEAKAGE	No leakage or seepage was observed.	
STRUCTURE TO ABUTMENT/EMBANKMENT JUNCTIONS	On the right abutment, the existing gravity wall has been raised 18 in.± by the addition of a concrete parapet which runs into the hillside. On the left abutment, the existing masonry has been capped with new concrete walls, parapets and a concrete cutoff wall running up to River Road.Condition of junction considered good.	
DRAINS	No drains were visible.	
WATER PASSAGES	Three 4.0 ft. wide x 4.5 ft. high bottom outlets are built into the overflow section. Controls are timber gates, hoist operated. A 66-inch diameter old penstock on the right abutment is in a closed position and not used. A 30-in. diameter penstock passes through the left non- overflow section. The pipe is squashed downstream.	Permanently plug 66-inch diameter abandoned penstock.

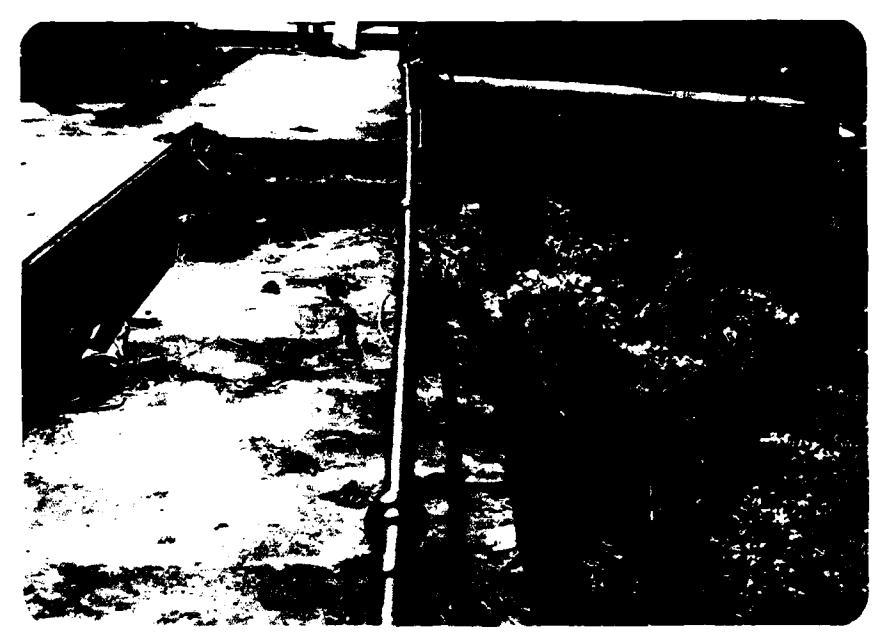
Photo 3 - View of the dam from the right abutment showing old and new non-overflow sections and the relation to the spillway walkway elevation.
