268 CONNECTICUT RIVER BASIN AD-A156 CLAREMONT, NEW HAMPSHIRE CLAREMONT PAPER COMPANY DAM NH 00139 STATE NO 47.06 PHASE I INSPECTION REPORT NATIONAL DAM INSPECTION PROGRAM JUL 0 8 1985 FILE COPY G DEPARTMENT OF THE ARMY **NEW ENGLAND DIVISION, CORPS OF ENGINEERS** WALTHAM, MASS. 02154 A TUTTE a talease; Approvi FEBRUARY 1979 Dist 85 06 12 013

NATIONAL DAM INSPECTION PROGRAM PHASE I INSPECTION REPORT

Identification No.:NH00139Name of Dam:Claremont Paper Company DamCity:ClaremontCounty and State:Sullivan County, New HampshireRiver:Sugar RiverDate of Inspection:November 21, 1978

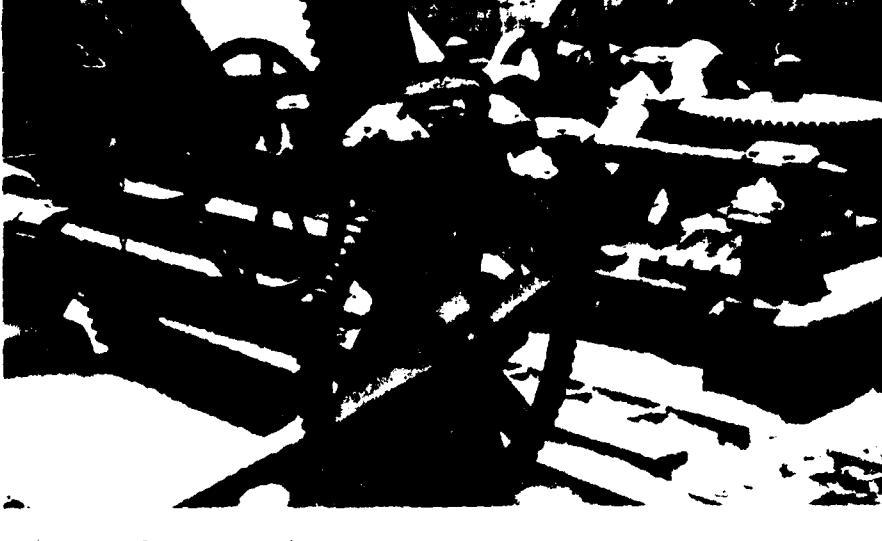
The gate mechanisms were covered with ice and snow but appeared to be in good condition. (See Appendix C - Figure 5.) The trash gate is mechanically operated by a wheel. The lowlevel sluice gate is electrically operated and the motor was in good condition.

Figure 5 - Looking at the gate mechanisms on the service bridge.
