## RYEGATE PAPER COMPANY DAM NH 00014

# PHASE I INSPECTION REPORT NATIONAL DAM INSPECTION PROGRAM

DEPARTMENT OF THE ARMY NEW ENGLAND DIVISION, CORPS OF ENGINEERS WALTHAM, MASS. 02154

JUNE 1979

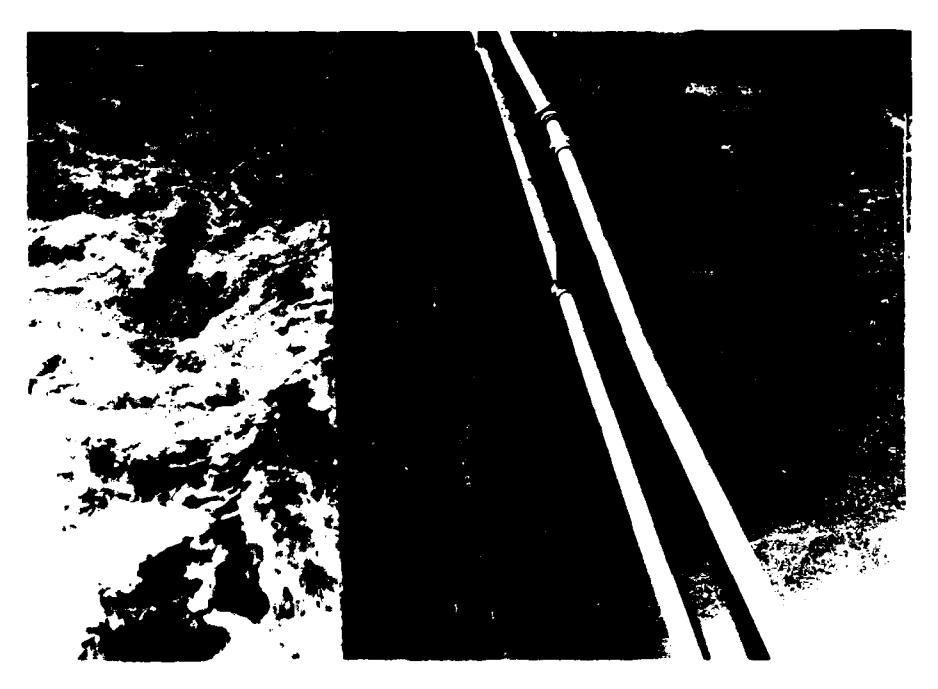
The training wall was observed to be in fair condition. All sides of the wall revealed some surface deterioration to a maximum depth of six inches. (See Appendix C-Figure 6.) A hairline crack was noticed at the center of the wall and having an east-west orientation approximately opposite the crest of the dam. (See Appendix C-Figure 7.) Considerable efflorescence was observed on the sides of the wall at cracks. (See Appendix C-Figure 6.) Also rust staining was observed at embedded steel items.

(3) The deteriorated condition of the training wall.

Figure 6 - View of the surface deterioration of the training wall.

(2) Investigate, design, and construct repairs to correct the deteriorated protions of the training wall.

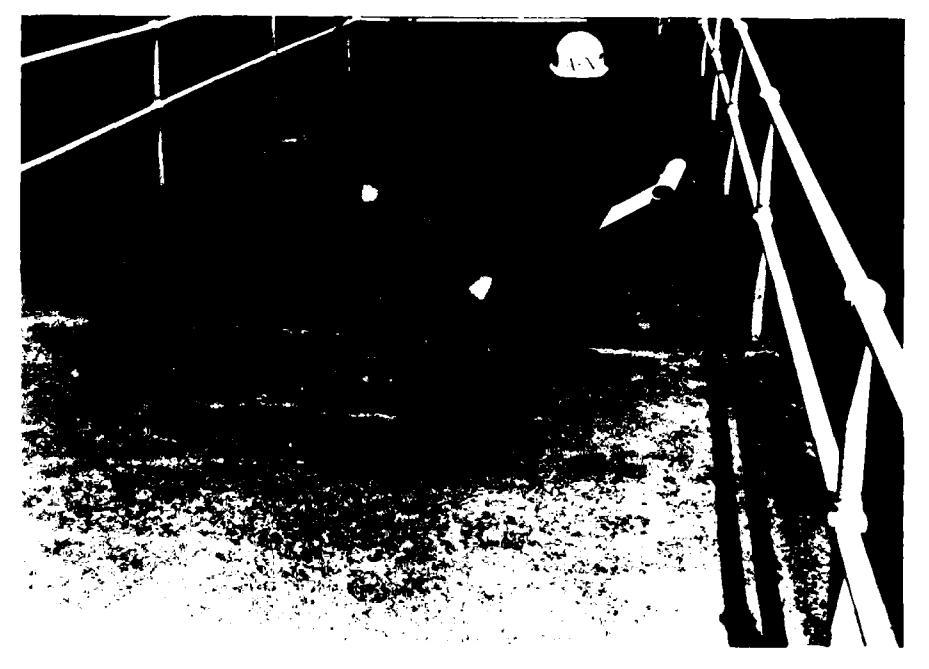
Figure 7 - Looking at the transverse crack in the center of the training wall.

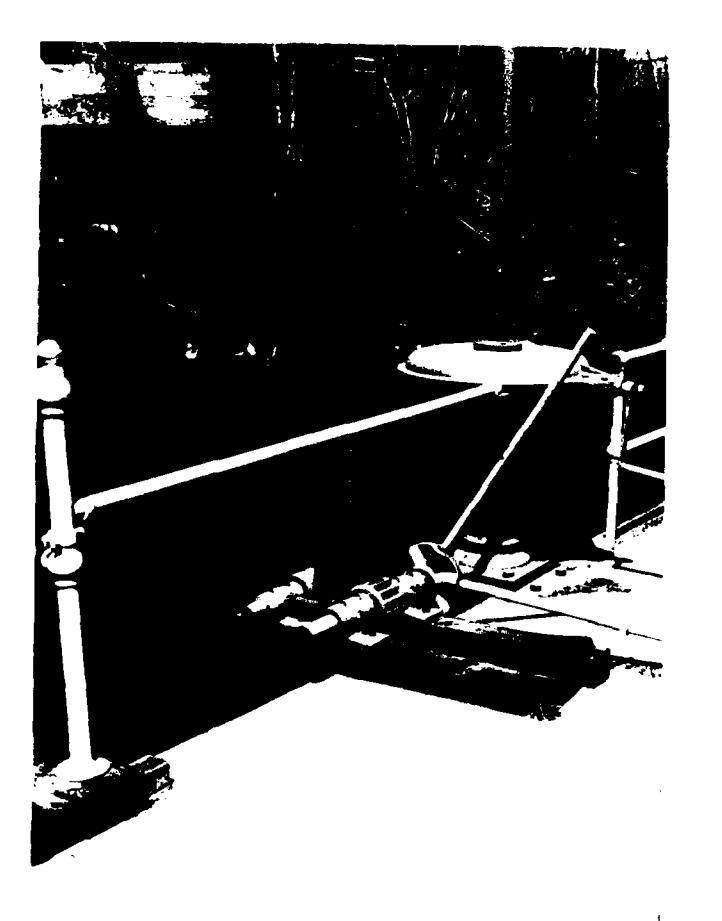
Figure 9 - Looking at the gate mechanisms which control the high-level and low-level gates.
