4. TITLE (and Sublilio)	S. TYPE OF REPORT & PERIOD COVERED
	INSPECTION REPORT
Pierce Power Dam	
NATIONAL PROGRAM FOR INSPECTION OF NON-FED	ERAL 6. PERFORMING ORG. REPORT NUMBER

• The dam has a hydraulic height of 28 ft. and is 420 ft. long. It is a run of the river, concrete counterfort combined with a concrete gravity dam. The dam is in poor condition with some major concerns. It is small in size with a sig- nificant hazard potential. A major breach at top of dam would probably result in the loss of 3 to 4 lives and appreciable damage.

NATIONAL DAM INSPECTION PROGRAM PHASE I INSPECTION REPORT

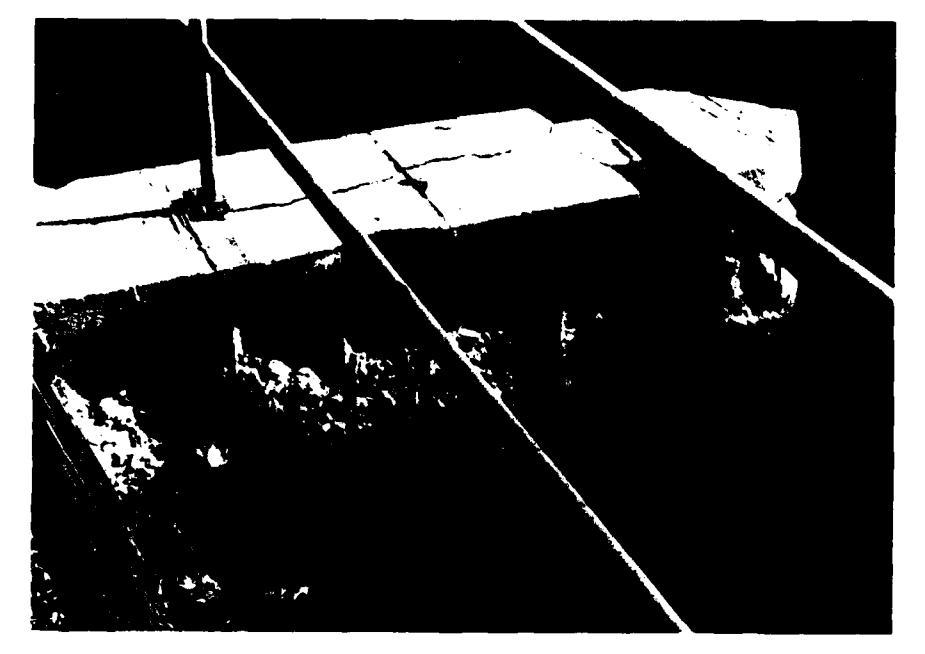
c. Appurtenant Structures. Visual inspection of the gate structure on the upstream face of the powerhouse was limited to the visible portion above the water line. The leading edges of the gate intake structure have deteriorated and reinforcing steel is exposed above the water line. (See Appendix C - Figure 8.) Portions of the gate support walls have eroded up to 3 inches. Limited areas of the concrete walkway in front of the trash racks have also eroded, exposing some of the reinforcing steel in the deck. The submerged condition of the gates prevented inspection; however, the gate operating mechanisms were noted to be in good condition. (See Appendix C - Figure 9.)

Figure 8 - Looking at the deteriorated leading edges of the gate intake structure. Note the exposed reinforcing steel.

(2) Design and specify remedial repairs for the deteriorated concrete in the dam and appurtenant structures.
