#### NATIONAL DAM INSPECTION PROGRAM PHASE I INSPECTION REPORT

Identification No.:NH00073Name of Dam:Smith Pond DamTown:EnfieldCounty and State:Grafton County, New HampshireStream:Unnamed tributary to Mascoma LakeDate of Inspection:May 9, 1979

#### NATIONAL DAM INSPECTION PROGRAM PHASE I INSPECTION REPORT SMITH POND DAM

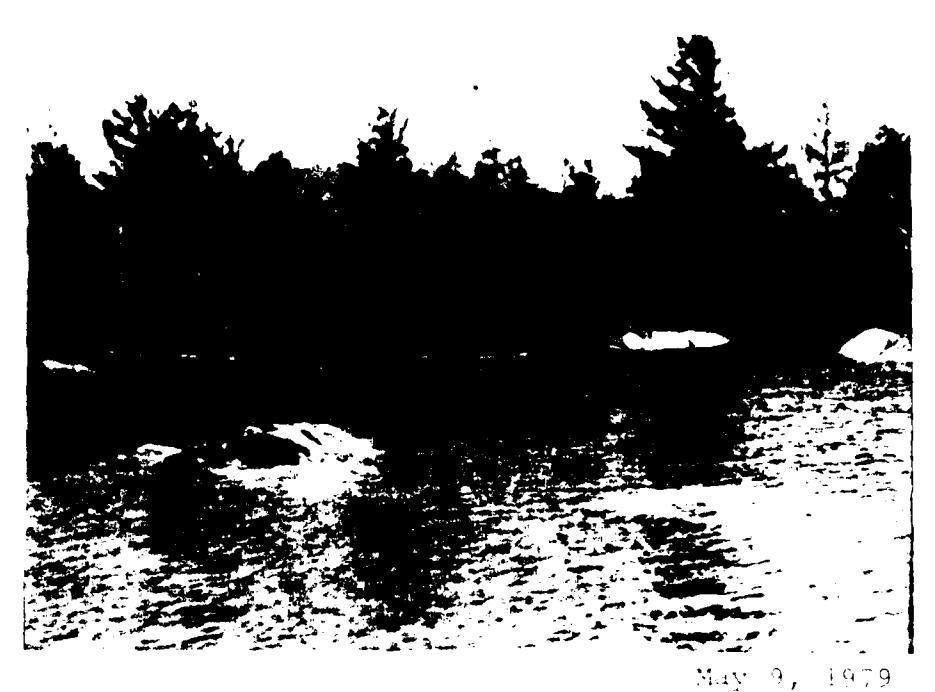
Figure 2 - Looking at upstream face of the dam from the west bank of the pond.

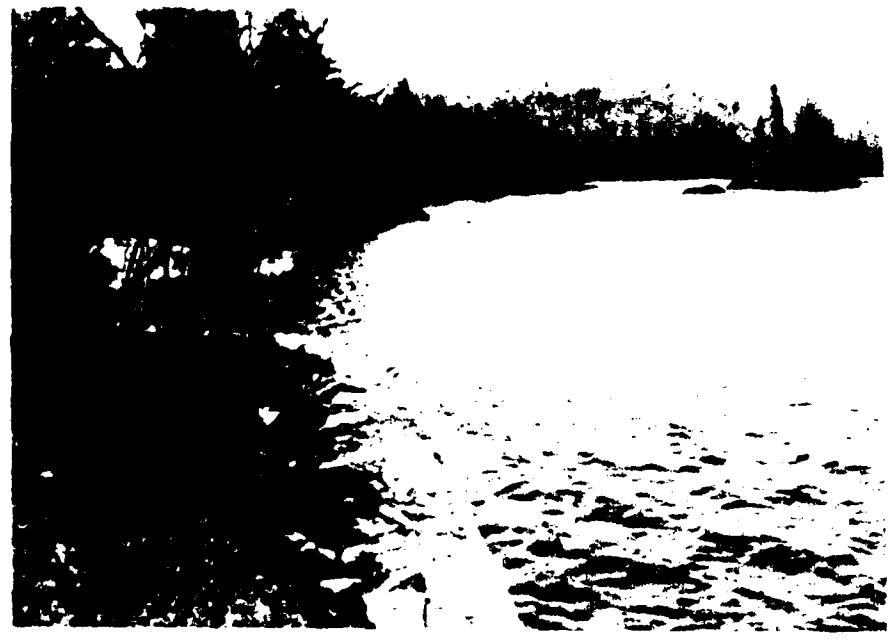
The one-foot-deep depression on the crest of the dam above the low-level outlet pipe is evidence of some past problem, which may have been overtopping, piping, or collapse of or leakage and piping into the low-level outlet pipe. The same problem may develop again and could lead to failure of the dam if remedial action is not taken. The concrete facing on the upstream face is in poor condition (poorly constructed).

Figure 3 - Looking eastward along crest of main dam from the west abutment. Note irregularity of concrete facing.

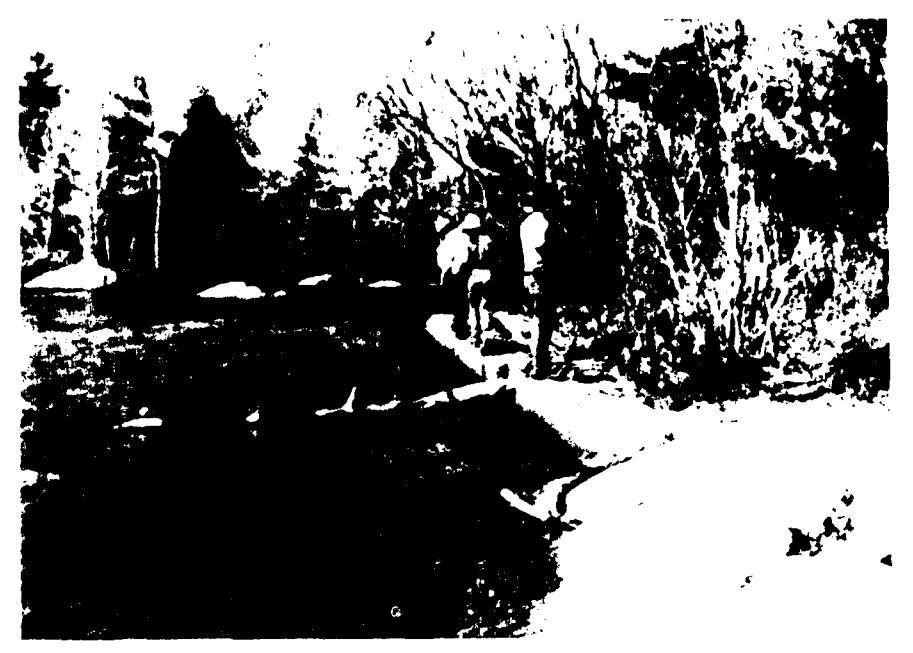
Based on the visual inspection, Smith Pond Dam is in poor condition. Brush is growing on the crest of the dam. If it is allowed to continue growing, the crest will become covered with trees. If a tree then blows over and its roots are pulled out, or if a tree dies or is cut and its roots rot, serious seepage and erosion problems may result.

Figure 6 - Looking west along crest of main dam. Note the brush and saplings growing on the crest of the dam.
