MERRIMACK RIVER BASIN EPSOM, NEW HAMPSHIRE

NORTHWOOD LAKE DAM NH 00285

PHASE I INSPECTION REPORT NATIONAL DAM INSPECTION PROGRAM

OCTOBER 1978 Approximity STATEMENT A Approximity STATEMENT A Approximity STATEMENT A Distriction Unlimited 85 6 18 V45

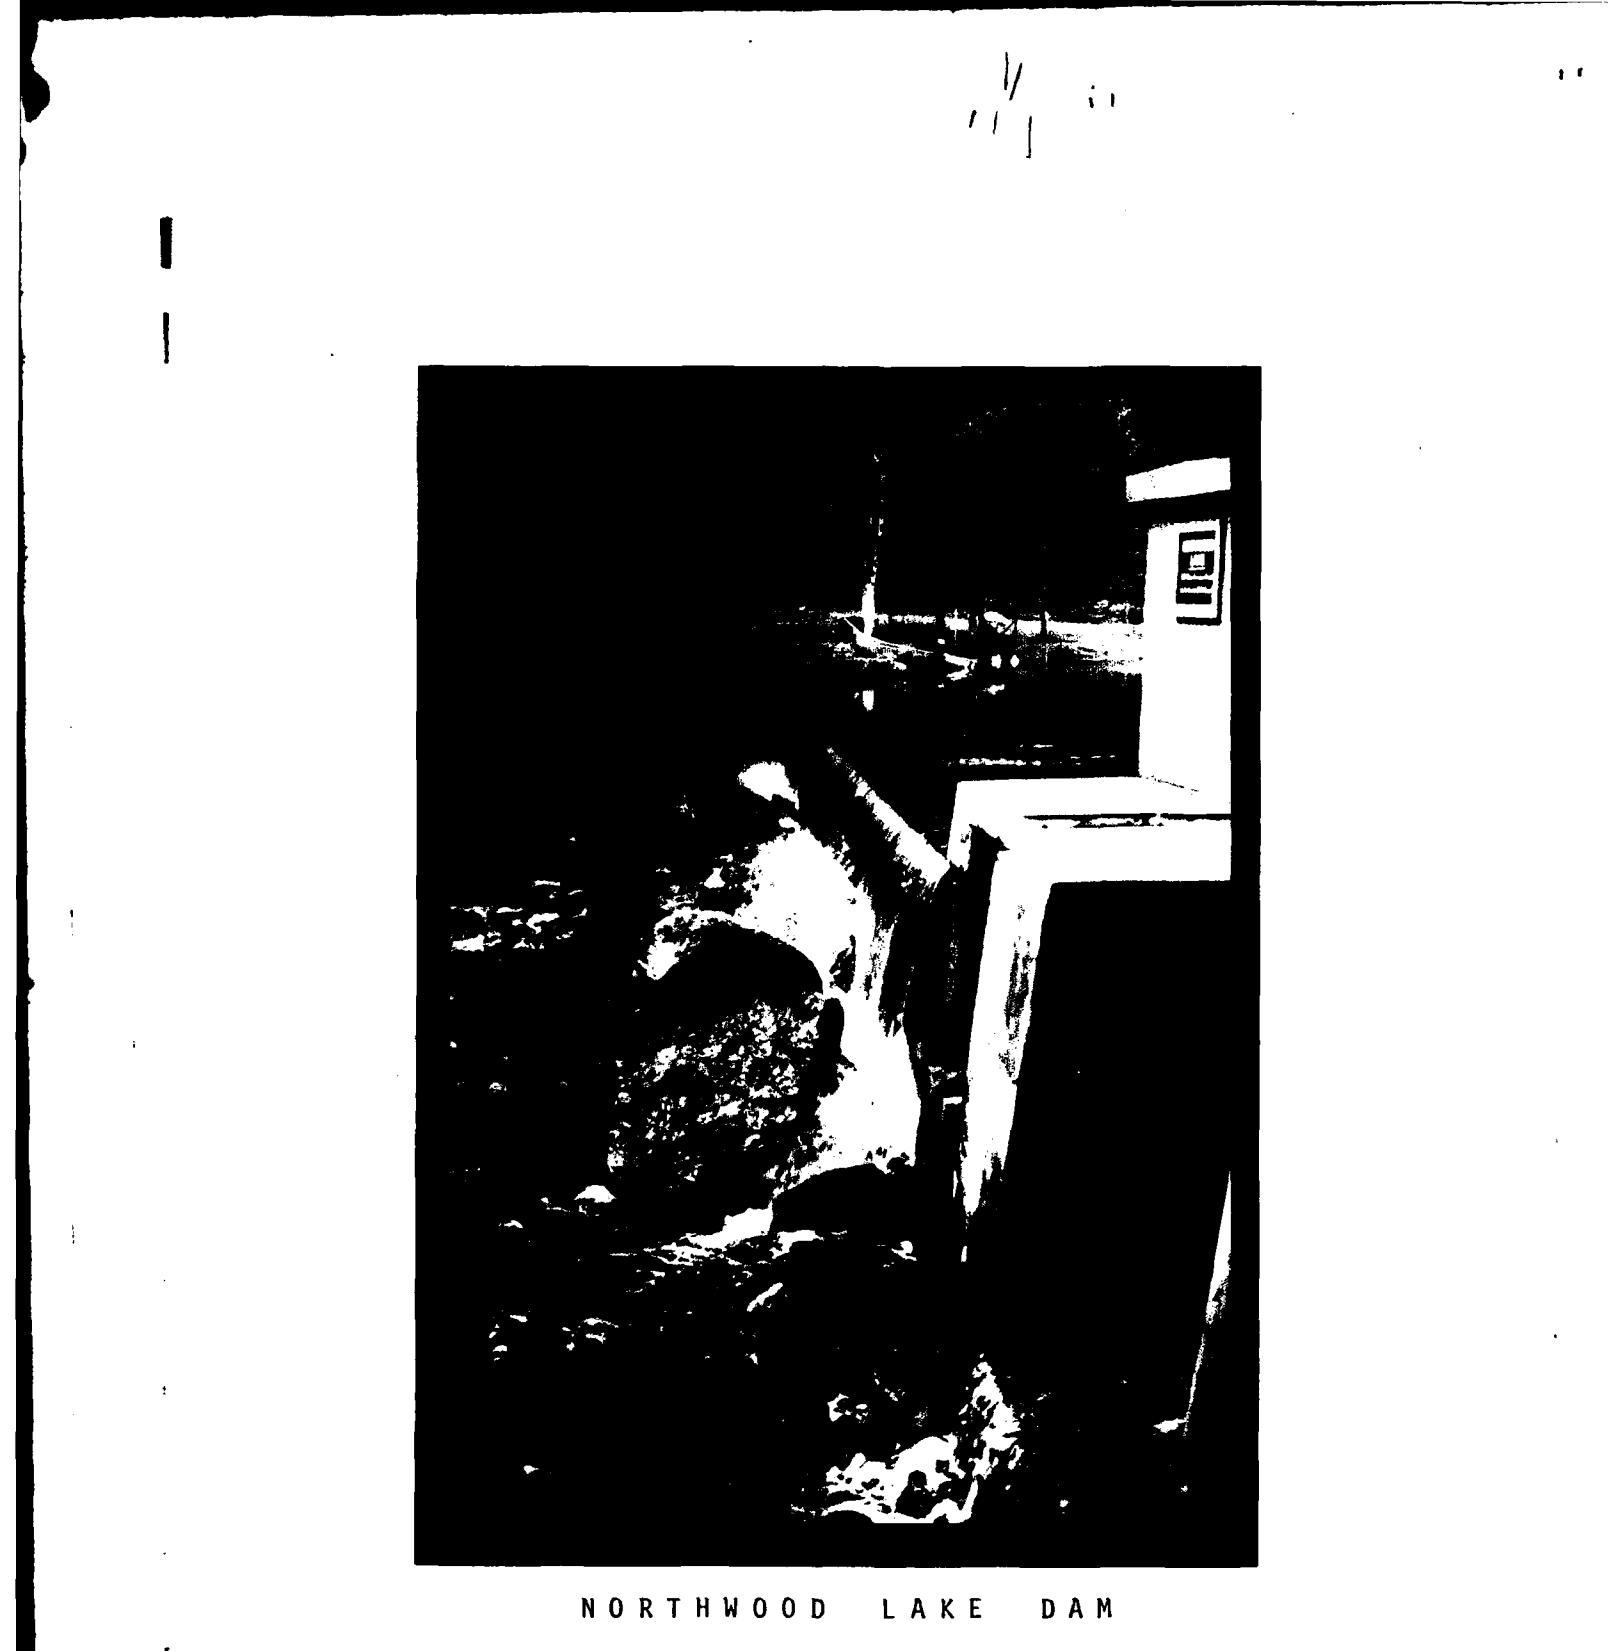
General view of the dam from downstream looking toward the right abutment. The stop plank section and the low level outlet are in the foreground, the spillway section is in the background.

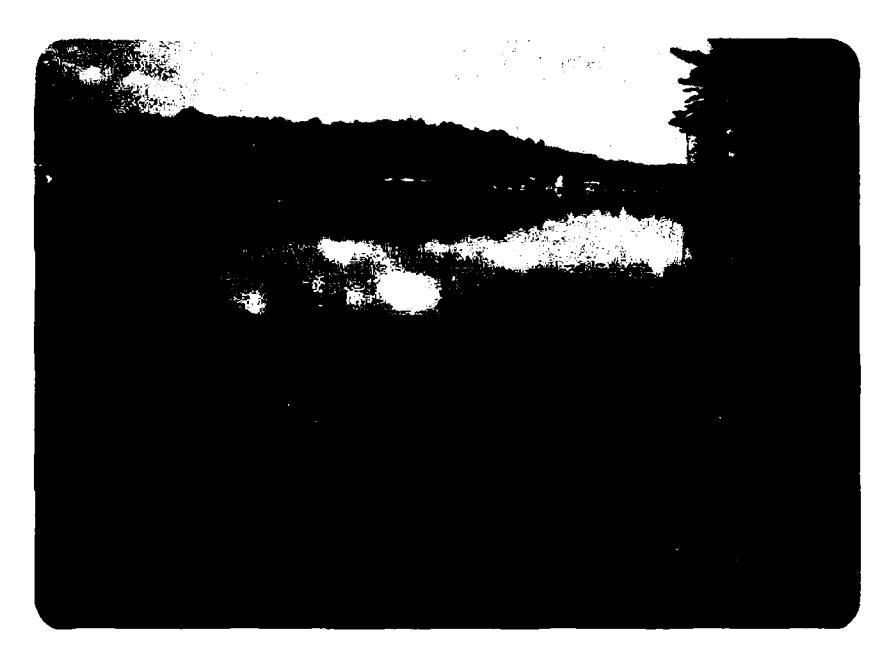
Photo 6 -View of the rim of Northwood Lake taken from the dam axis.
