16	
4	SACO RIVER BASIN
156	CONWAY, NEW HAMPSHIRE
	PEQUAWKET POWER
	COMPANY DAM
	NH 00322
	NHWRB NO. 52.02
	PHASE I INSPECTION REPORT
NA	TIONAL DAM INSPECTION PROGRAM
	JUL 0 9 1985
ľ	DEPARTMENT OF THE ARMY NEW ENGLAND DIVISION, CORPS OF ENGINEERS WALTHAM, MASS. 02154
÷	JUNE 1980 DISTRUCTION STATEMENT A Approved for public released Distribution Unlimited

Identification No: NH 00322

NATIONAL DAM INSPECTION PROGRAM PHASE I INSPECTION REPORT PEQUAWKET POWER COMPANY DAM

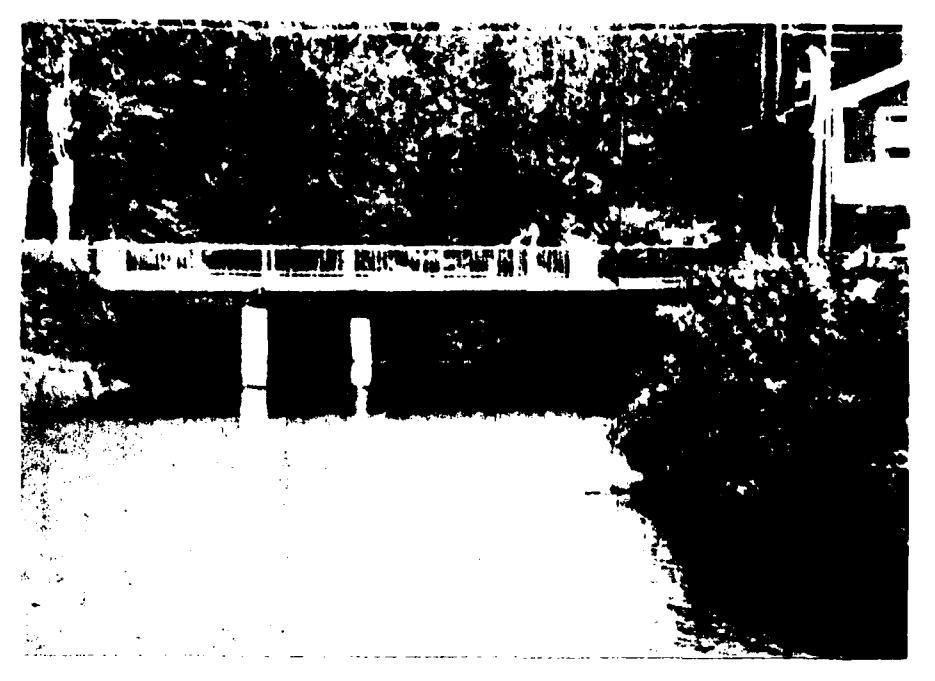
Photo No. 1 - Main Street Bridge and approach channel to dam

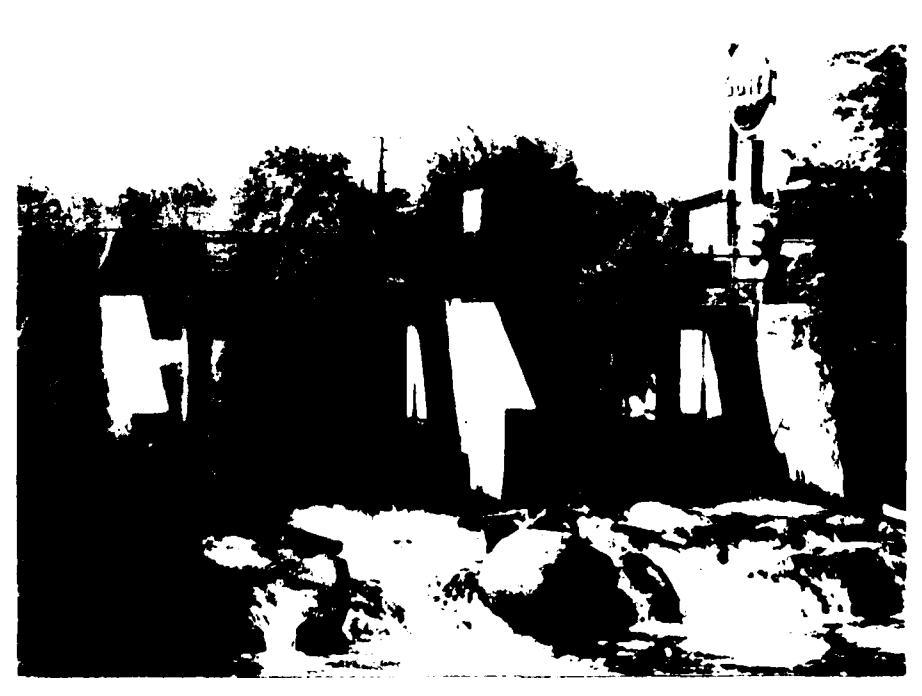
Photo No. 2 - General view of downstream face of dam
