MERRIMACK RIVER BASIN FRANKLIN, NEW HAMPSHIRE

CHANCE BROOK DAM NH 00410

# PHASE I INSPECTION REPORT NATIONAL DAM INSPECTION PROGRAM

**AUGUST** 1978

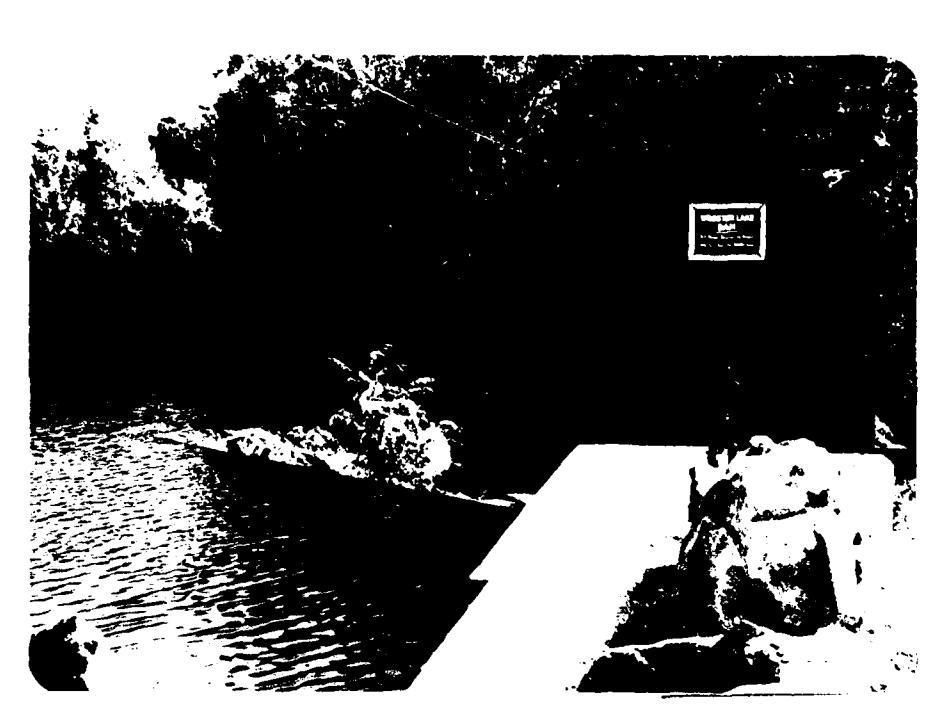
Overview from right abutment

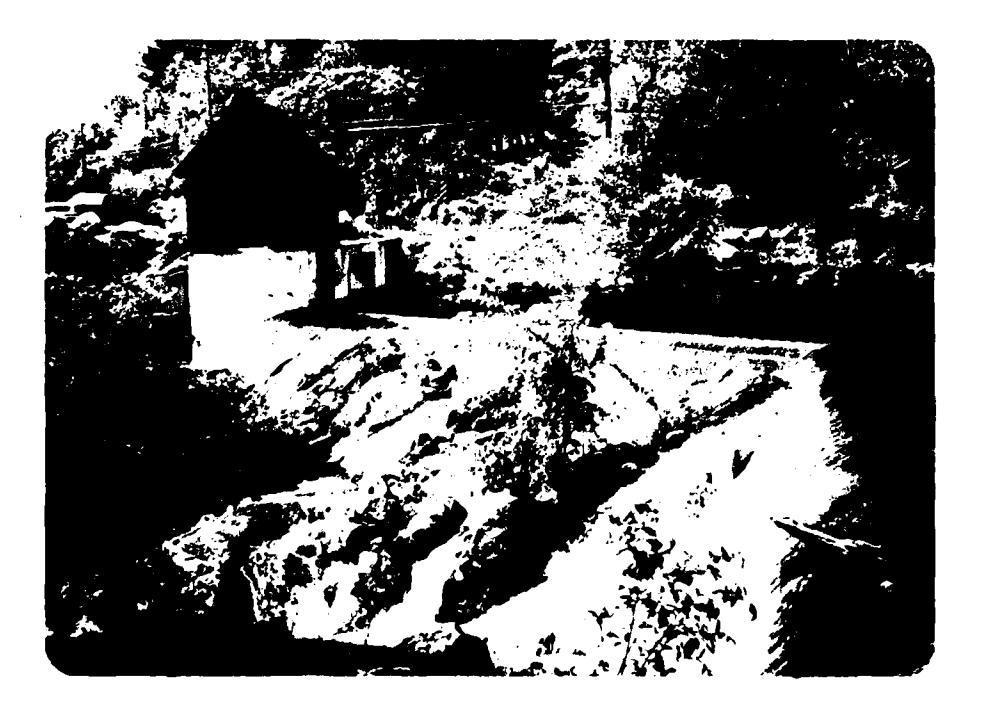
Overview from left abutment

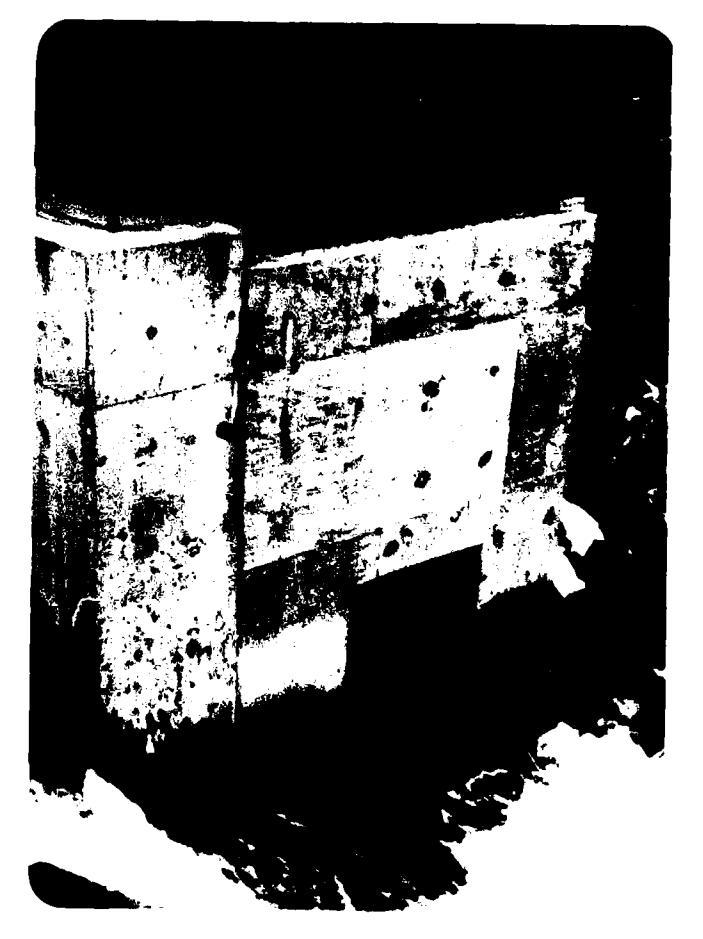
2. Detail of gatehouse outlet from downstream right side
