MERRIMACK RIVER BASIN CONCORD, NEW HAMPSHIRE

ST. PAULS SCHOOL DAM NH 00361

NHWRB NO. 51.25

PHASE I INSPECTION REPORT NATIONAL DAM INSPECTION PROGRAM

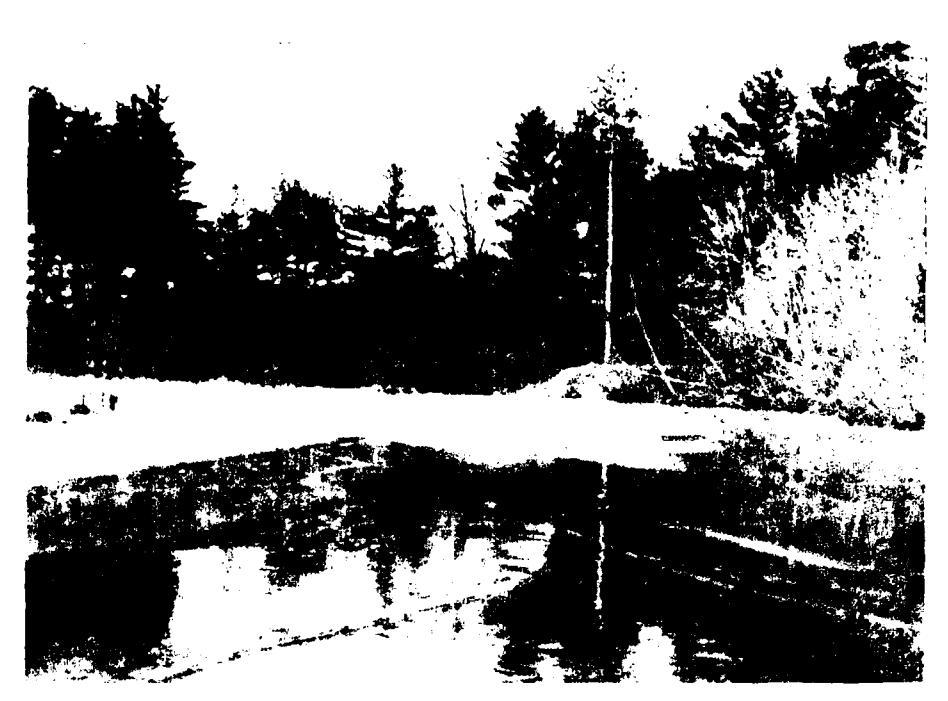
d. <u>Reservoir Area</u>. The slopes of the reservoir appear to be stable. No evidence of significant sedimentation was observed. The approach channel to the dam is unobstructed. (See Photo No. 1.)

Photo No. 1 - General view of pond from dam.

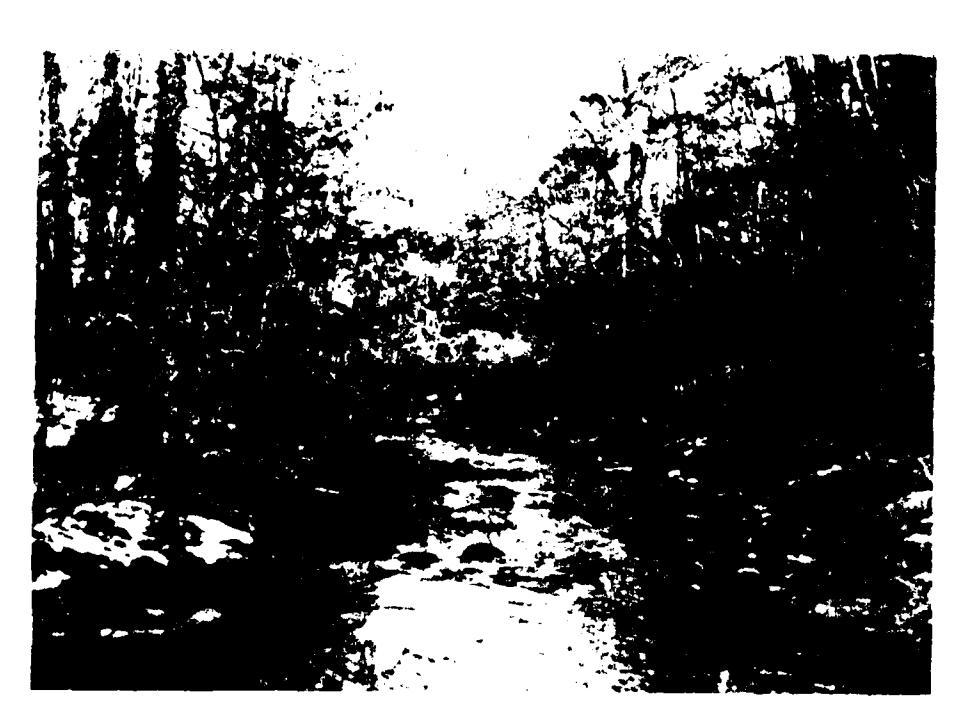
Froto No. 9 - View of Howestriam channel approximately 100 feet below dam.

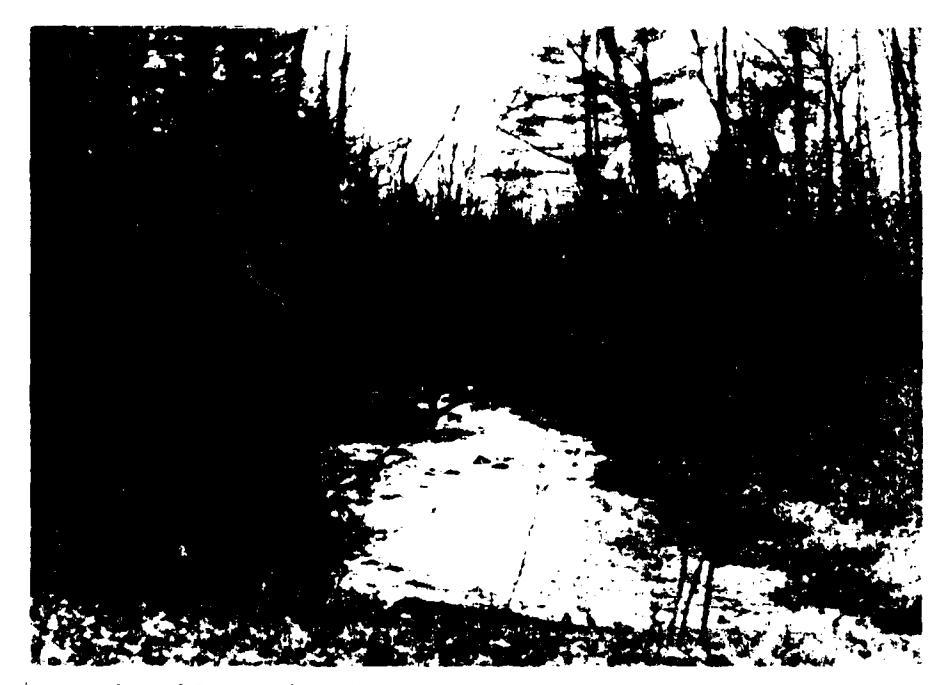
booto No. 10 - Ticw looking upstream from bridge approxicately 1,000 feet below dam.

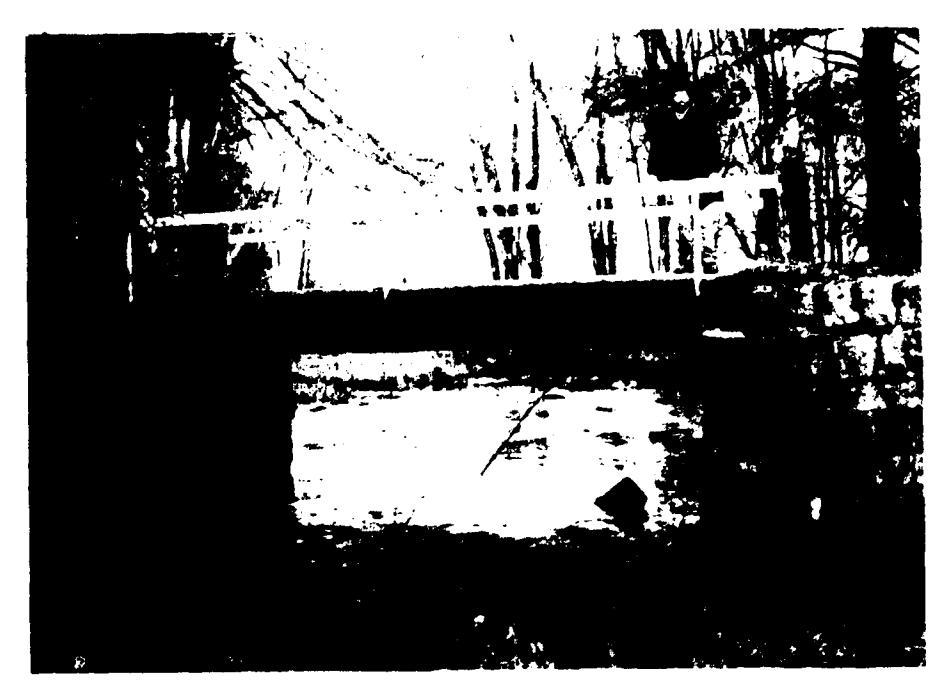
Photo No. 11 - View of upstrcam face of bridge.
