STORRS POND DAM NH 00050 NHWRB 108.07

## CONNECTICUT RIVER BASIN HANOVER, NEW HAMPSHIRE

PHASE I INSPECTION REPORT NATIONAL DAM INSPECTION PROGRAM

#### NATIONAL DAM INSPECTION PROGRAM PHASE I - INSPECTION REPORT BRIEF ASSESSMENT

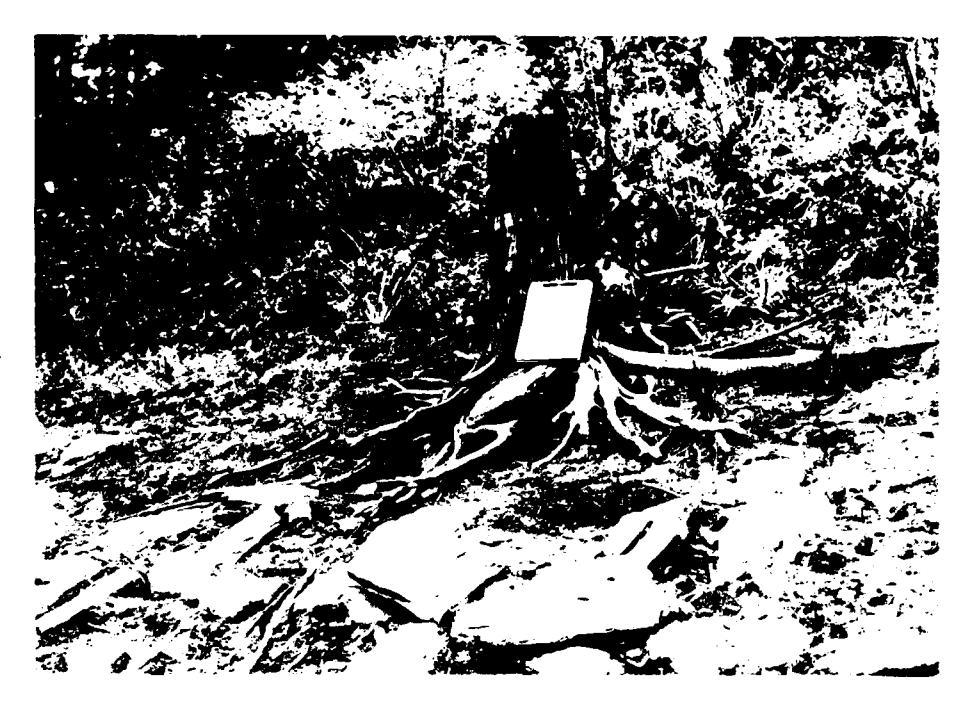
PHOTO NO. 7 - Rotted tree stump on upstream face of dam.

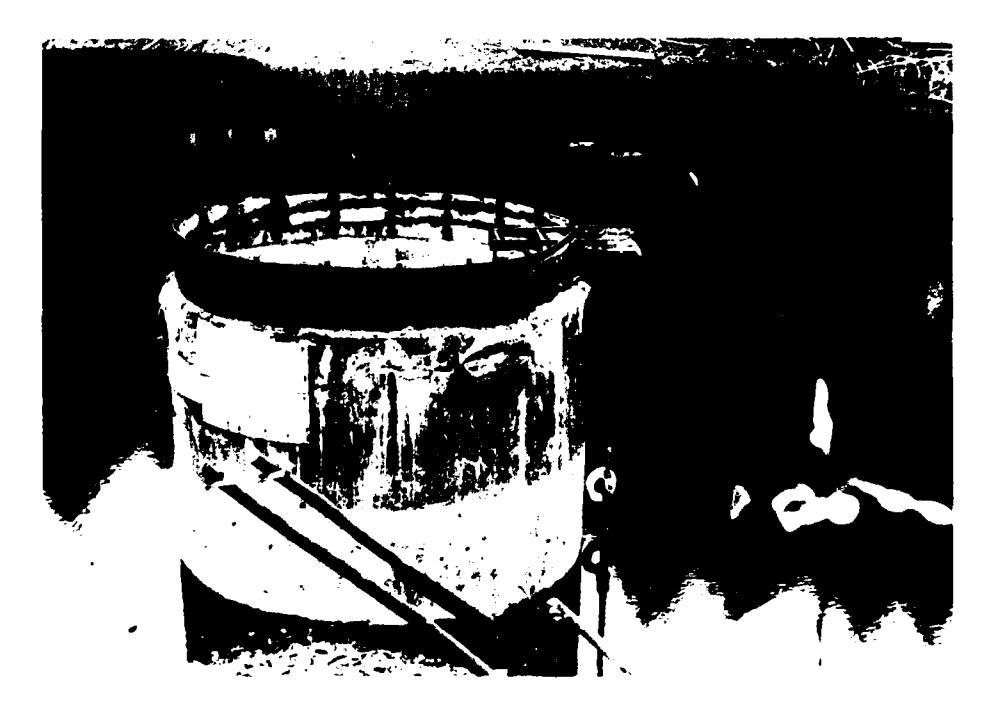
The circular spillway structure, as seen in Photo Nos. 8, 9 & 10, consists of three elements: a circular inlet overflow control, a vertical transition (cylindrical structure) and outlet tunnel. The circular spillway structure has provision for crest adjustment which was in place. The spillway structure is located at the toe of the embankment near the center of the Visual inspection revealed that the concrete spillway dam. structure has extensive decay on the top and the side surface. (Photo Nos. 9 & 10). The gate operating mechanism appeared to be operational, as the reservoir level was recently lowered. There was no means of access to the gate operating mechanism. There were remains of supports for a catwalk from the dam to the gate wheel as seen in Photo No. 11. The outlet gate, as seen in Photo No. 13, was subject to some minor leakage but otherwise appeared to be in fair condition.

PHOTO NO. 8 - Spillway crest and upper portion of riser.

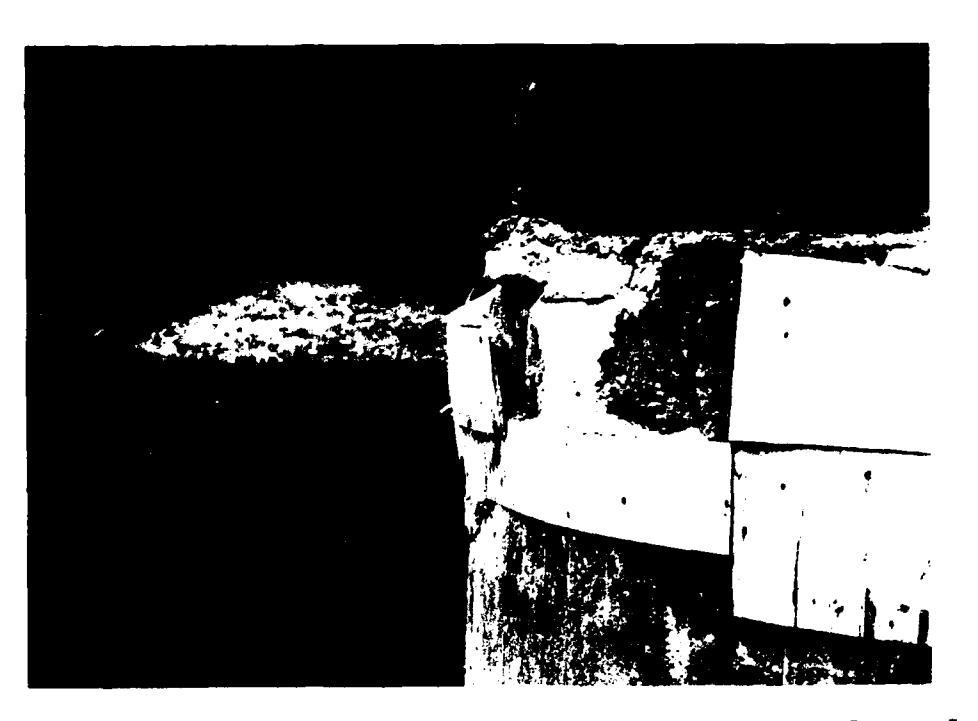
PHOTO NO. 9 - Detail of concrete spillway. Note plywood patch forms.
