Inclosed is a copy of the Clarkville Pond Dam (RI-01309) Phase I Inspection Report, prepared under the National Program for Inspection of Non-Federal Dams. This report is based upon a visual inspection, a review of past performance, and a preliminary hydrological analysis.

NATIONAL DAM INSPECTION PROGRAM

PHASE I - INSPECTION REPORT

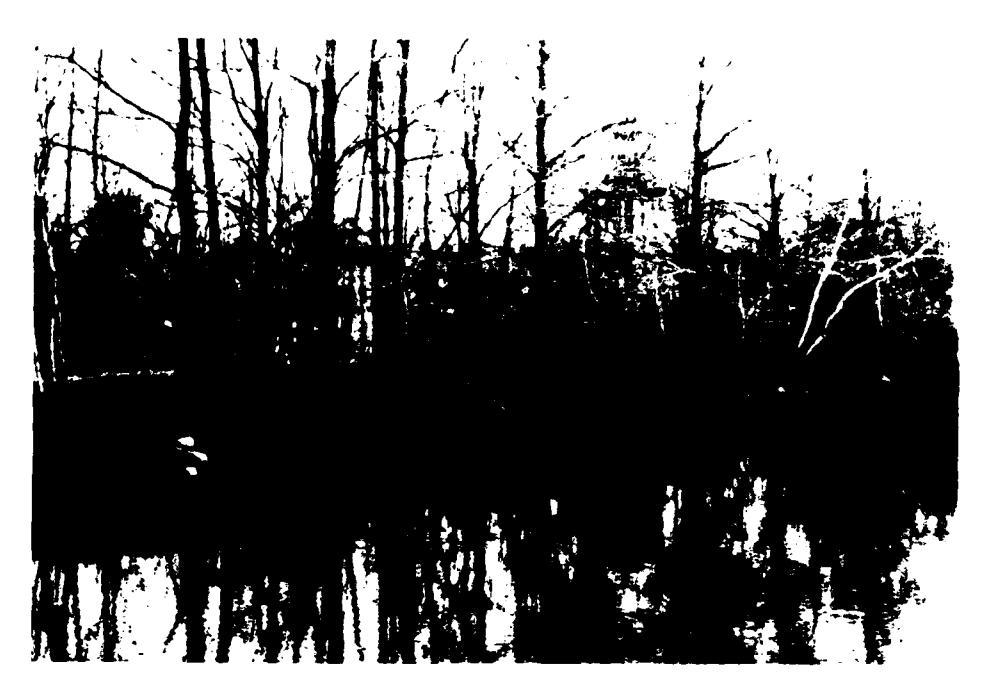
Photo 1. Overall view of dam from left abutment. Note spillway training wall at left, extensive tree growth on dam, and irregular riprap on upstream slope. Note faint outline of white mill structure in background.

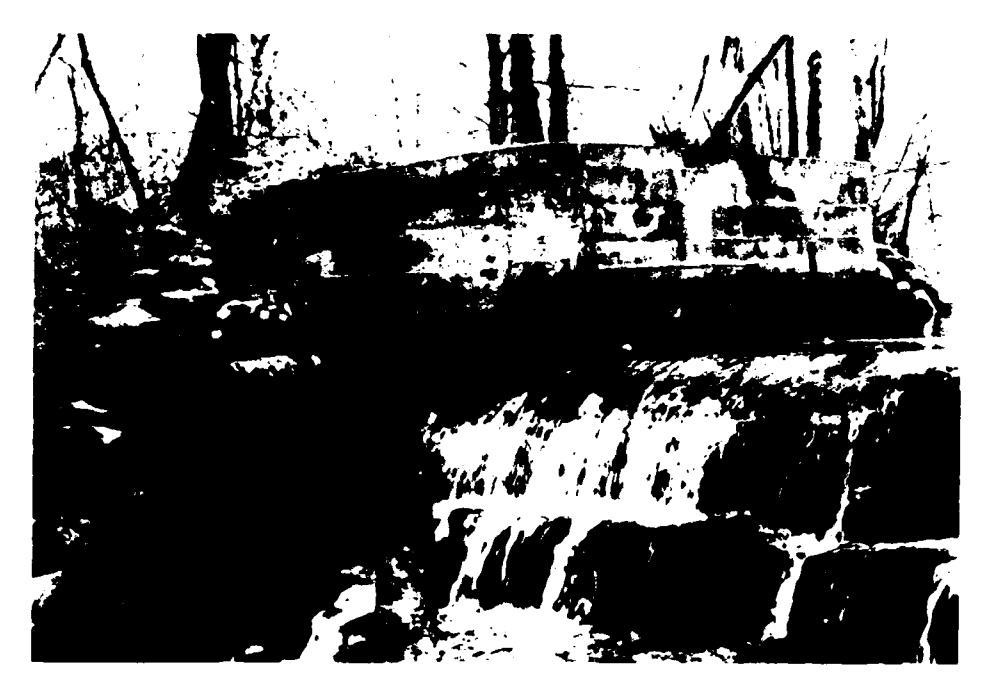
Photo 4.

4. Right training wall of spillway. Note undermining in reinforced concrete wall and steel bars on crest of spillway.

- f. The spillway training walls should be reconstructed. The deteriorated concrete walls must be removed and new walls should be erected according to plans prepared by an engineer.
- g. The power canal intake structure should be reconstructed or removed and properly filled.
- h. The riprap protection along the upstream face of the dam embankment should be re-established.

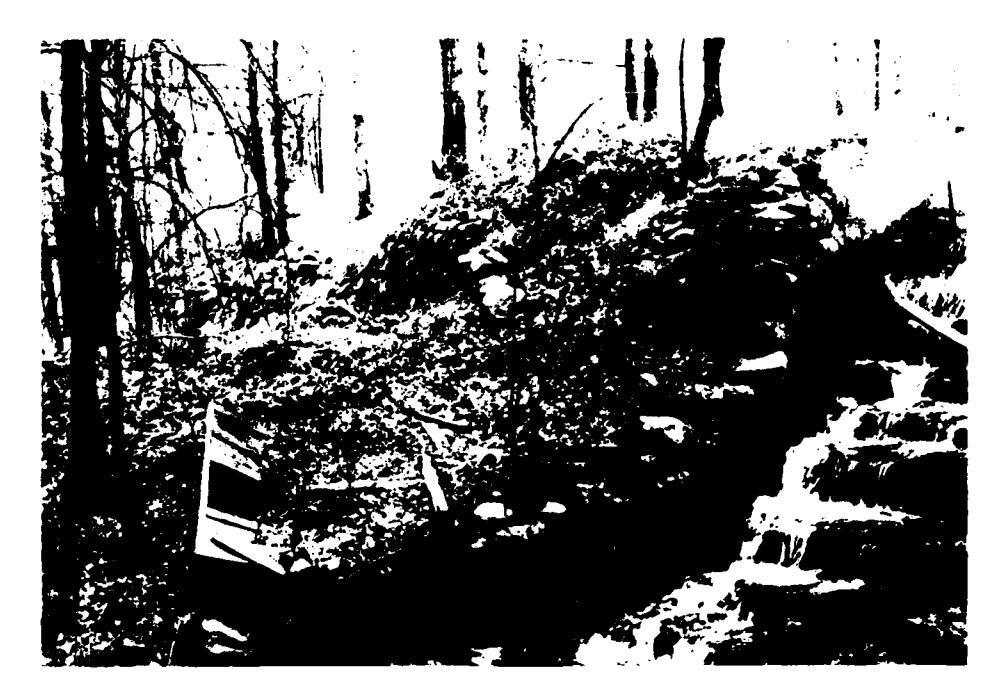
Photo 5. Right side of spillway looking towards dam embankment. Note sloughing and collapsed sections of downstream stone wall of dam.

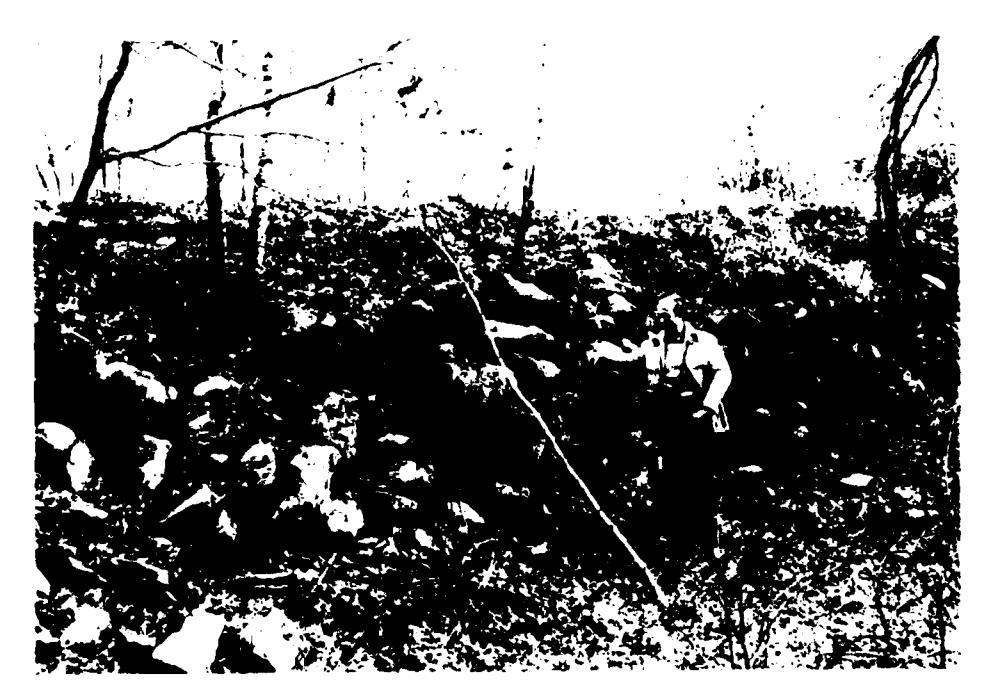
Photo 6. Downstream stone wall near right abutment of dam. Note collapsed stone wall and tree growing behind wall.

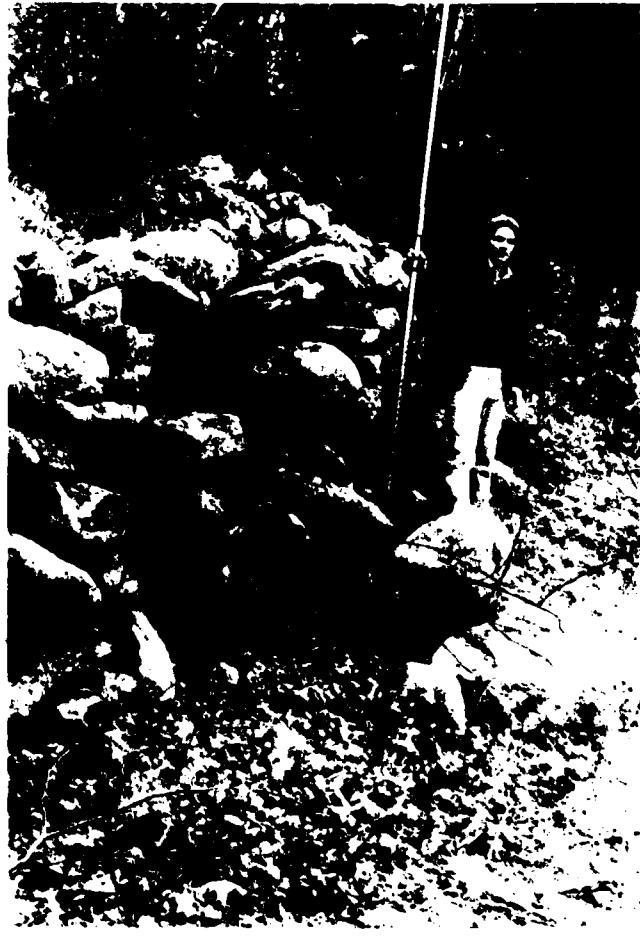
Photo 10

3. Downstream slope: The state of advanced deterioration of the downstream slope (1H:1V) is due to the collapse of the stone walls, sloughing and erosion. Approximately within 30 feet to the right of the spillway, the wall is completely collapsed and there is extensive sloughing on the earth embankment (Photo 5). There is also a 20 inch diameter tree growing on the downstream slope in this area. Approximately 70 feet from the spillway, another section of the wall has crumbled, due probably in part to the additional pressure of a tree growing at this location. There are large voids in the wall and the earth embankment is sloughing. Another section of the wall, approximately 50 feet left of the power canal, has bulged extensively (Photo 9 and 10).

Same stone wall viewed from downstream side. Note large openings between stones.
