REPORT DOCUMENTAT	READ INSTRUCTIONS	
I. REPORT NUMBER	2. GOVT ACCESSION NO	3. RECIPIENT'S CATALOG NUMBER
<b>T</b> 00016/0000		
TITLE (and Subilie)		5. TYPE OF REPORT & PERIOD COVERED
Hewell Brook Dam Site No. 3		INSPECTION REPORT
NATIONAL PROGRAM FOR INSPECTION	OF NON-FEDERAL	6. PERFORMING ORG. REPORT NUMBER
DAMS		S. CONTRACT OR GRANT NUMBER(+)
U.S. ARMY CORPS OF ENGINEERS NEW ENGLAND DIVISION		
. PERFORMING ORGANIZATION NAME AND AD	DRESS	10. PROGRAM ELEMENT, PROJECT, TASK AREA & WORK UNIT NUMBERS

Inclosed is a copy of the Jewell Brook Dam Site No. 3 Phase I Inspection Report, which was prepared under the National Program for Inspection of Non-Federal Dams. This report is presented for your use and is based upon a visual inspection, a review of the past performance and a brief hydrological study of the dam. A brief assessment is included at the beginning of the report. I have approved the report and support the findings and recommendations described in Section 7 and ask that you keep me informed of the actions taken to implement them. This follow-up action is a vitally important part of this program.

# OVERVIEW PHOTOGRAPH JEWELL BROOK DAM SITE NO. 3

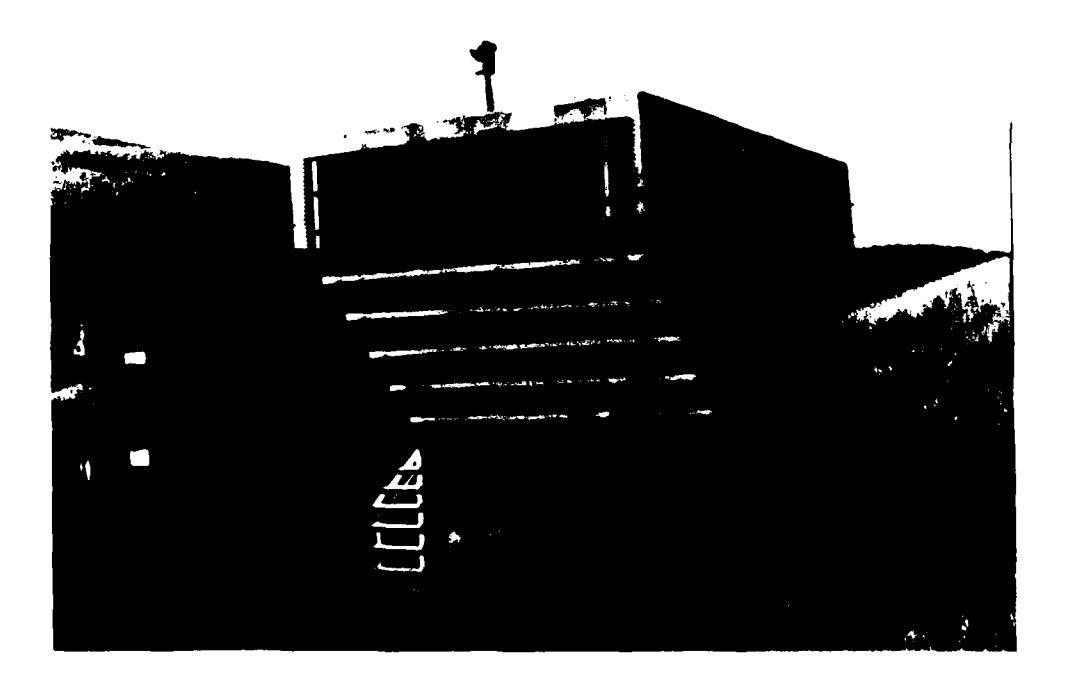
The intake structure (Photo 12) is in good condition. The concrete shows no signs of cracking or of efflorescence. The condition of the steel trash racks is good. Access to the top of the tower is provided by a makeshift rope ladder in poor condition. Because of the auxiliary recreational use of this structure it is suspected that the rope ladder was installed by persons other than the owners.

#12 PRINCIPAL SPILLWAY RISER

- 1. All slopes of the dam should be mowed annually, including the steeper ones.
- 2. Repair the shallow sloughs on upstream slope and the wave cut on upstream side of the right abutment. These areas should be observed on an annual basis to detect any future problems.
- 3. Place filtered erosion-control material in the gully that has formed on downstream half of the downstream right abutment contact line.
- 4. Annually inspect and repair minor erosion that has occurred under root mat of grass cover.
- 5. The outflow from the downstream drain should be observed periodically so that any changes in seepage conditions will be detected. Also, monitor downstream slopes and abutments, preferably during or just after periods of high reservior level.
- 6. Remove rope ladder and use a portable ladder for access to the control tower of the intake structure.

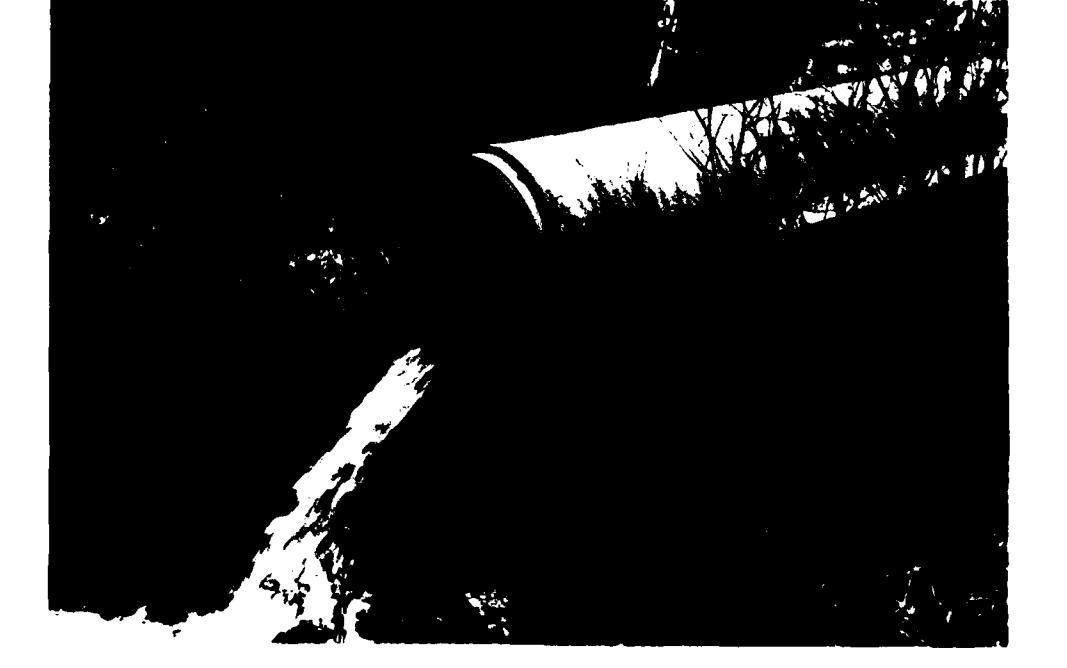
The outlet conduit is exposed approximately 25 feet at the discharge end (Photo 13). Minor efflorescence was observed on the cradle which supports the outlet end of the concrete conduit. A hairline crack with efflorescence was detected at the downstream conduit joint but no seepage was evident. The condition of the conduit is generally good (Photo 14).

#13 OUTLET CONDUIT
