REPORT DOCUMENTATION PAGE	READ INSTRUCTIONS
REPORT NUMBER	NO. 3. RECIPIENT'S CATALOG NUMBER
An A 1.56	AIP .
TTLE (and Sublille)	5. TYPE OF REPORT & PERIOD COVERE
Chittenden Dam	INSPECTION REPORT
NATIONAL PROGRAM FOR INSPECTION OF NON-FEDERAL	6. PERFORMING ONG. REPORT NUMBER
AUTHOR(a)	8. CONTRACT OR GRANT NUMBER(+)
U.S. ARMY CORPS OF ENGINEERS	
VEW ENGLAND DIVISION	
PERFORMING ORGANIZATION NAME AND ADDRESS	10. PROGRAM ELEMENT, PROJECT, TASP AREA & WORK UNIT NUMBERS
CONTROLLING OFFICE NAME AND ADDRESS	12. REPORT DATE
IEW ENGLAND DIVISION, NEDED	January 1979
24 TRAPELO ROAD, WALTHAM, MA. 02254	55
MONITORING AGENCY NAME & ADDRESS(If different from Controlling Offic	e) 18. SECURITY CLASS. (of this report)
	UNCLASSIFIED
	The DECLASSIFICATION DOWNGRADING
DISTRIBUTION STATEMENT (of the obstract encored in Block 20, if differen	ED 1 from Report)
APPROVAL FOR PUBLIC RELEASE: DISTRIBUTION UNLIMIT	ED 1 frem Report)
APPROVAL FOR PUBLIC RELEASE: DISTRIBUTION UNLIMIT	ED 1 from Report)

I am forwarding to you a copy of the Chittenden Dam Phase I Inspection Report, which was prepared under the National Program for Inspection of Non-Federal Dams. This report is presented for your use and is based up

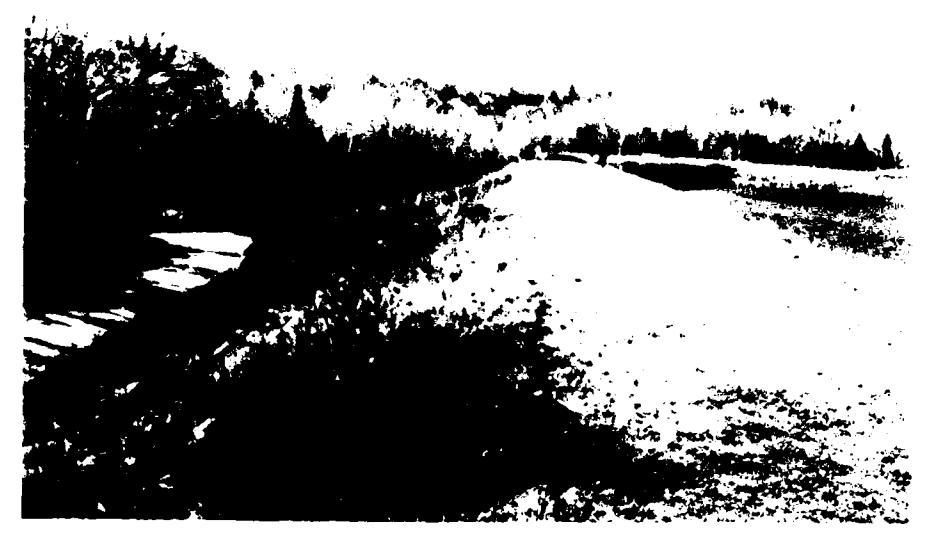
The crest of the dam has no pavement. Photo 5 shows a typical section of the crest which has an excellent grass cover. There was no evidence of cracking or misalignment due to significant embankment movements.

PHOTO NO. 5 - View of dam (downstream slope) from left abutment. Note excellent grass cover at crest of the dam.

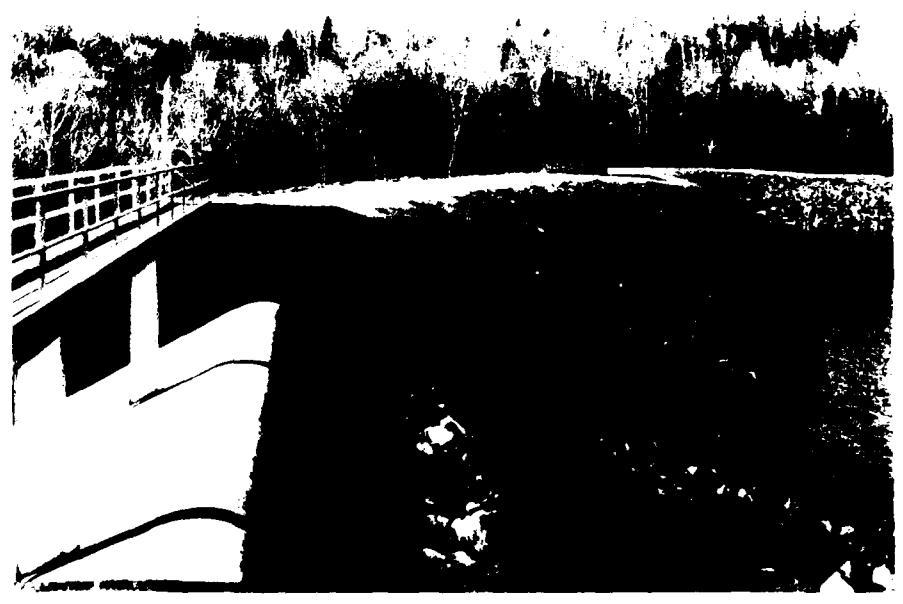
PHOTO NO. 11 - Spillway crest viewed from left training wall. No misalignment of concrete structures due to embankment movement.

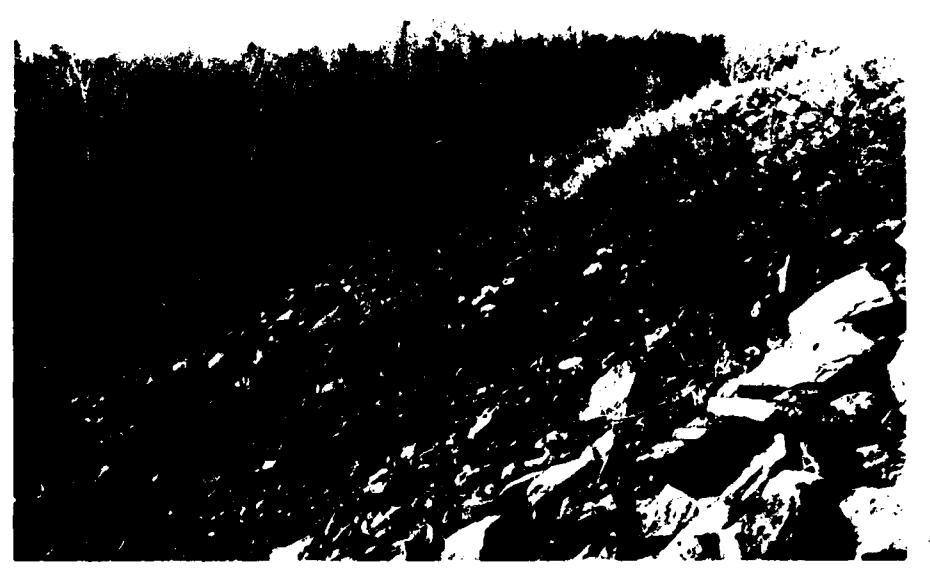
PHOTO NO. 16 - Downstream slope of dam viewed from about midheight, adjacent to right training wall of spillway.

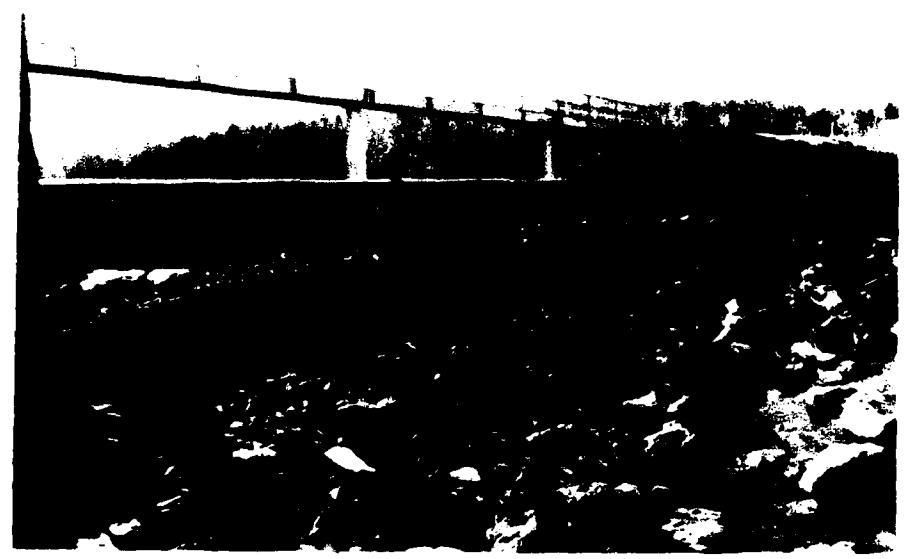
The foot bridge over the spillway is a three span continuous beam structure (2-15" channel shapes). The main longitudinal beams, bearing plates, connections, railing and wooden floor are generally in good condition as shown in Photos 20, 21 and 22.

PHOTO NO. 20 - View of spillway and foot bridge from reservoir side.

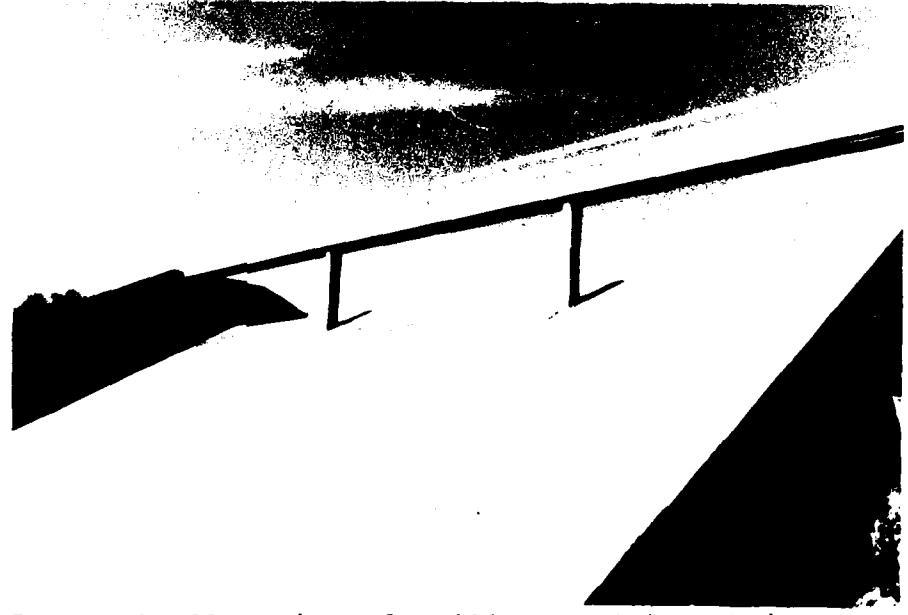
PHOTO NO. 21 - View of spillway and foot bridge structure from left training wall (downstream side).

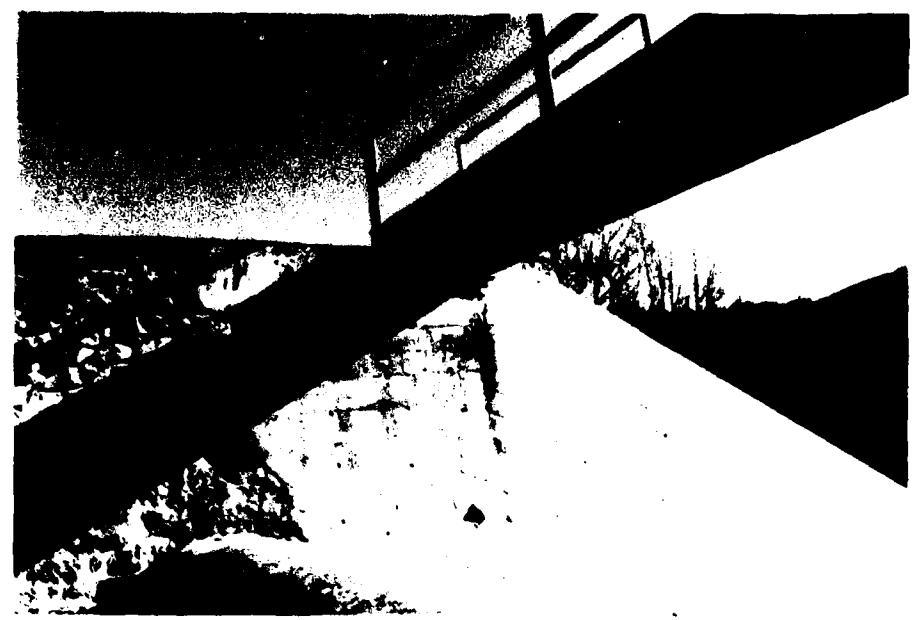
PHOTO NO. 22 - Left training wall at spillway crest with detail of foot bridge support.
